NYSERDA Deep Energy Retrofits: House 2 Report

Exterior Rigid Foam Retrofit Strategy

November 12, 2012

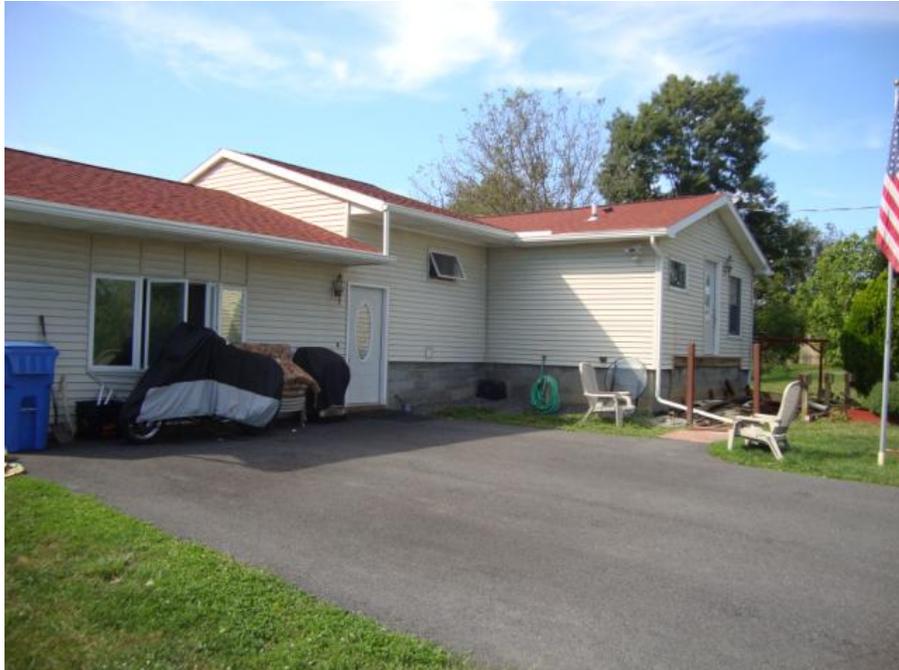
This photo shows the front of House 2 before any DER work was done. The removal of the front deck by the homeowners can be seen on the right side of the photo.

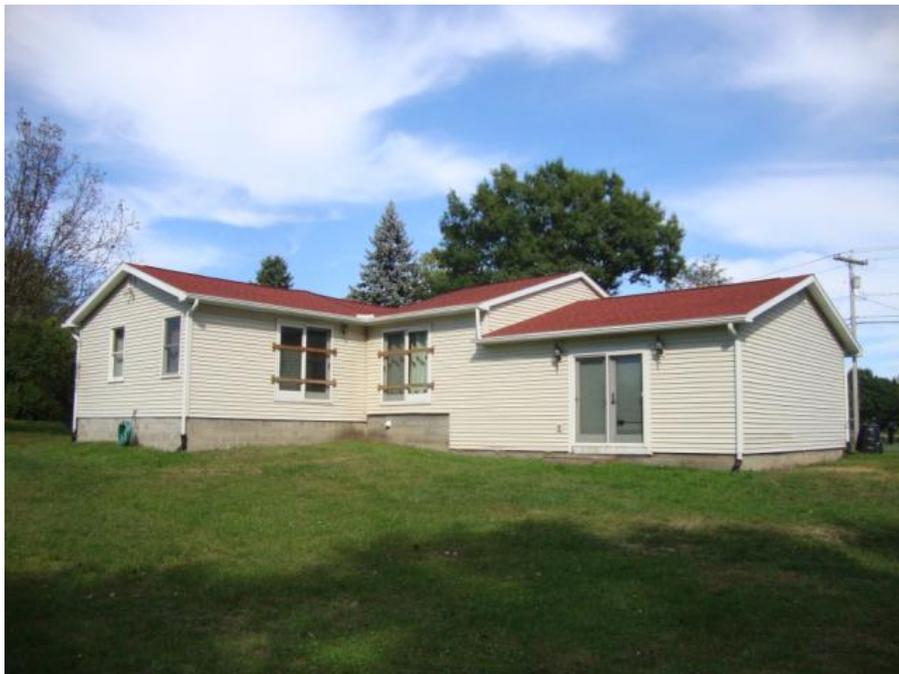
This view shows the back of the house before any DER work was done. Notice the removal of the back deck (center of photo) by the homeowners.

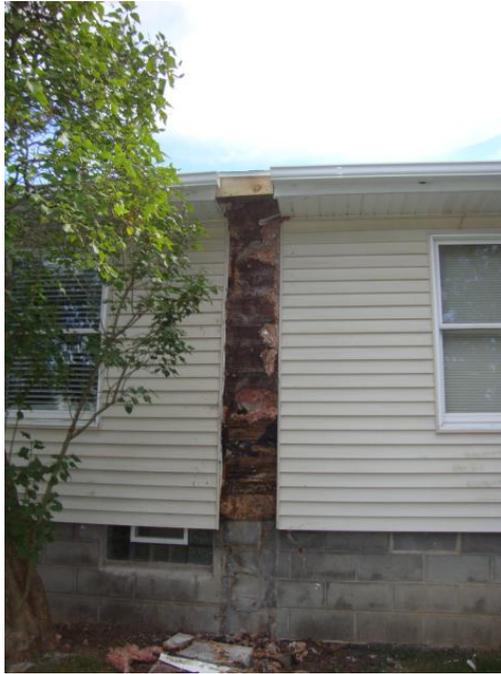
This view shows the removal of the chimney before any DER work was done.

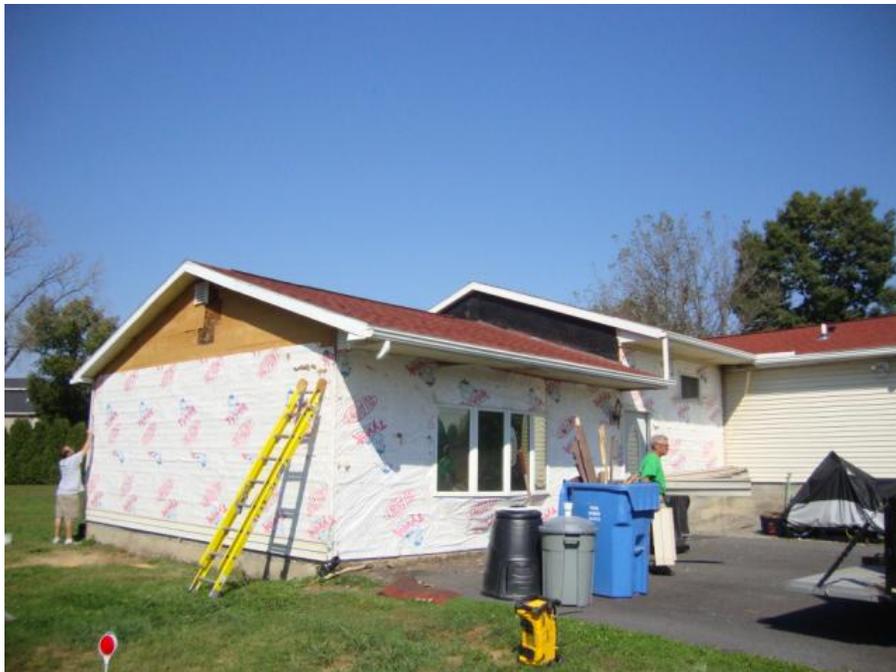
Removal of existing siding is shown here. The Tyvek® building wrap shown here was original to the construction of the house and was kept where it was still intact.

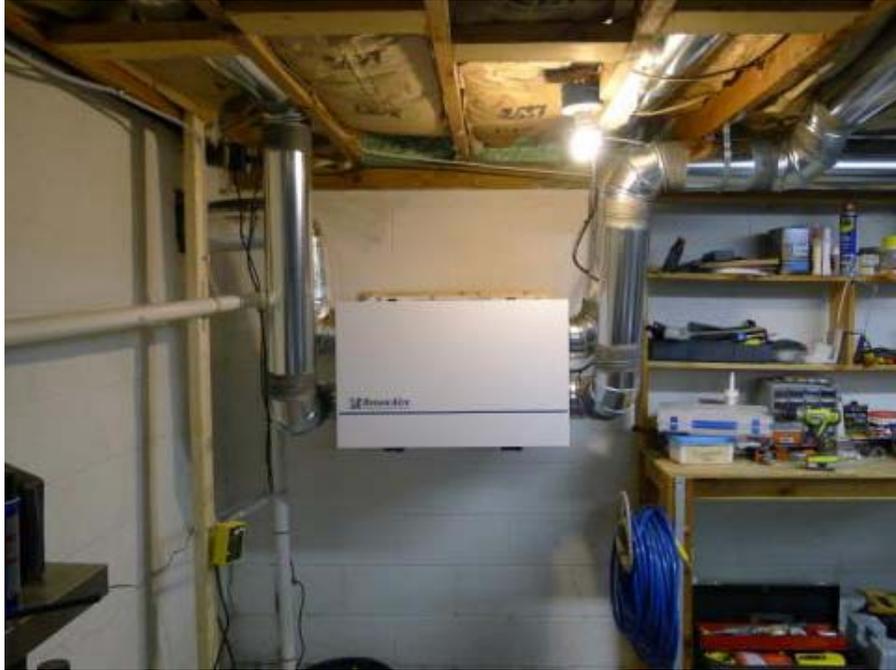
This view shows the energy recovery ventilator (ERV), model number Renewaire EV130, that had been installed in the basement.

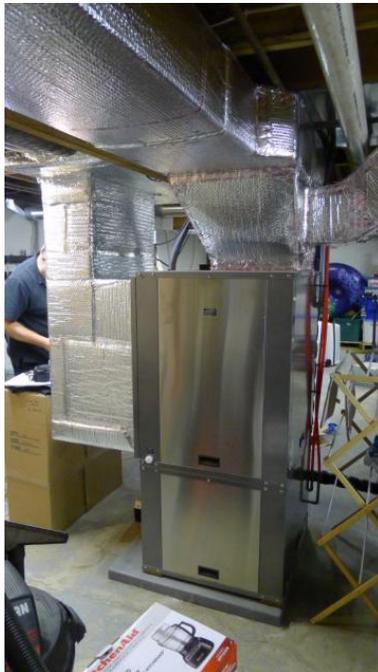
All HVAC equipment was existing as well as insulation and duct sealing. Geothermal is a Hydron Module heat pump supplying FHA and cooling. There is a 80 gallon storage tank connected to a desuperheater, an auxiliary heat-recovery system providing some of the domestic hot water. The rest is done with a standard 40 gallon electric water heater.

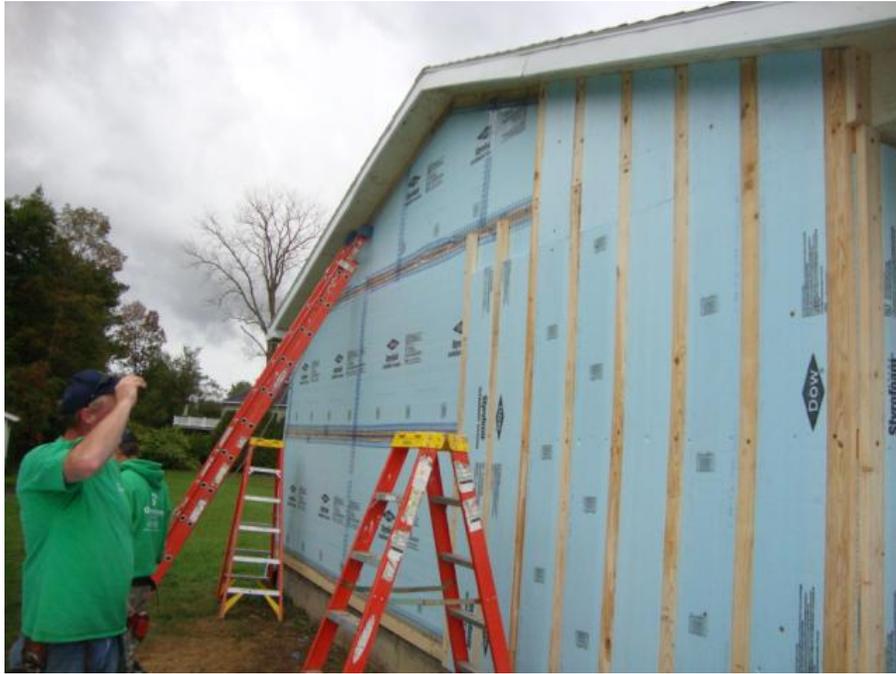
This view shows the first layer of rigid foam insulation that was installed horizontally and the beginning of the installation of the second layer, which is vertical. Vertical strapping in the form of 2x4s was inset into the second layer to allow for the fastening of siding.

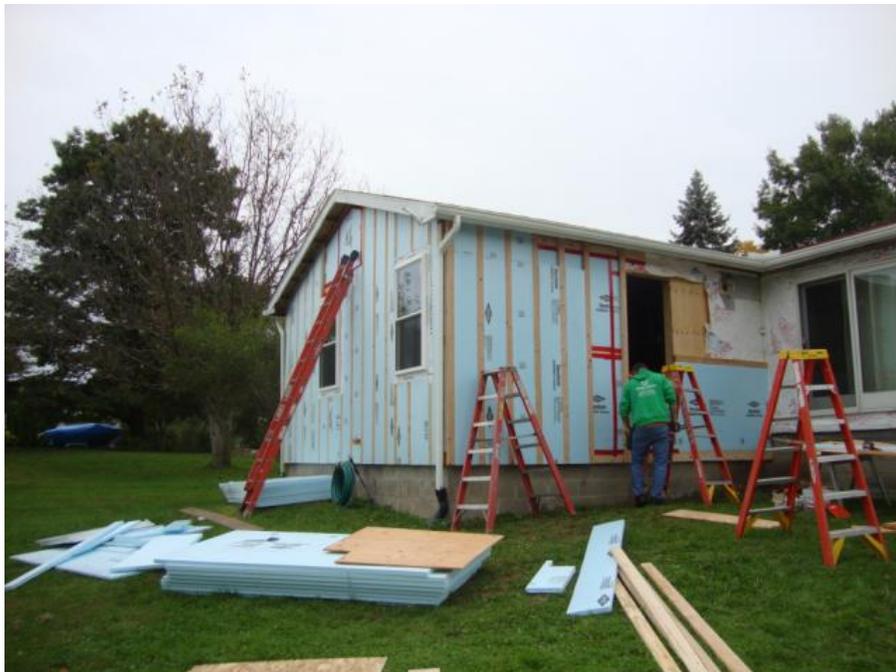
This picture shows the start of a rough opening for a window. Refer to the construction details for the sequencing of materials.

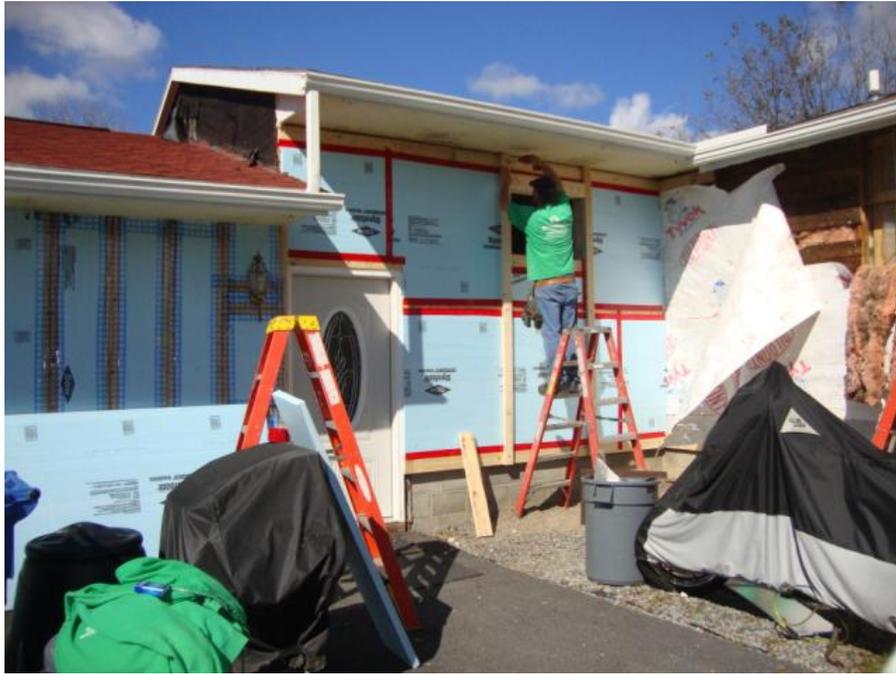
A contractor frames out the rest of the rough opening with the first layer of insulation applied.

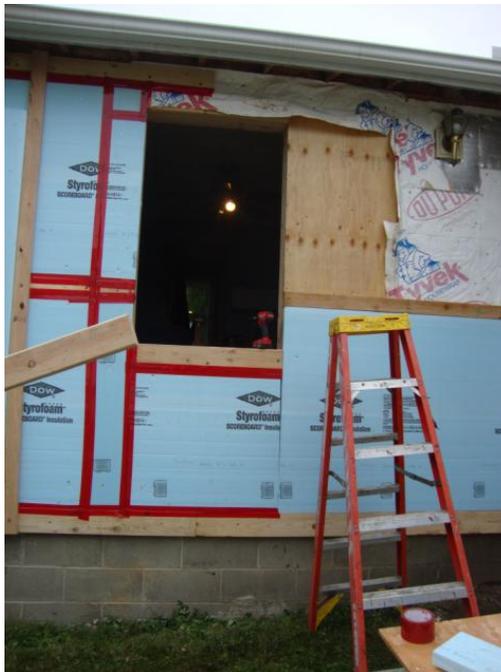
A close-up view of the rough opening pictured previously. The rigid foam in view is the first layer of insulation. Additional strapping will be installed adjacent to the opening and flush with the second layer of rigid foam.

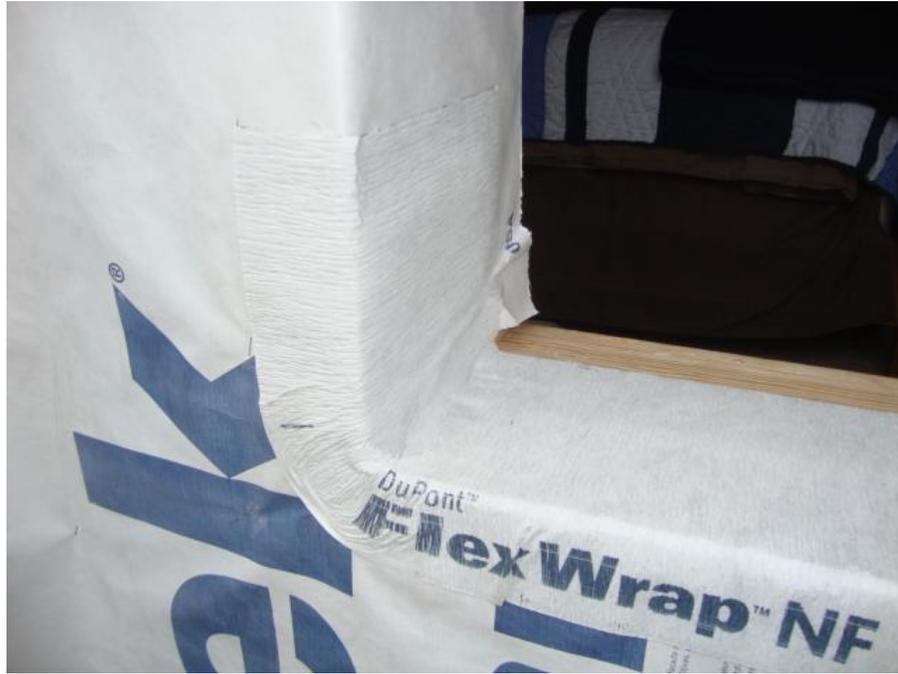
This picture shows the flex wrap flashing that was applied on the exterior of the rough opening to create a pan flashing.

The mock-ups did not address all potential flashing details. The contractors followed the Dow straight flash tape specifications for housewrapped homes, even though our design does not include housewrap. In some areas, the contractors used Tyvek to cover broad spans of the rough opening where a drainage plane was needed for windows. Not wanting to span the entire area with tape, the contractors used Tyvek to cover the area and then followed with the initial indented tape flashing details.

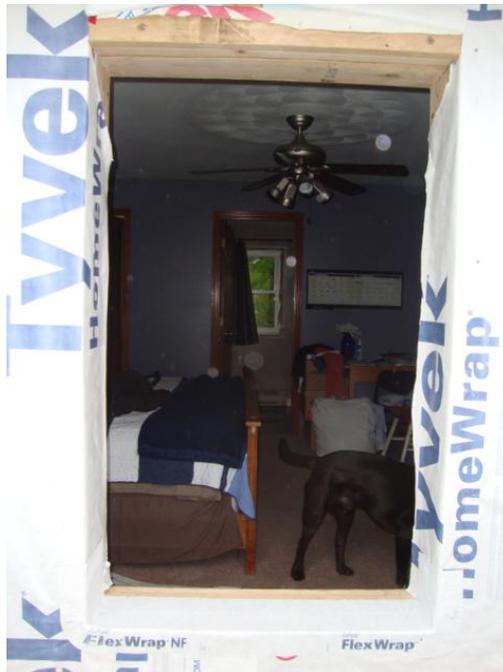
This is a full view of the entire rough opening from the exterior.

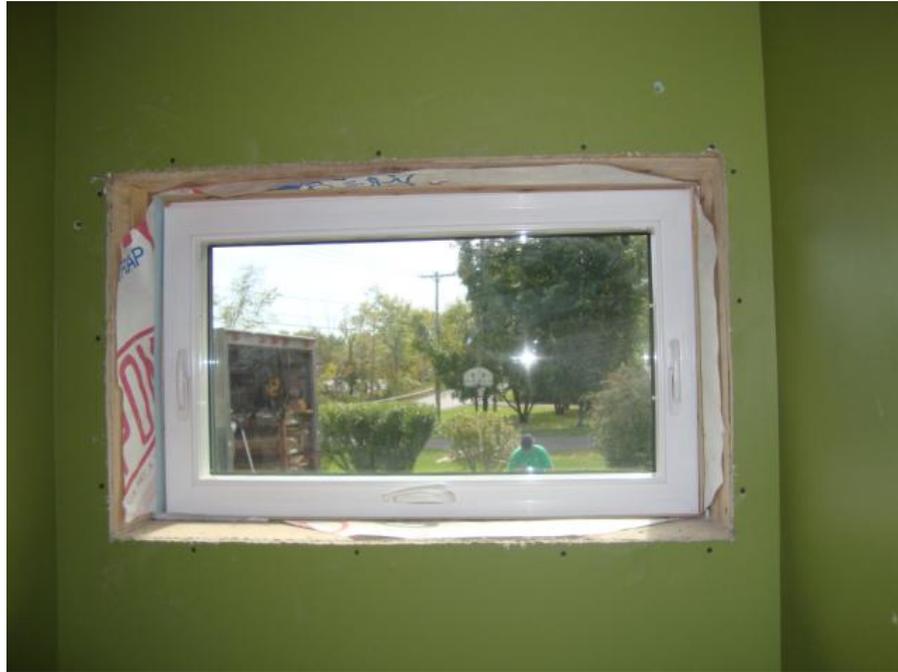
This is a view of the installed window from the interior of the house, showing the thickened exterior wall.

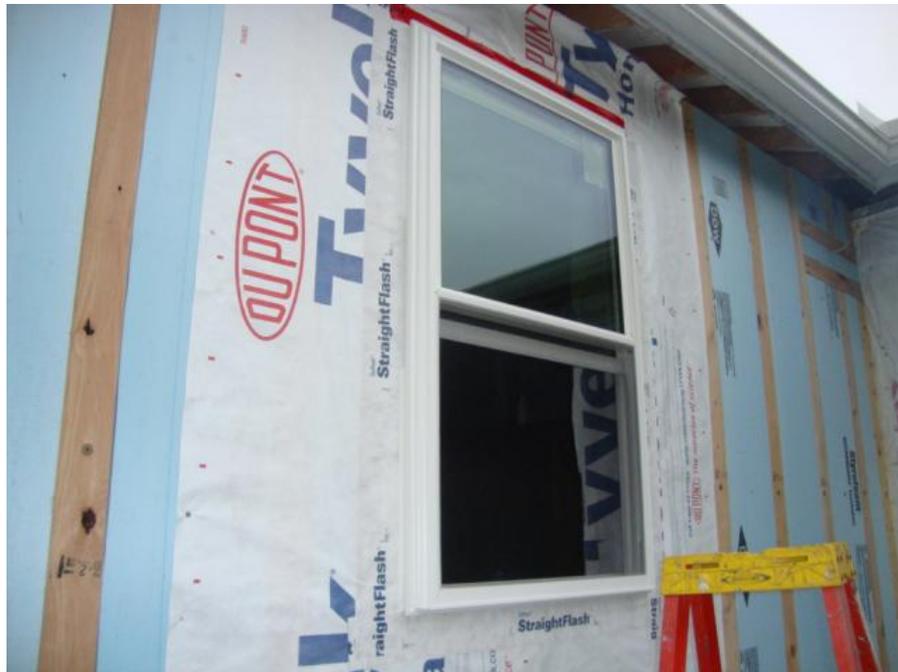
This picture shows the newly installed window from the exterior.

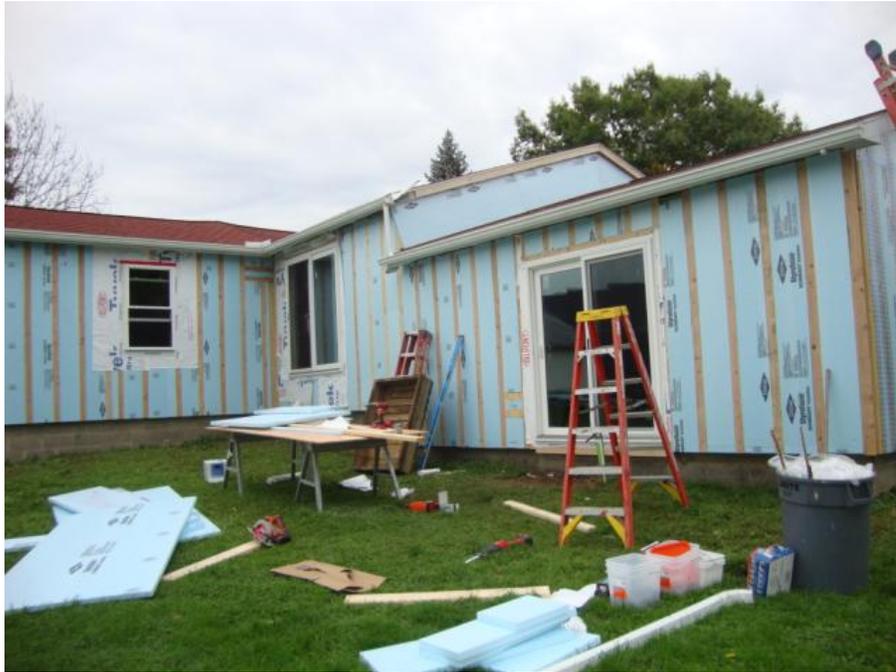
This rear view of the house shows the completed installation, of foam board prior to the installation of the tape of the vertical strapping.

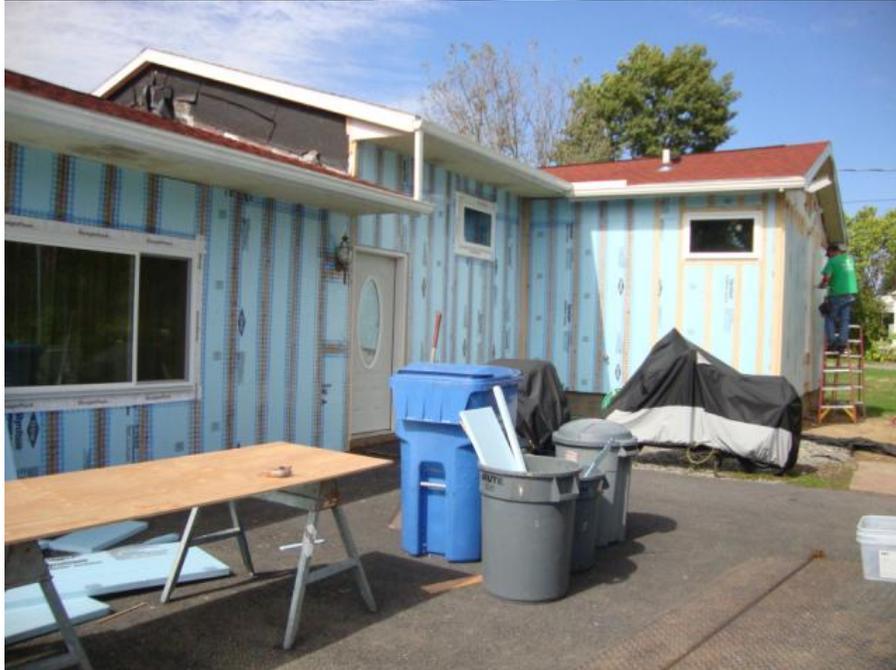
This front view of the house shows that both layers of insulation have been installed. Construction tape was installed over the vertical strapping so the second layer of foam could act as a continuous drainage plane.

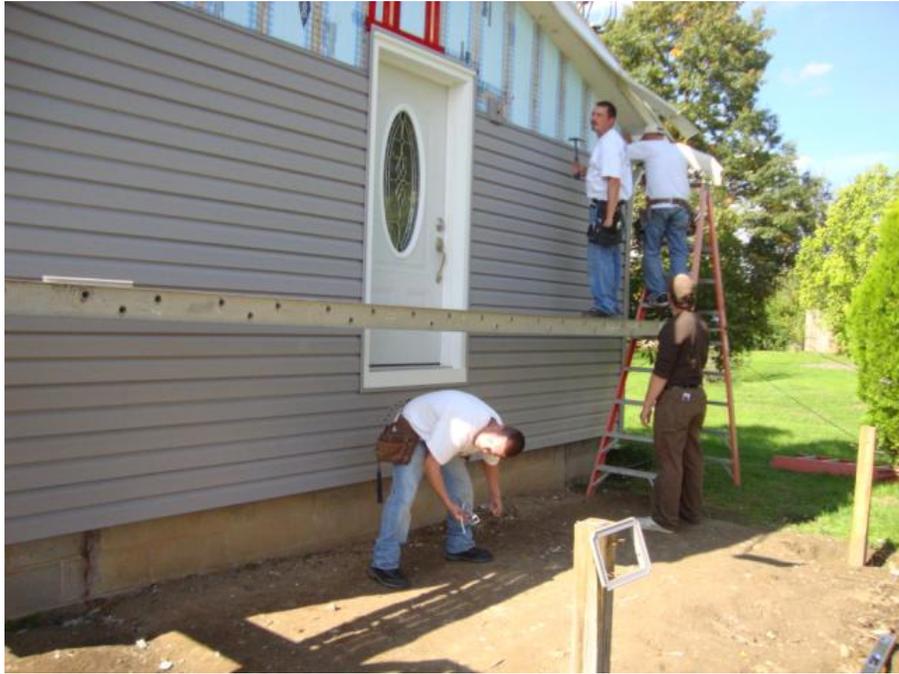
Here the siding is being installed around the new front door.

Existing doors, not framed out as the windows were, also raised questions about flashing. A combination of tape and other sealants was used, as well as coil stock to protect the original door installation. To remove the door that the homeowners wished to keep, simply flashing is, at best, a risky affair. Based on the contractors' experience, reinstalling lesser-quality doors can cause the assembly to pull apart, making reinstallation more difficult or even breaking the new door. It would be preferred to start with a new door and to install the flashing properly. The contractor felt the flashing and sealant approach was second best.

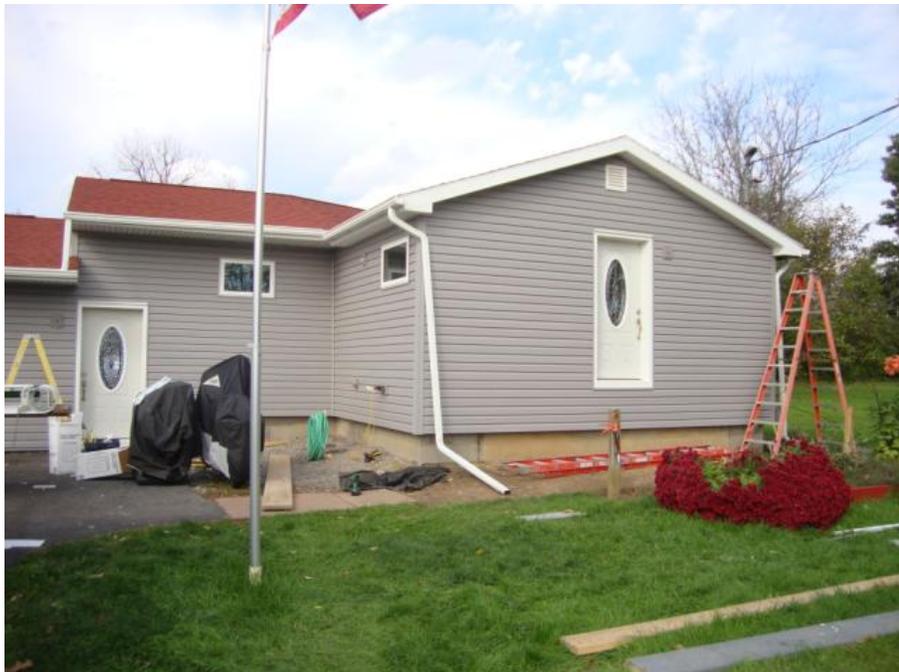
This photo shows the home with the new siding and downspout installation complete.
