Optimized Strategy for Scaling Up Deep Energy Retrofit

Hawthorne Circle House

February 15, 2013

Taitem Engineering

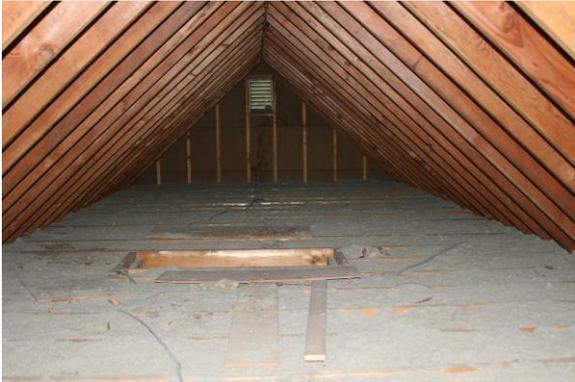
The attic plane was a major source of air leakage. A thorough clean-out of the attic involved the removal of fiberglass batts by hand, followed by vacuuming of cellulose and debris with a gas-powered insulation removal vacuum.

Attic prior to start of work. Fiberglass batts and cellulose insulation totaled about 5".

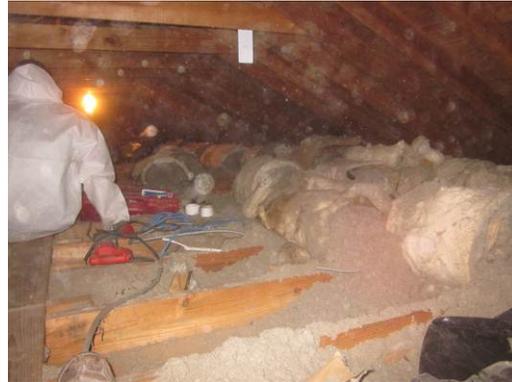
Attic cleanout in progress.

This restored the attic to a very clean condition, and it allowed complete inspection and sealing of air leaks in accordance with best practices for new construction. Attic air sealing was checked by a combination of visual inspection, blower door (including zone pressure diagnostics) and infrared inspection.

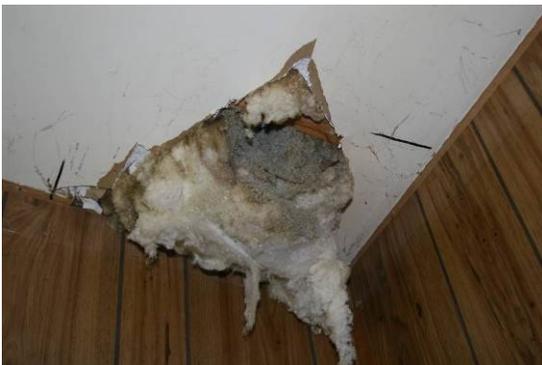
Holes were patched and repaired.

- a) General repairs to holes in sheetrock were performed by the general contractor. An older recessed light was removed, the sheetrock patched, and a surface-mounted fixture installed.

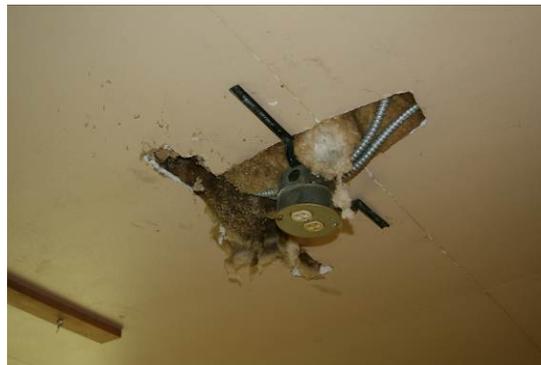
The ceiling plane contained some obvious air sealing opportunities.

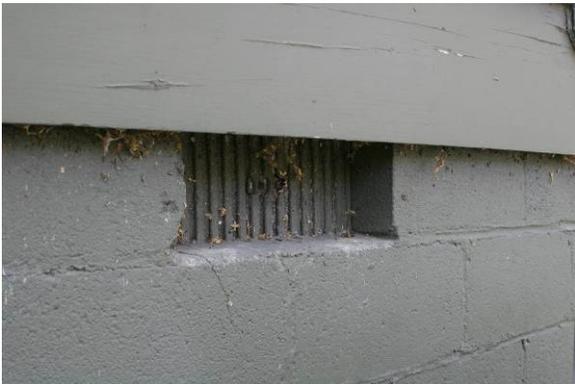
Each of the two crawlspaces contained metal crawlspace vents. These were replaced by CMU blocks, mortared in place.

Metal crawlspace vents were replaced with CMU blocks.

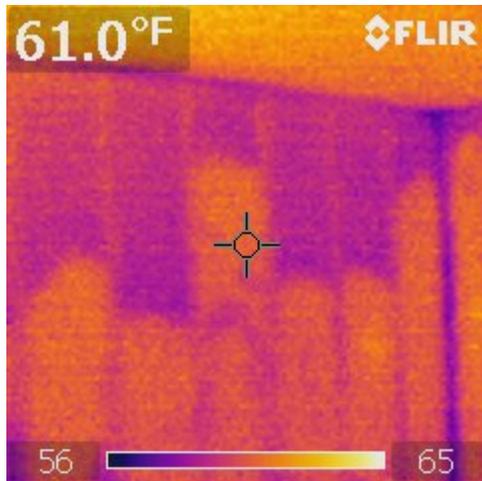
Smaller leaks were associated with gaps in the sheathing, electrical penetrations, and a range hood vent. Wall cavities were mostly full of old urea formaldehyde foam insulation, which had shrunk and cracked, leaving voids toward the tops of many wall cavities. Voids were estimated at ~8% of total wall area. Voids were identified with infrared scanner and dense-packed with cellulose insulation.

2. Existing cavity insulation limits the effectiveness of dense pack cellulose as an air leakage reduction method. While the Hawthorne Circle house met the DER air tightness goals, the CFM50/SSF was considerably higher than for the West Hill House. A large part of the difference appears to relate to the fact that for the West Hill project, we started with cavities partially full of aged UFFI insulation. The dense pack was able to seal the large voids and some of the smaller channels in the UFFI; however, we believe that the overall result was not as good as if we had started with empty cavities.

Infrared image of walls prior to insulating.

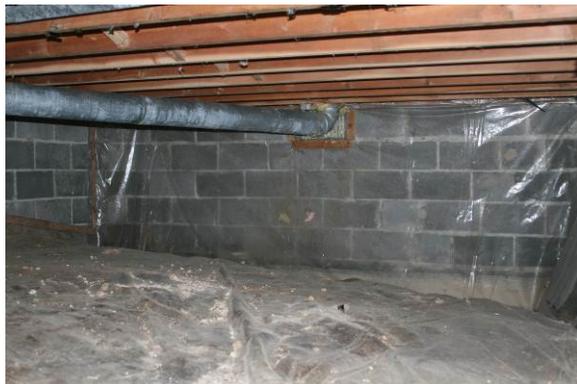
Vented crawlspace with inadequate vapor barrier.

4. Crawlspace floors can be treated cost-effectively to provide vapor management and increase R value. Our approach does not include insulation of concrete slabs below grade; energy modeling indicated that this measure provides only tiny energy savings at considerable cost. However, dirt-floor crawlspaces can be treated at more modest cost. A well-sealed vapor barrier is required over the soil for radon and moisture control. A flexible EPS floor insulation was installed under the vapor barrier. Because the crawlspace floor is closer to grade than the basement floor, the insulation of these surfaces has a greater impact on comfort and energy use.

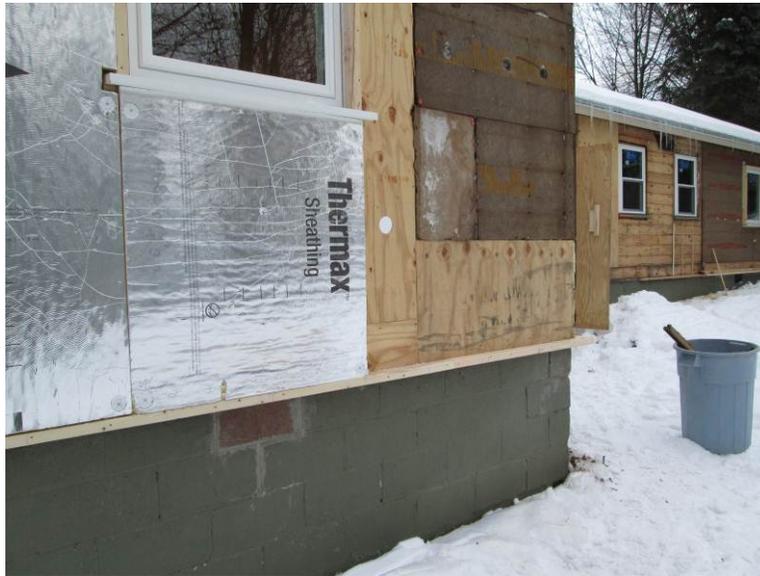
Thermax installation in progress. Rotten fiberboard sheathing was replaced by plywood.

- a) 4" Ci-lock screws were used to attach Thermax sheathing to wood-frame walls.
- b) The number of screws per sheet was reduced from the manufacturer's recommendation of 28-30 per full sheet to 12 per full sheet. This seemed to provide very secure attachment. In this house, the siding contractor decided to attach $\frac{3}{4}$ " furring strips with 5" Head-lok screws over the Thermax. The Head-lok screws went directly into the studs. This was done in order to provide a vented air space behind the fiber-cement siding. It also provided an extra-secure attachment for the Thermax.
- c) Where possible, a single Ci-lock screw was used to span the joint between two sheets of Thermax.

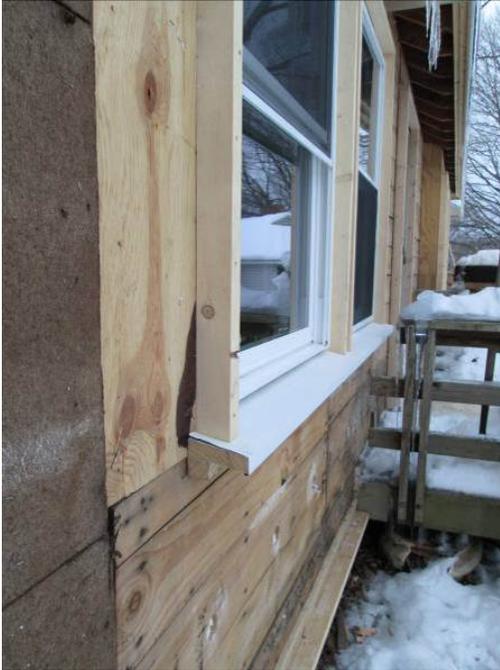
- a) The buck and flashing approaches tested in the time and motion studies were designed for new, flanged windows. The windows in this project were a mix of existing wood/vinyl inserts, which were left in place and new, unflanged vinyl windows, which were installed as inserts to match the style of the existing windows. Bucks, including sill extensions, were built of 2x framing lumber. Aluminum coil stock was bent on a brake to provide an impermeable sill flashing. After the foam sheathing was installed, straight flashing was used to span the joints between the foam and the buck, and between the buck and the window. The flashing was covered with fibercement stops and casings. Straight flashing was also used for the side and head flashings, and a piece of Weathermate construction tape was used to protect the head flashing from low-angle shear per Building Science Corp. recommendations. The straight flashing worked well, although the general contractor complained that it was very hard to remove residue if the flashing extended too far onto the vinyl windows and had to be trimmed back after the fibercement stops were installed.

Window bucks. Note the aluminum flashing covering the sill.

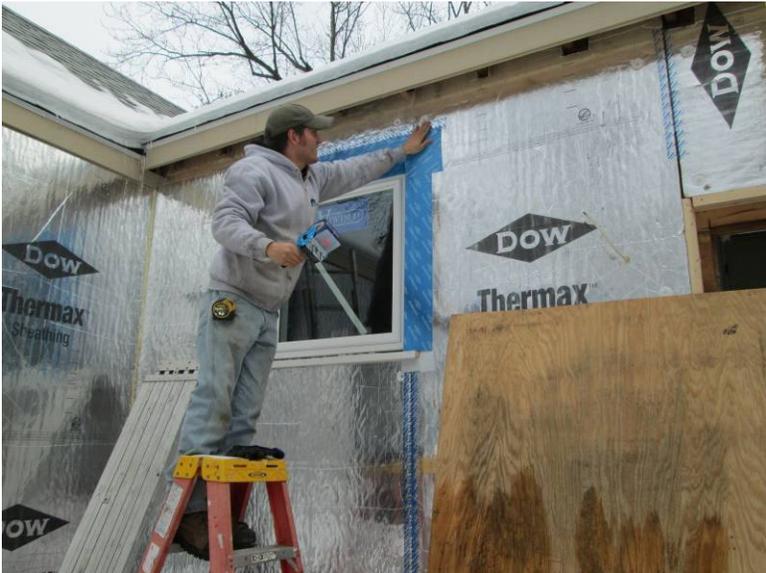
Installing Weathermate tape to protect the head flashing from low-angle shear.
