## NYSERDA Deep Energy Retrofits: House 1 Report

### Exterior Spray Foam Retrofit Strategy

November 7, 2012

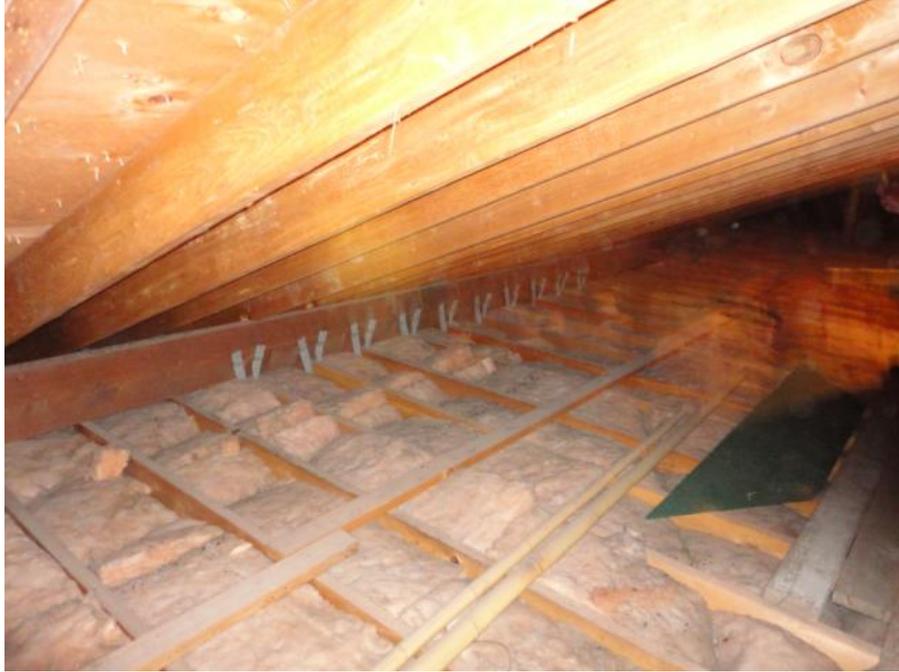
This view shows the existing insulation in the attic before any work was done.

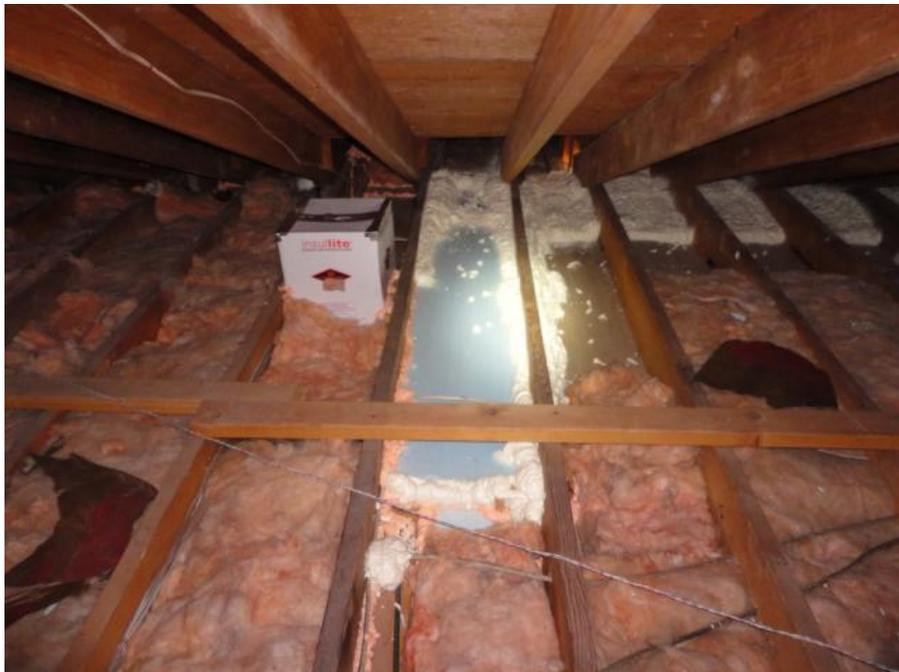
The attic received spray foam sealing and insulite boxes for all can light penetrations into the conditioned space. These insulite boxes were used as a standard for all recessed can lights.

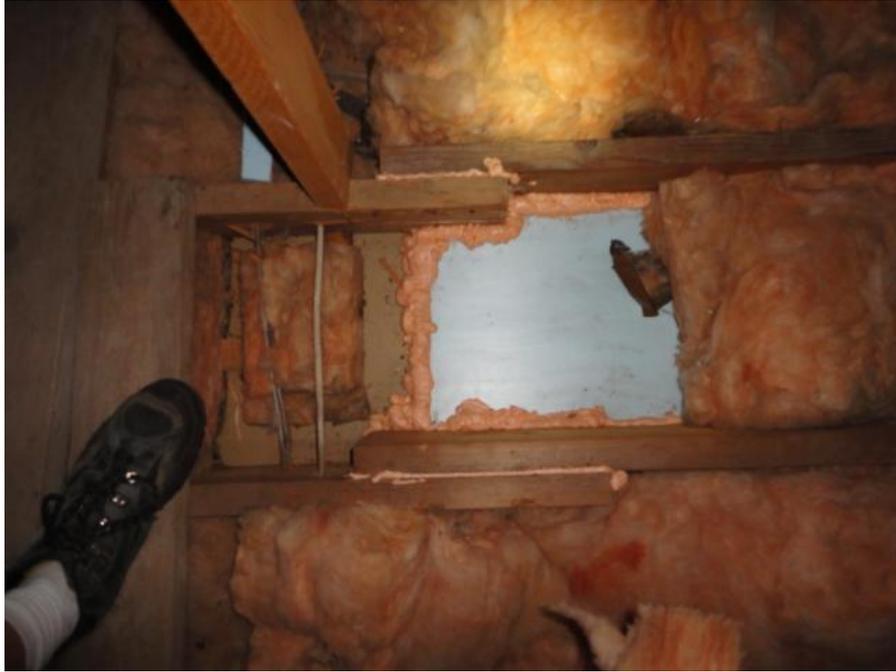
This view shows a hole that was patched and sealed with spray foam.

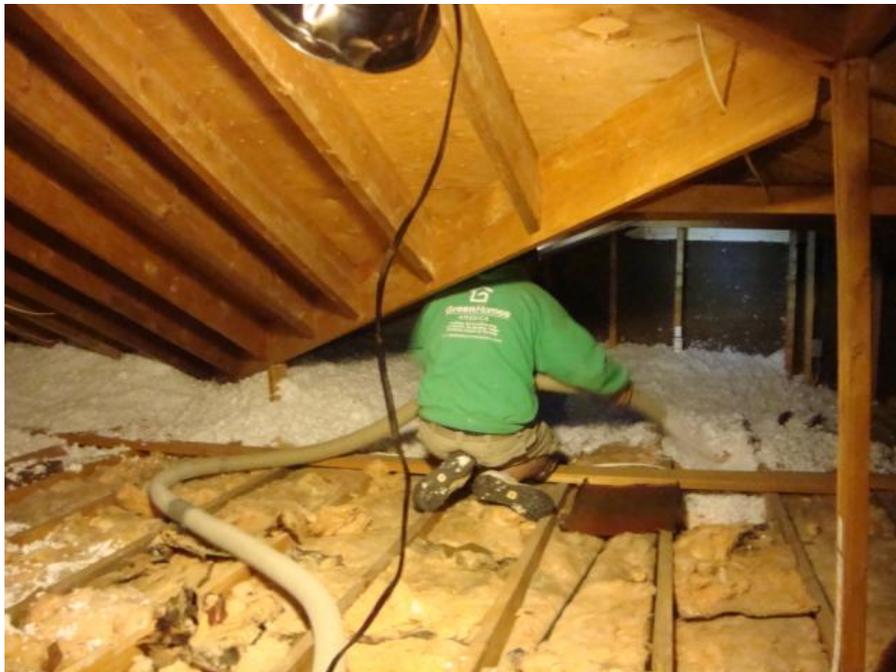
Here, the GHA contractors are installing the blown insulation for the rest of the attic. The existing fiber glass insulation did not need to be removed to install the new insulation and fill the large holes.

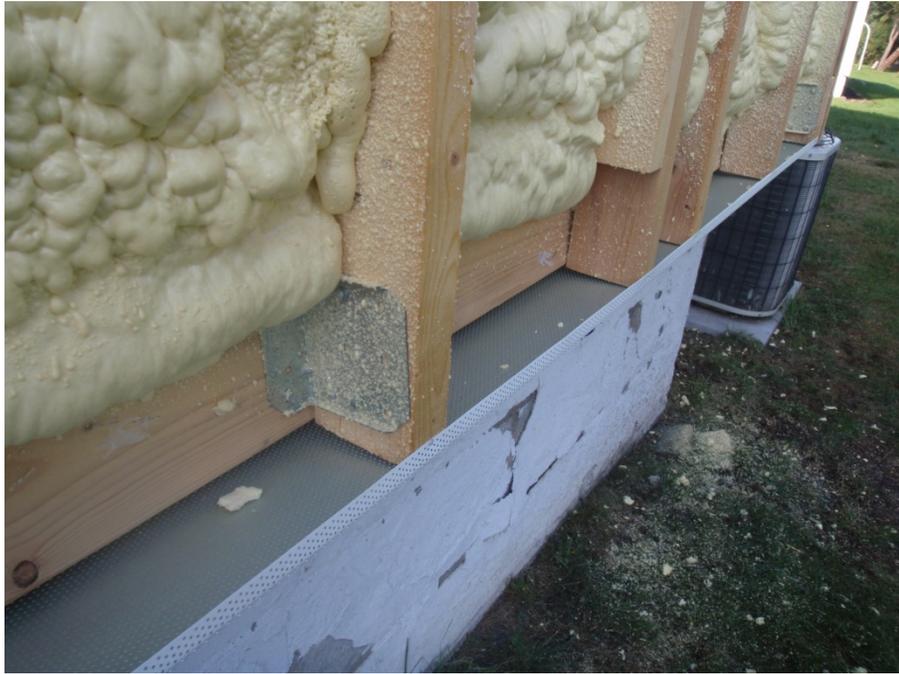
This view shows the connections that were used with this application. Simpson Strong-Tie clips were installed at the top and bottom.

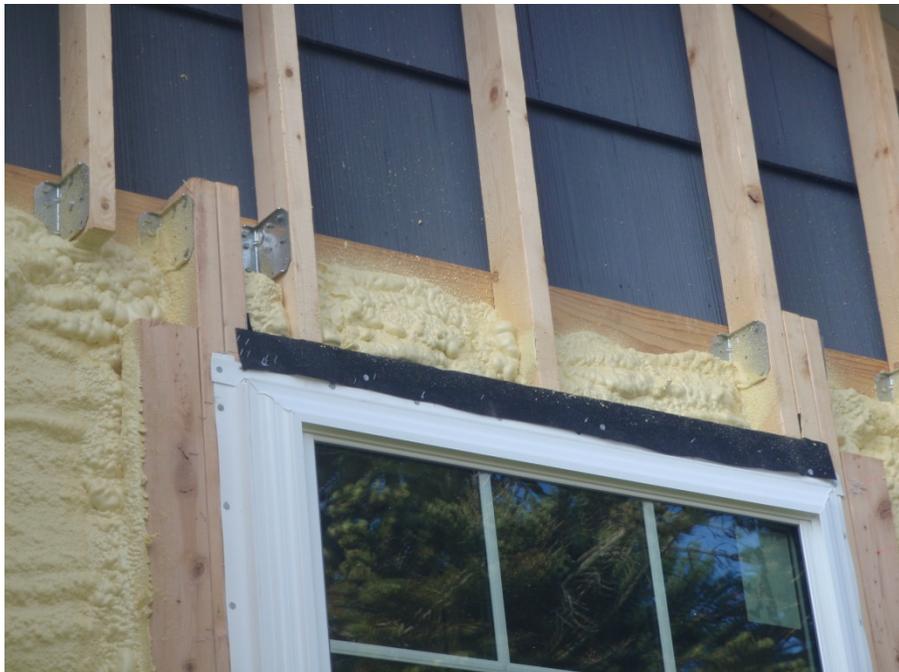
Here is another view of the connections at the top of the framing and around the windows.

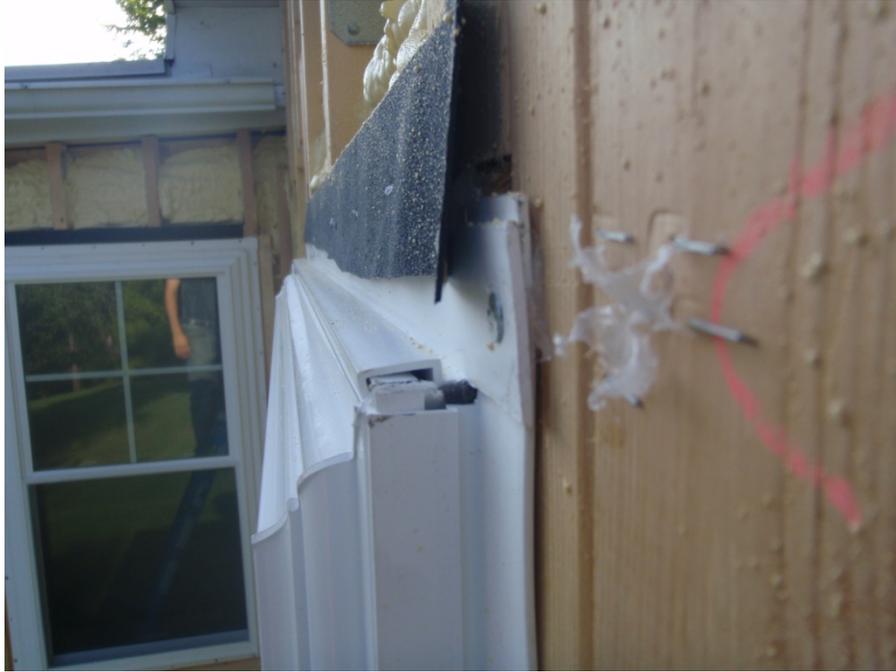
This view shows the questionable window installation that was happening on site. When visiting the site, IBACOS made recommendations, and the installation was corrected.

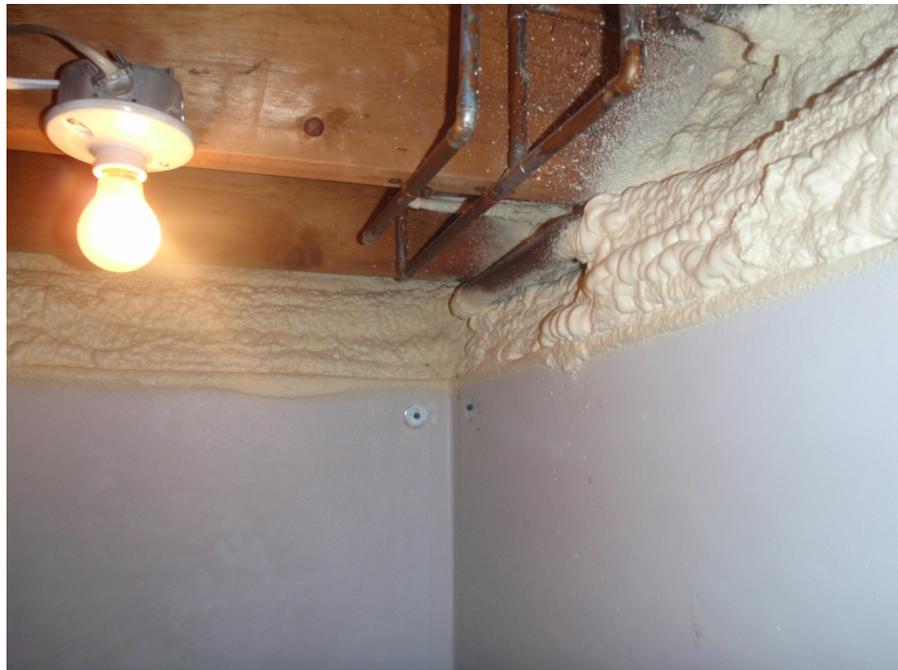
This final picture of the basement shows the spray foam of the rim band joint on top of the THERMAX. The THERMAX was donated and just the cost of labor was needed. The white finish is a new option with THERMAX and was easier to use since the contractor did not have to do any interior finishing.

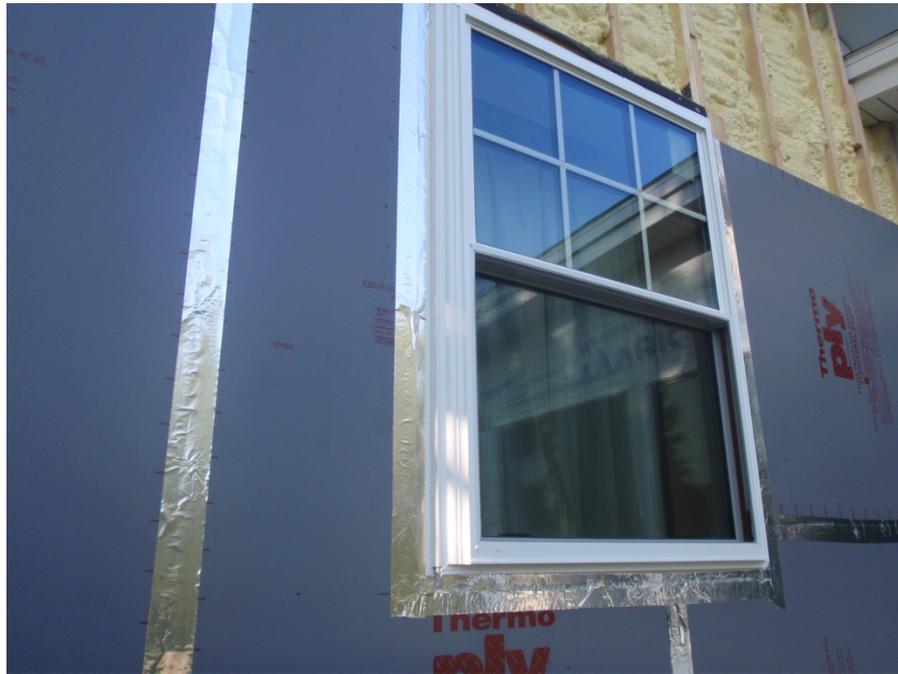
This view shows the tape that was originally used for flashing the windows.

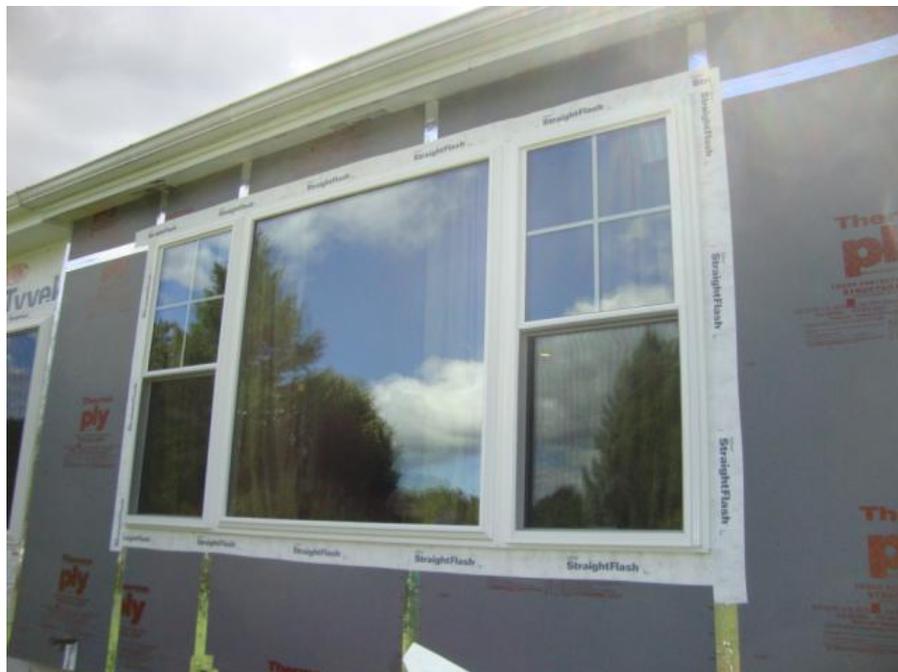
This view shows the correct flashing tape that was installed once corrected.

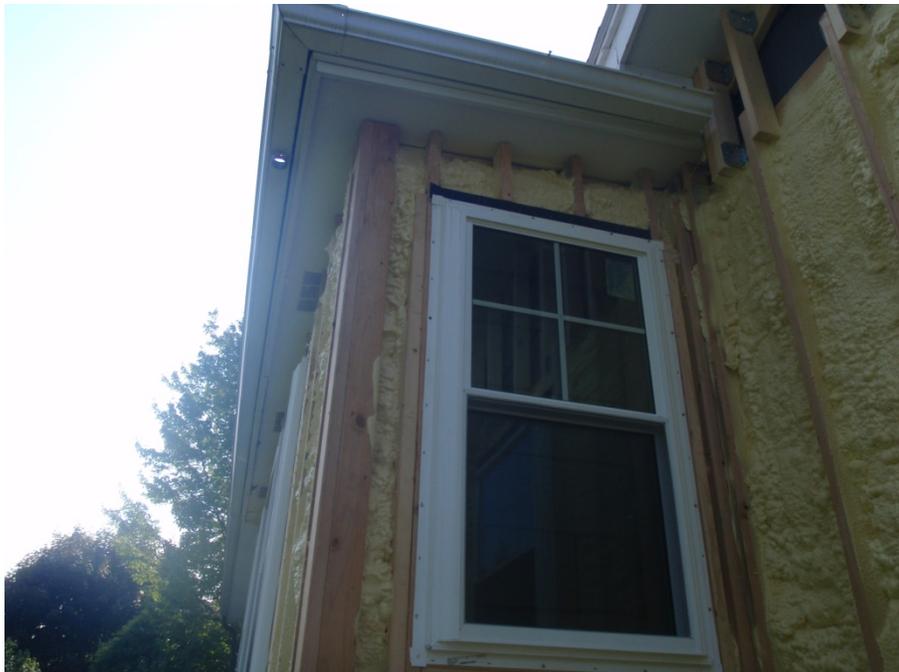
This photo shows the top of the DER where the system intersects with the roof line.

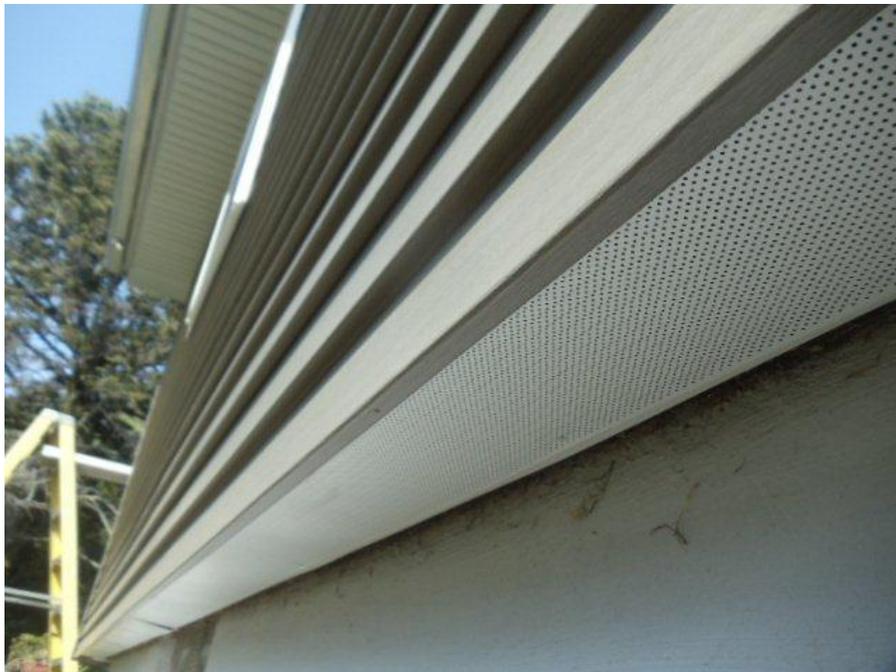
This view shows the bug screen that was installed at the bottom of the new siding application.
