## **NYSERDA Deep Energy Retrofits: House 3 Report**

### **Exterior Rigid Foam Retrofit Strategy**

February 15, 2013

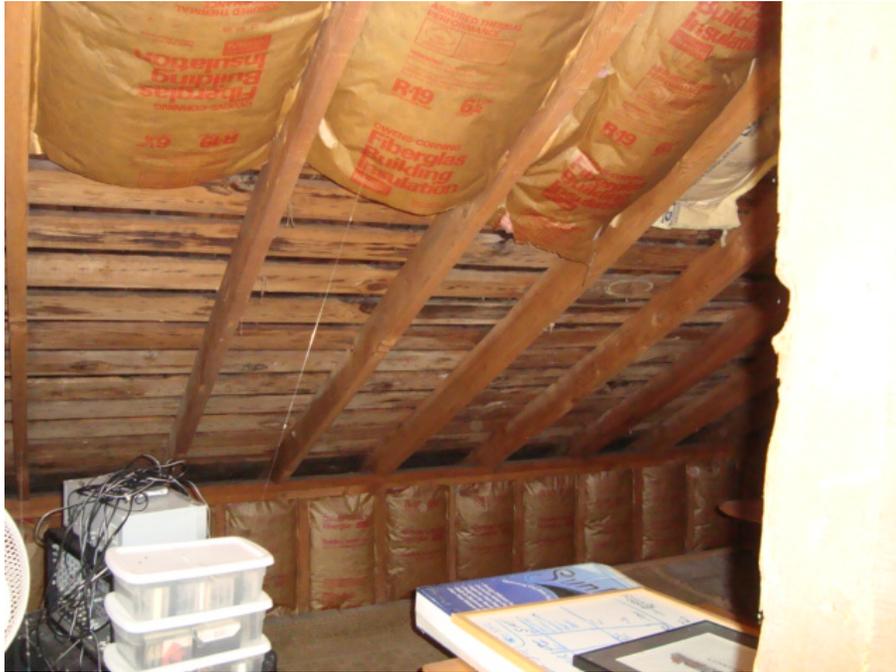
This view shows the existing attic with minimal and patchy batt insulation.

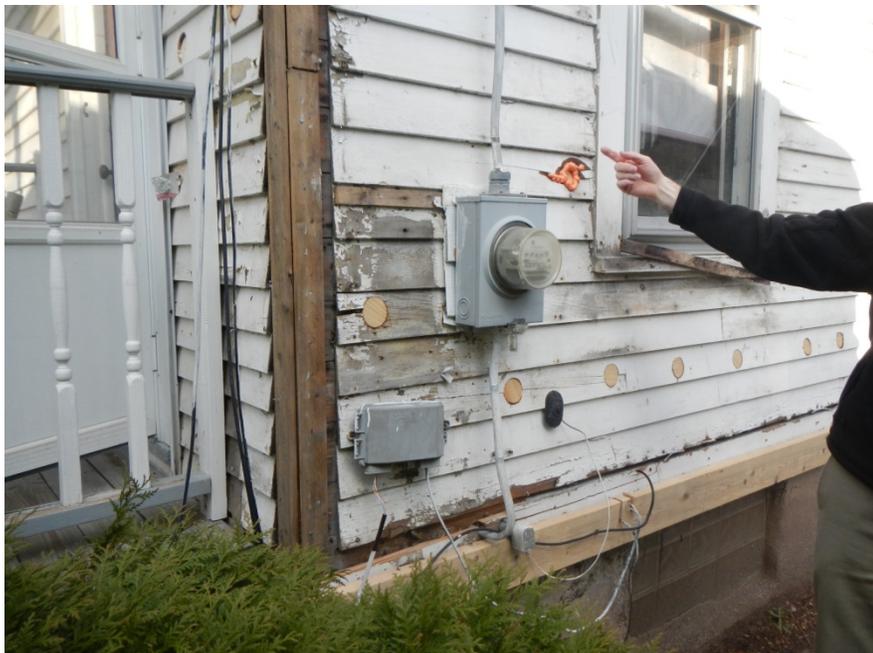
The electrical service on the house had to be removed when the existing siding was removed. There were some difficulties with this, and the removal and reinstallation had to be scheduled in advance.

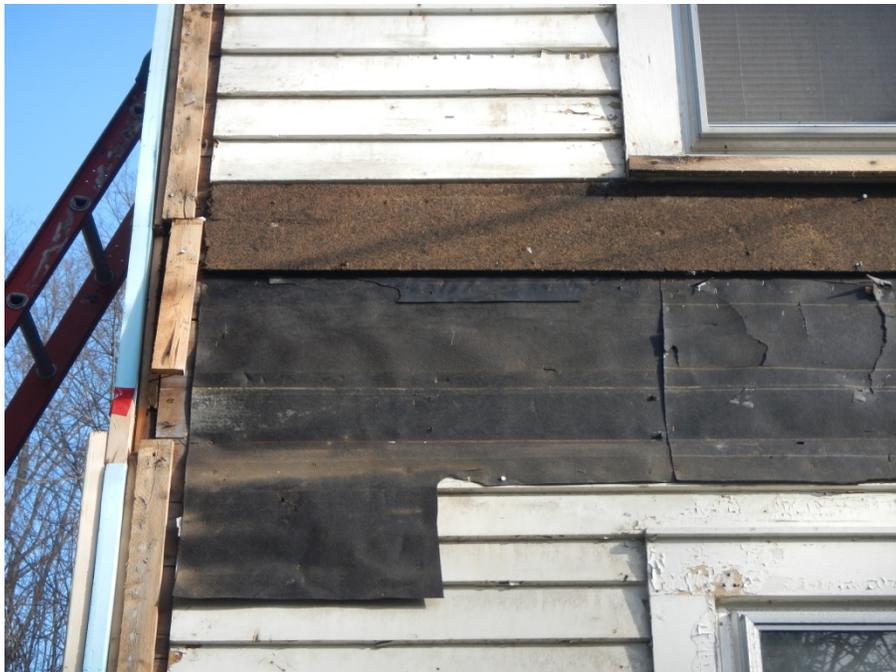
The existing overhang was removed. After removal, it was determined that the overhang was not original to the construction of the home.

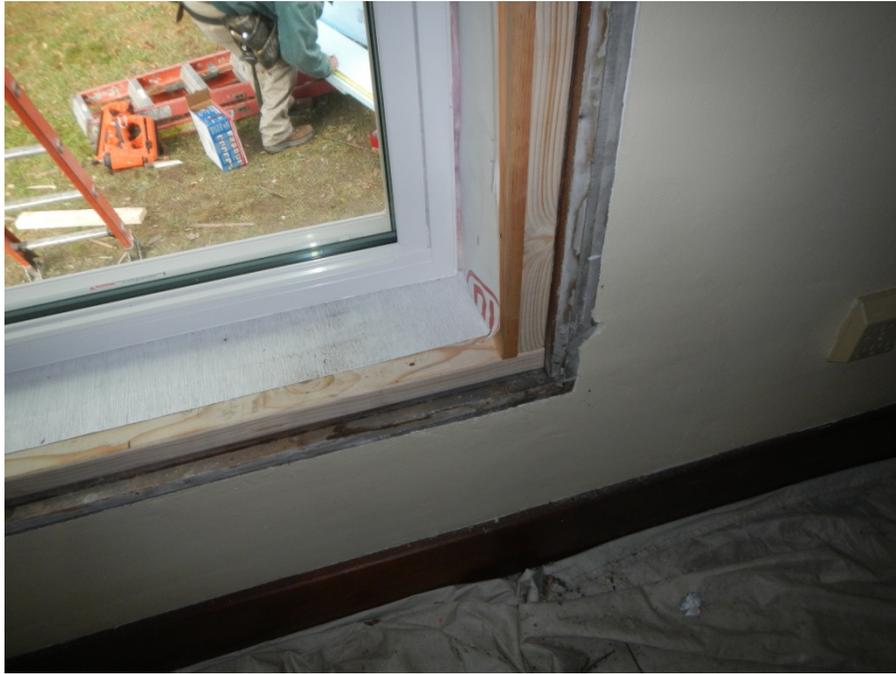
The house originally had weights and pulleys at the interior of the windows. These were removed and filled in, resulting in a larger window opening than the original window.

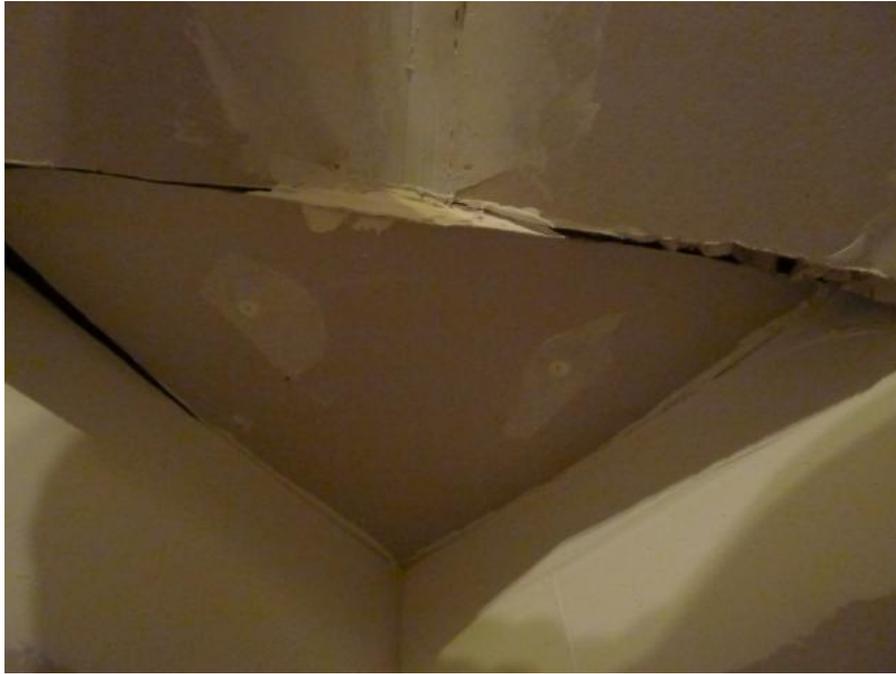
Following the homeowners' complaint about irregular snow melt on the roof line, GHA visited the home to diagnose the problem. This photo shows the corner of the attic where the drywall was not properly installed. A thermal bridge past the insulation and this unsealed drywall appeared to be resulting in a cold spot.

Infrared images reveal some of the weaknesses discovered, in addition to the ice that has formed at the corners of the roof. GHA plans to use spray foam and will finish these areas. Some drywall may need to be removed to access some areas to stop these leaks.

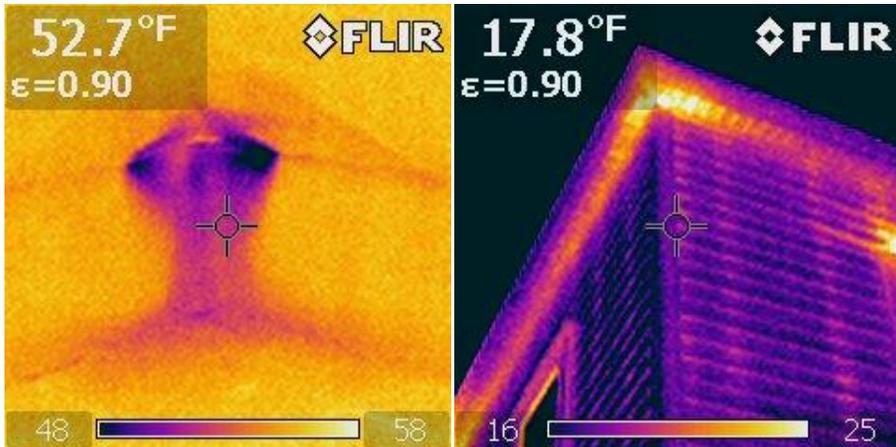
These infrared camera images show the air leakage coming from that area in the interior of the space and the exterior.

The airflow issue can be seen in the corners of the home. The cavities between the rafters were filled with spray foam, but the rafters resting on the corner of the kneewall over the years have likely twisted and warped, leaving small gaps. It was discovered that the drywall was not completed in each corner. For an unknown reason, the line following down each hip section of the roof was terminated short of the kneewall, and a small return was installed. This was not taped shut, and airflow resulted, as shown in the infrared images.

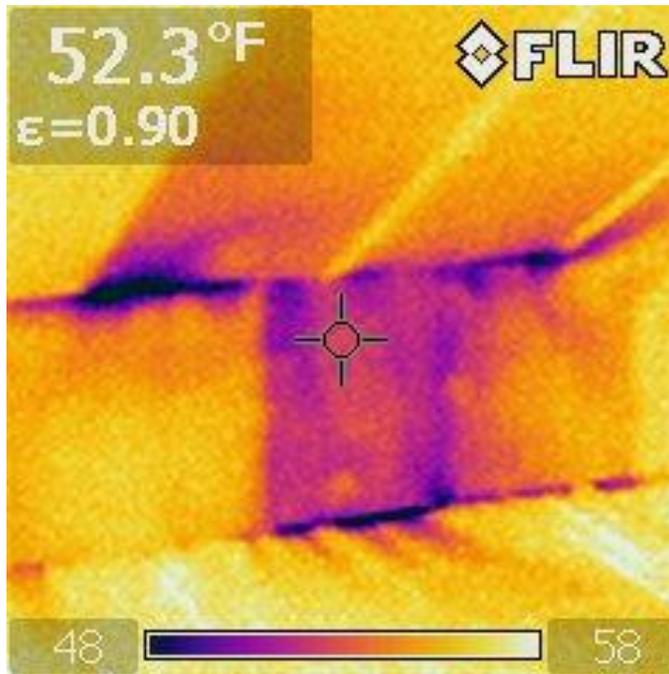
This infrared camera image shows the interior of the attic where the chimney had been located. It was determined that excessive wood was used at this location to patch the hole left by removing the chimney, resulting in poor thermal performance.

The team concluded that, when covering the cavity where the chimney had been, the roofers added wooden framing that was not covered with spray foam. This wood material nailed onto the existing framing held the new deck well but left a weak point for airflow. The cavities were filled, but the wood-to-wood connection was never sealed. To address this issue, GHA went back to the home and removed drywall, removed the excess wood on the interior of the home, and covered the area in spray foam.

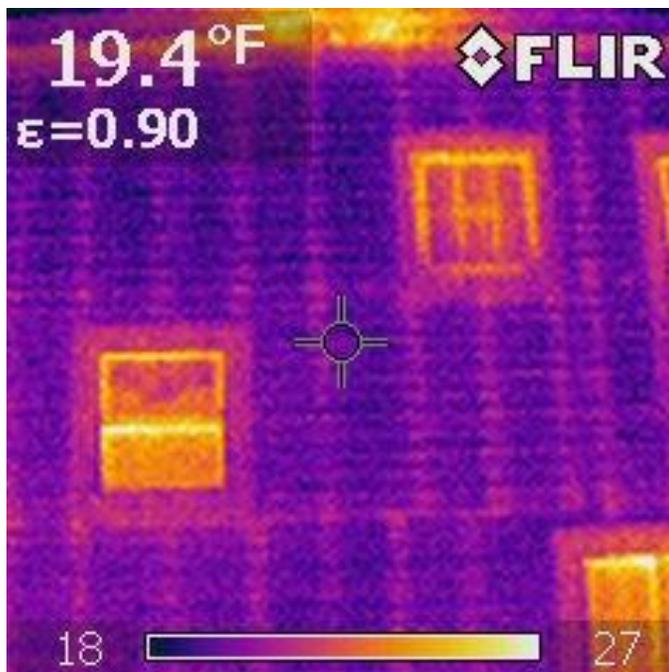
This infrared camera image shows the exterior of the home where the chimney had been located. It shows only leakage toward the roof line.
