Photo Documentation Requirements — EB and NC

All photos must be clear with readable labels or nameplates.

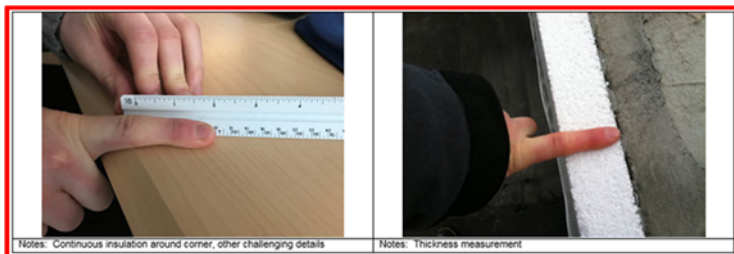
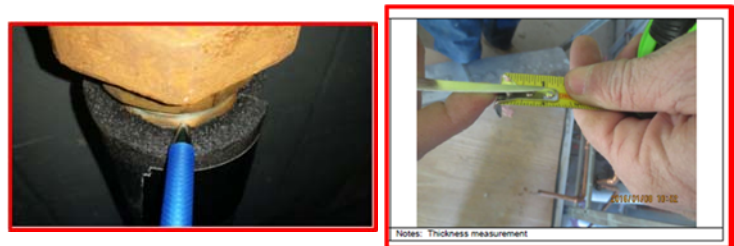
Incorrect: These photos show improper measurement methods.

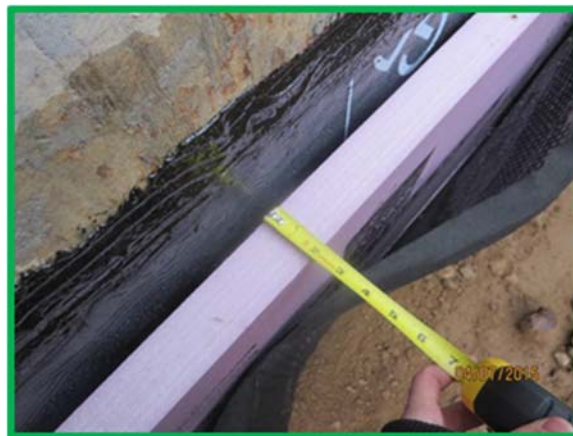
Correct: This photos show the use of a proper measurement tool.

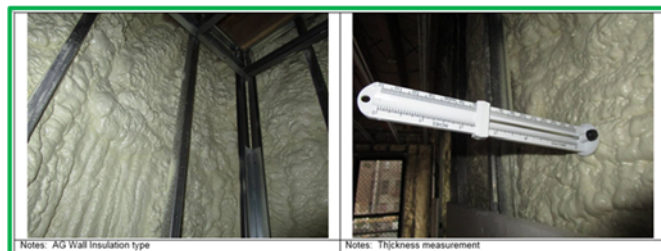
Correct: These photos show the insulation types installed and proper measurement techniques.

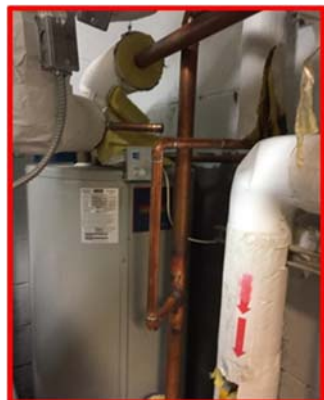
Incorrect: Improper and/or incomplete pipe insulation was seen on site.

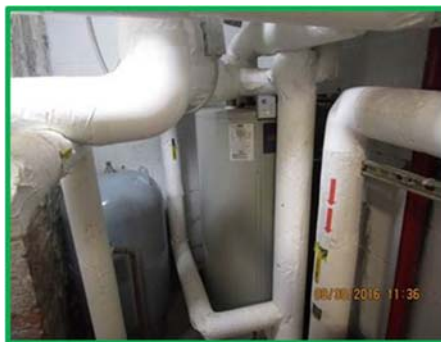
Correct: Partner submitted photos with pipe insulation correctly installed in the same area of piping.
