CONSTRUCTION PHOTO RESOURCE

1. Overview Photos: Home Address Verification

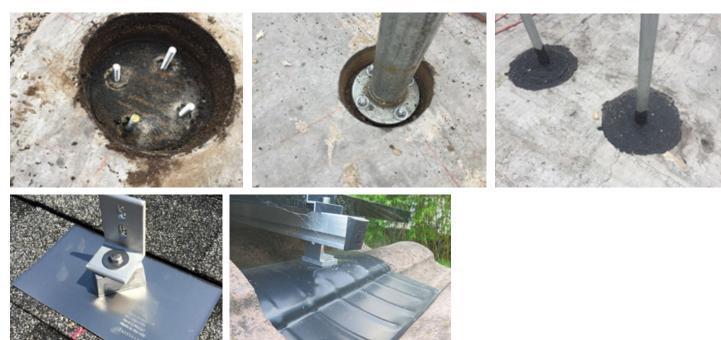
7. Array Racking Photographs: Racking End Clip Documentation

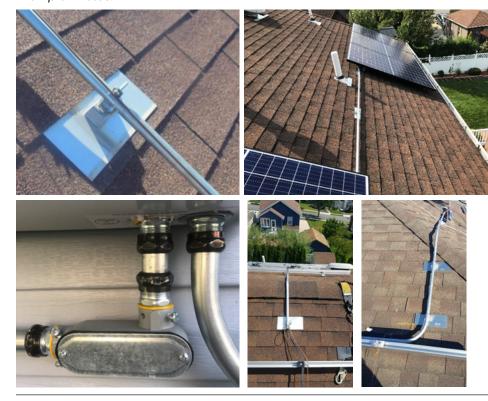
12. Conductor Conduit Photos: Conduit Roof Top Penetrations
