State-Licensed Disposal Area at West Valley: 2020 Annual Report

Final Report – March 2021

State-Licensed Disposal Area at West Valley:

2020 Final Report

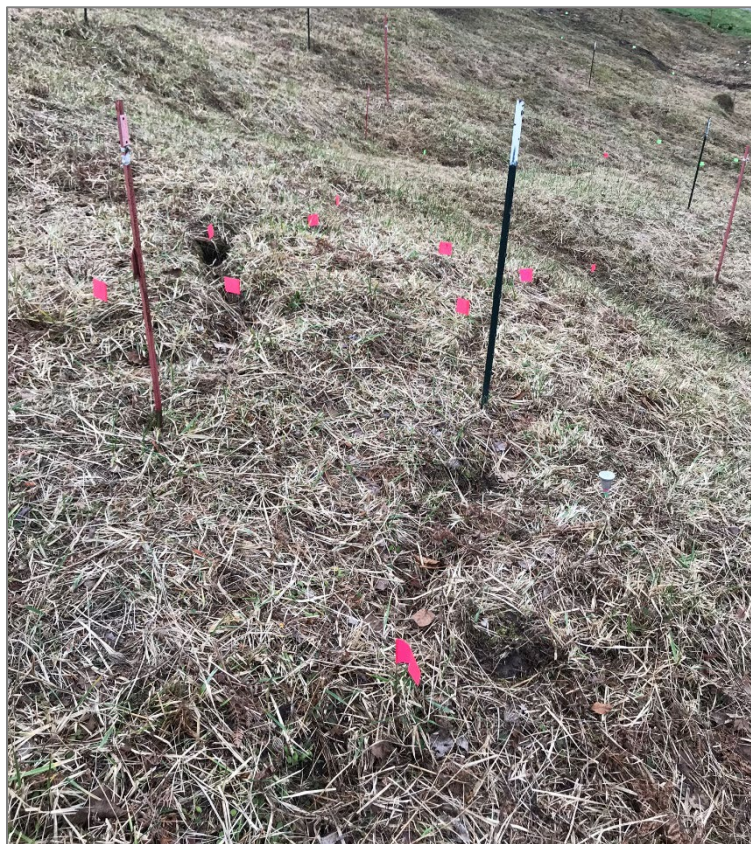
In 2020, visible cracking was observed along the north slope. In addition, lateral movement in a northwesterly direction was identified. The frequency of surveys was increased to quarterly, monthly, and back to quarterly for these observed areas surveys; and 36 monitoring survey hubs were installed above and below the cracks. In 2021, based on our engineering support contractor's recommendations, NYSERDA will complete an investigation of these areas of the north slope.

Figure 4-1. Crack along the North Slope

In addition, NYSERDA completed field inspections of the area where surficial cracking was observed, installed 36 new survey hubs above and down slope of the cracks, and performed maintenance activities to seal the cracks.

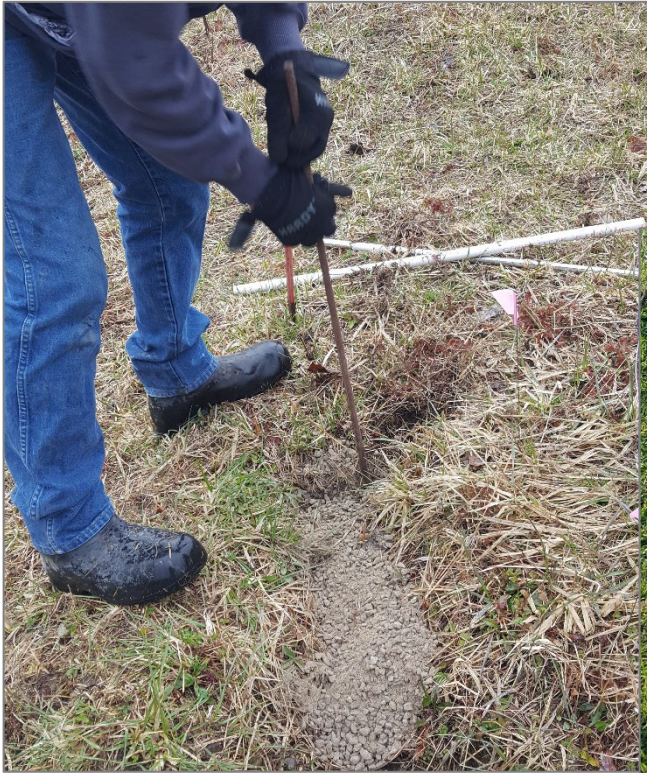
Figure 4-2. Crack Repairs on SDA North Slope

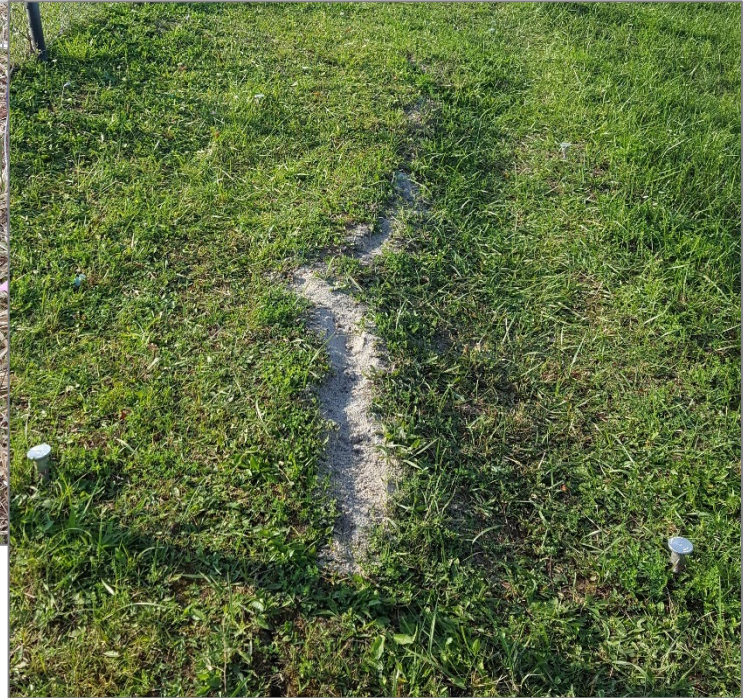
Figure 4-3. Filling of crack on SDA North Slope
