NYSERDA

State-Licensed Disposal Area at West Valley: 2014 Annual Report

Final Report

March 2015

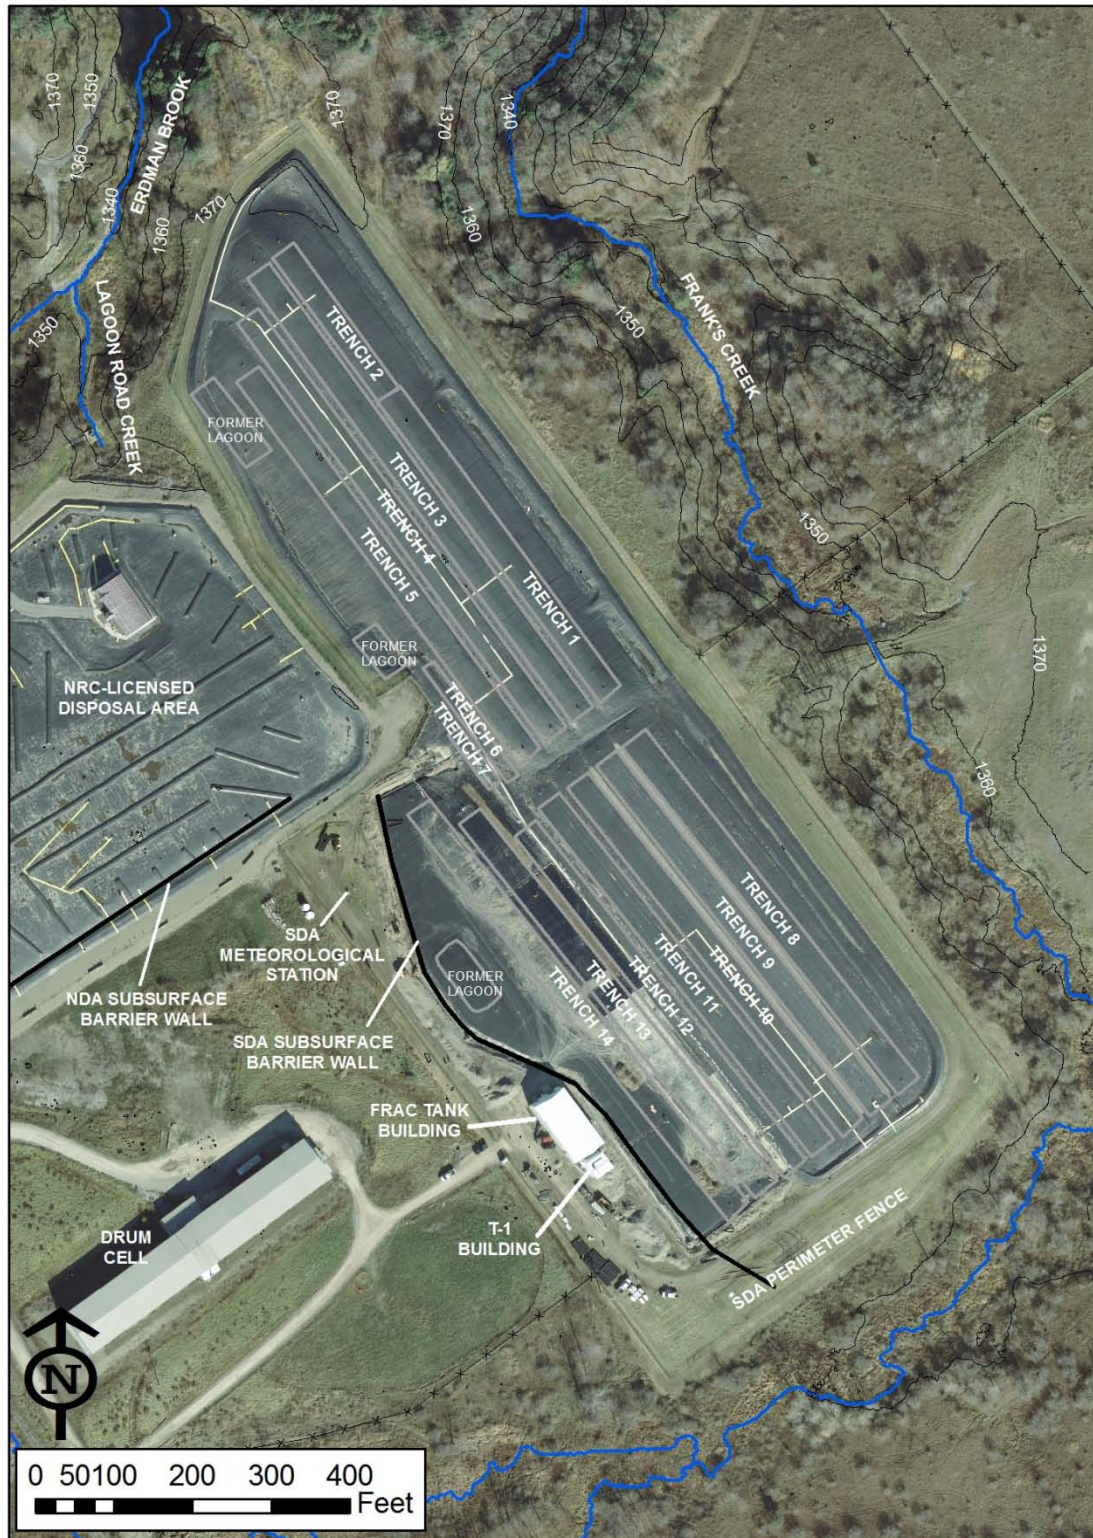
Figure 1-2. Aerial Photograph of the State-Licensed Disposal Area

The SDA occupies approximately 15 acres of the WNYNSC (Figure 1-1) immediately adjacent to the West Valley Demonstration Project (WVDP). The SDA consists of three filled lagoons and two sets of parallel trenches that contain radioactive waste: 1 through 7 in the northern area and 8 through 14 in the southern area (see Figure 1-2). The SDA is surrounded by an eight-foot-high, chain-link fence. NYSERDA controls access to the SDA by limiting the issuance of keys to the five, locked SDA gates. In addition, a contracted security service conducts routine patrols of the SDA's perimeter.

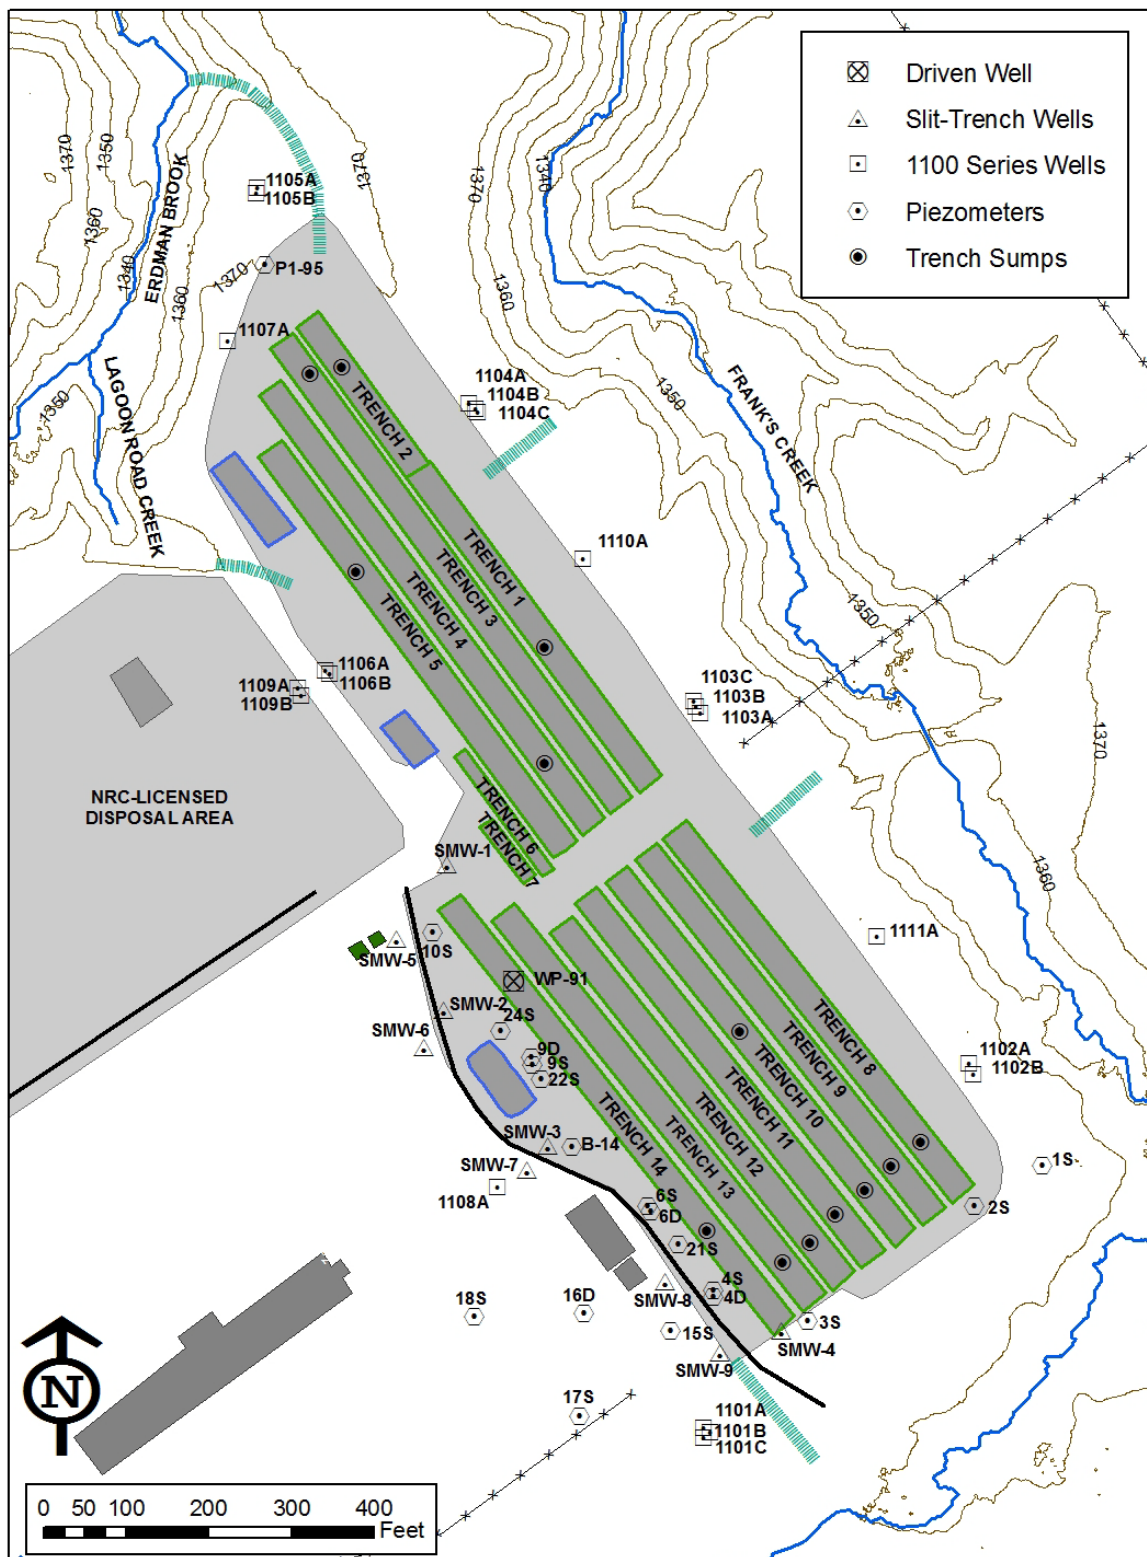
Figure 2-1. Trench Sump and Groundwater Monitoring Locations

The SDA groundwater monitoring network consists of 21 groundwater monitoring wells (the 1100-series wells), 19 piezometers and nine slit-trench wells. The location of each monitoring well is shown in Figure 2-1. The purpose of the groundwater monitoring program is twofold: (1) to provide data of sufficient quality and quantity to allow detection of the migration of radionuclides or volatile organic compounds (VOCs) from the SDA via groundwater; and, (2) to provide information on hydrologic conditions near the disposal trenches. The Groundwater Monitoring Program is conducted in accordance with the *Groundwater Monitoring Plan for the State-Licensed Disposal Area (SDA) at West Valley (GMP)*. The 1100-series wells, piezometers, and slit-trench wells are inspected and maintained as described in the GMP.

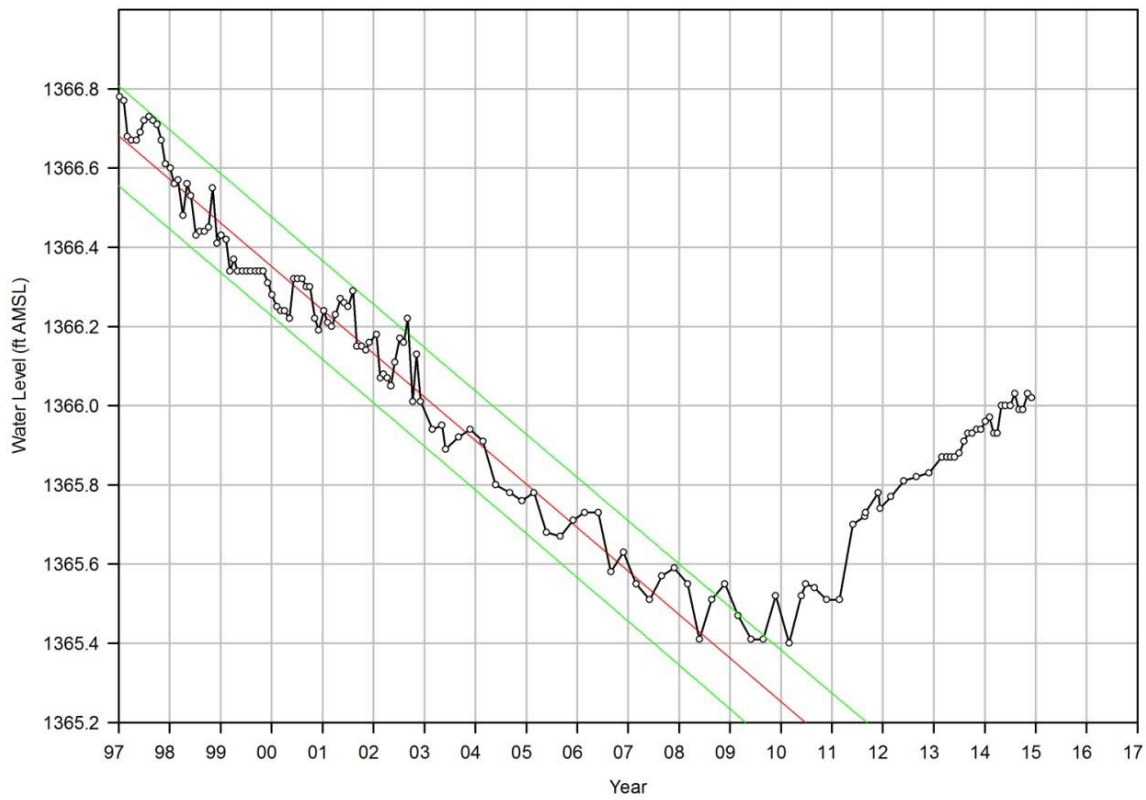
Regression line (red) for data for the period January 1997 to May 2008. $R^2 = 0.97$. 95% Prediction intervals shown in green. Predicted change in leachate elevation from this regression line is -1.32 inches per year.

Following the installation of infiltration controls in the mid-1990s, the Trench 14 leachate elevation followed a consistent and generally predictable decreasing trend (Figure 2-3a). A noteworthy change in behavior of this trend occurred in approximately 2008-2009 when the decreasing trend stopped.

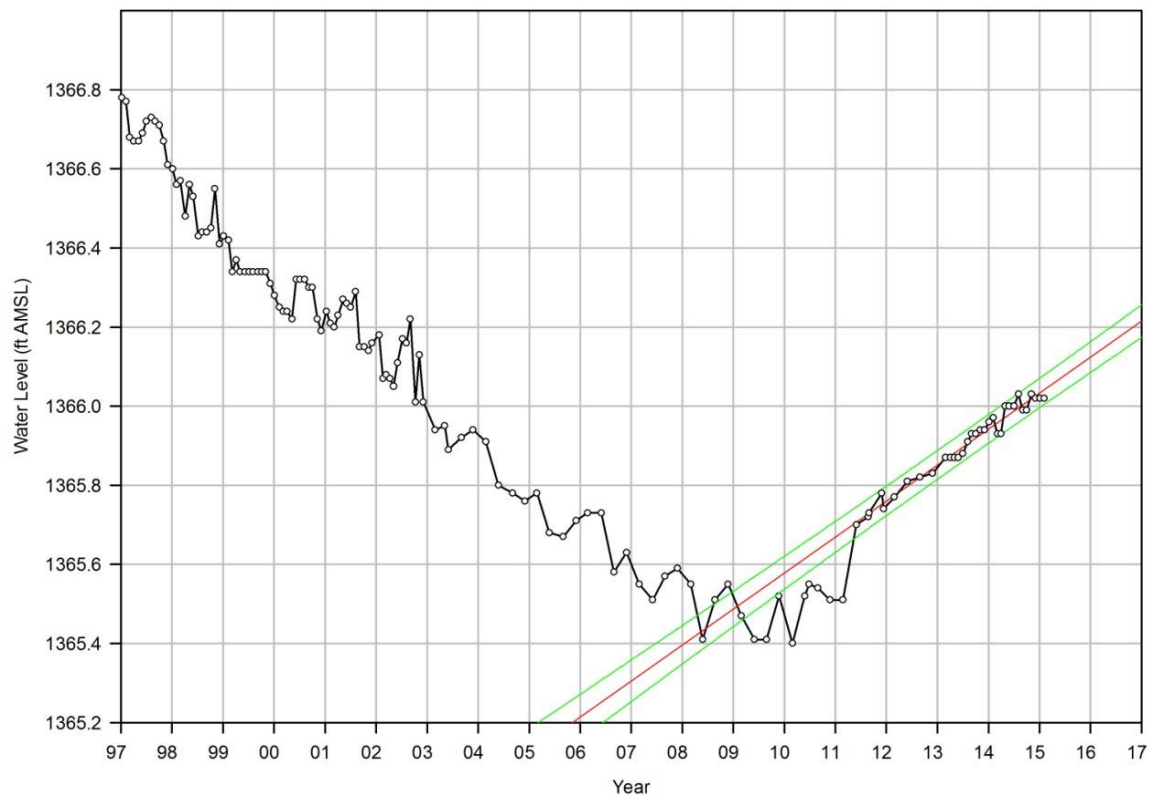
Figure 2-3b. Trench 14 Leachate (Water) Elevations for the Period 2011 to 2014, Inclusive.

Regression line (red) for data for the period June 2011 to December 2014. $R^2 = 0.97$. 95% Prediction intervals shown in green. Predicted change in leachate elevation from this regression line is +1.09 inches per year.

In early 2011, the leachate elevation increased by two inches. Small increases and decreases have been observed since 2011, but overall, the Trench 14 leachate elevation has continued to increase each year. Although none of the increases were large enough to trigger regulatory reporting requirements, the 2014 data set shows that the small increases are continuing, and have been consistent and predictable since mid-2011 (Figure 2-3b). During 2014, the leachate in Trench 14 increased by 0.72 inches. None of the nearby trenches are showing a similar increase.

The highest leachate elevation observed in Trench 14 was in 1992, when it was 1.5 ft higher than it is today. Even at this higher elevation, there was no release of leachate from the trench. As such, this current leachate elevation increase in Trench 14 does not present a threat to public health and safety, or the environment; however, NYSERDA is investigating the increase.

In 2015, NYSERDA will complete a more thorough evaluation of the increases in order to identify a cause or potential cause for the leachate increase, and to recommend actions to mitigate the increase.

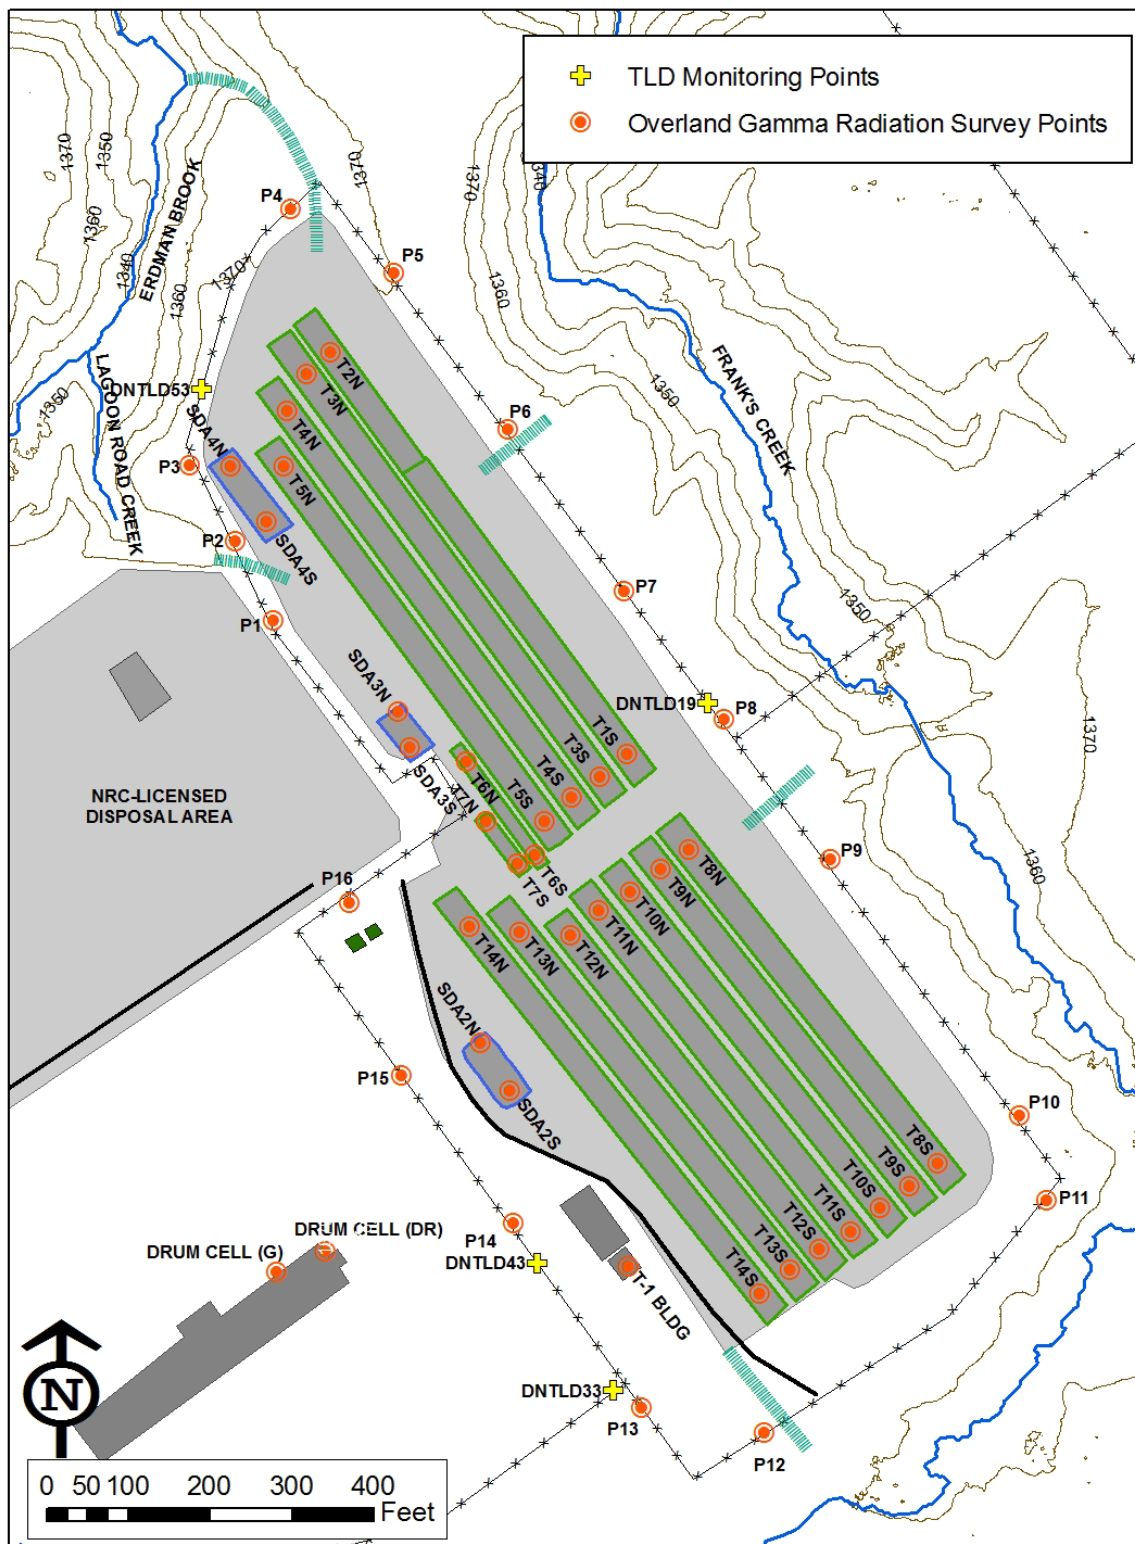
Figure 2-6. Gamma Radiation Monitoring Locations

Gamma radiation levels observed during both of the semiannual surveys were consistent with recently reported data.

Each calendar quarter, four environmental thermoluminescent dosimeters (TLDs) placed around the SDA are processed to obtain the integrated gamma radiation exposure from each location (see Figure 2-6).

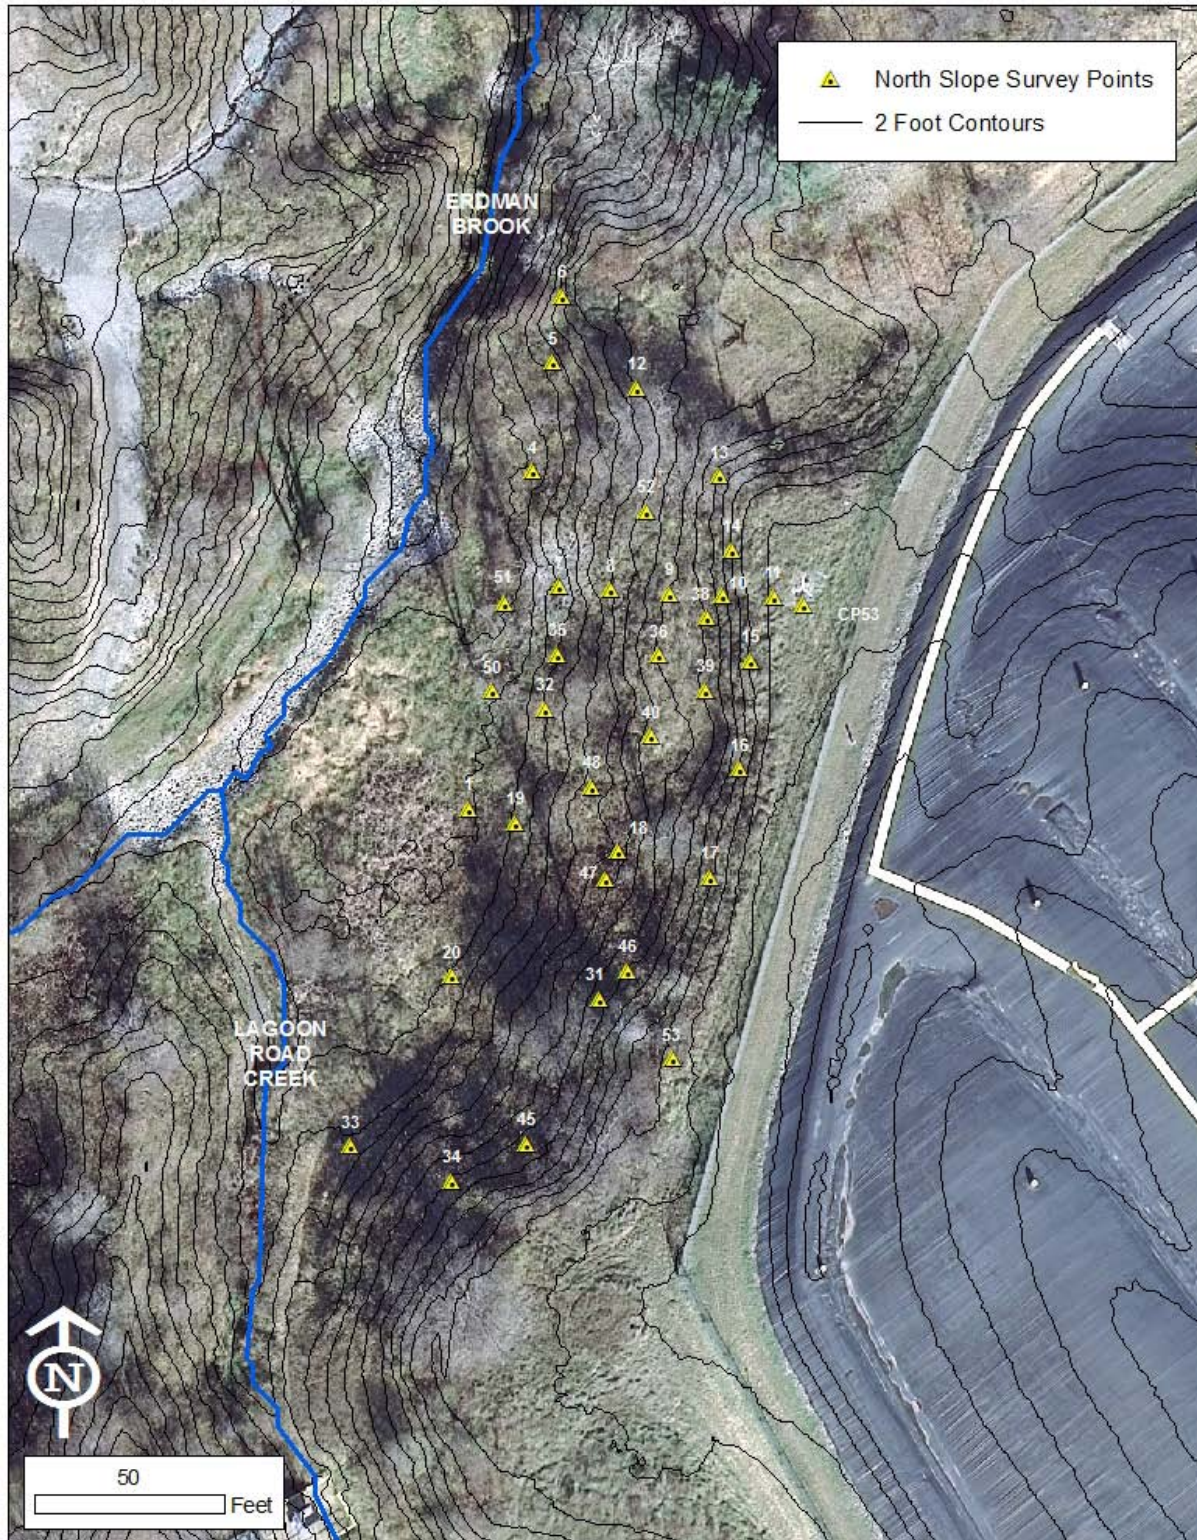
Figure 3-1. North Slope Ground Surface Elevation Survey Points

The 2014 elevations of the North Slope monitoring points (see Figure 3-1) are provided in Table F-1. A comparison of the 2014 elevation data with the 2013 data did not show any reportable changes (>0.5 feet) in the elevations of the monitoring points. A few of the numeric location points absent from Table F-1 are due to the physical point markers being damaged and removed during erosion mitigation construction activities.

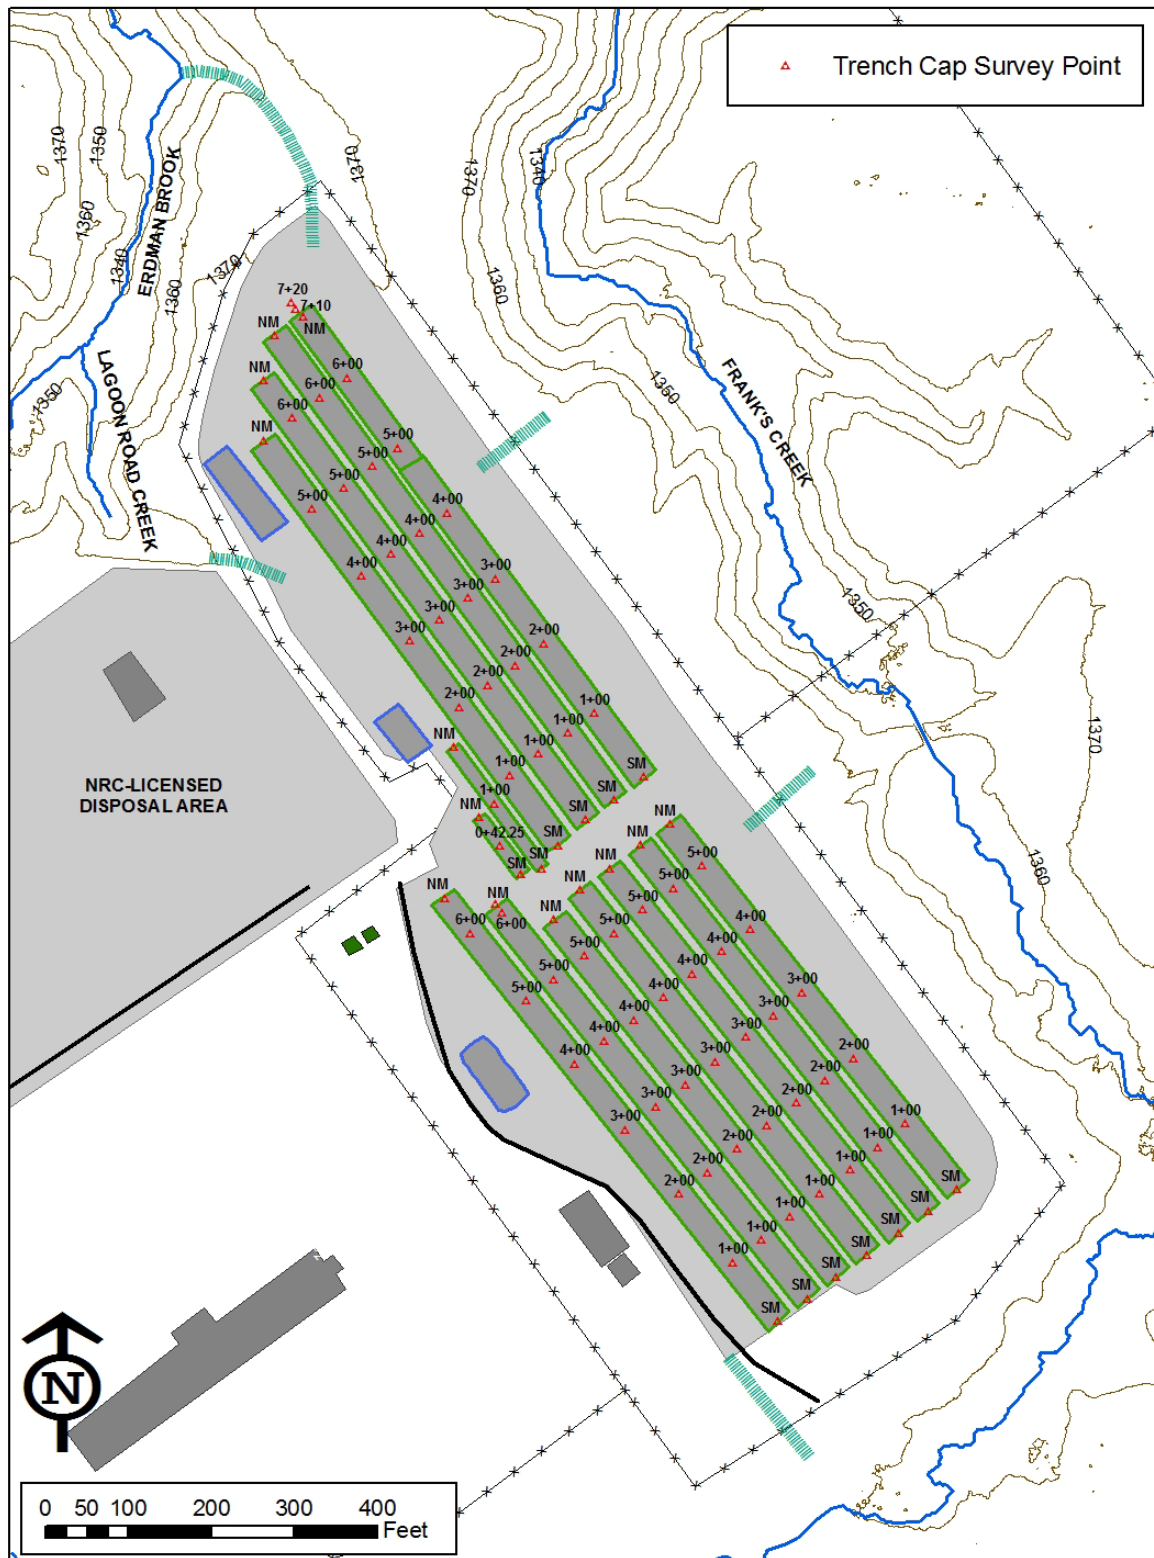
Figure 3-2. Trench Cap Ground Surface Elevation Survey Points

All trench cap surveys begin at the centerline mark of the south monument plaque, and continue northerly at 100-ft stationing along the centerline of the trench until reaching the centerline mark of the north monument plaque. Results of the trench cap survey are provided in Table F-2. A comparison of the 2014 trench cap centerline elevations with 2013 elevation data did not indicate any significant elevation changes (>0.5 feet). An area of settlement on the southern portion of Trench 13 was observed in 2013. Two points in the area were initially surveyed in 2013 for horizontal and vertical positioning, and when compared to data for the same points in 2014, it was confirmed that subsidence in the trench cap was 0.5 inch. Also in 2014, NYSERDA conducted a focused topographic survey of 70 additional data points in the area between the southern monument on Trench 13 and the 100 ft-stationing mark. NYSERDA will monitor these additional data points on a quarterly basis and report any significant results to NYSDEC.

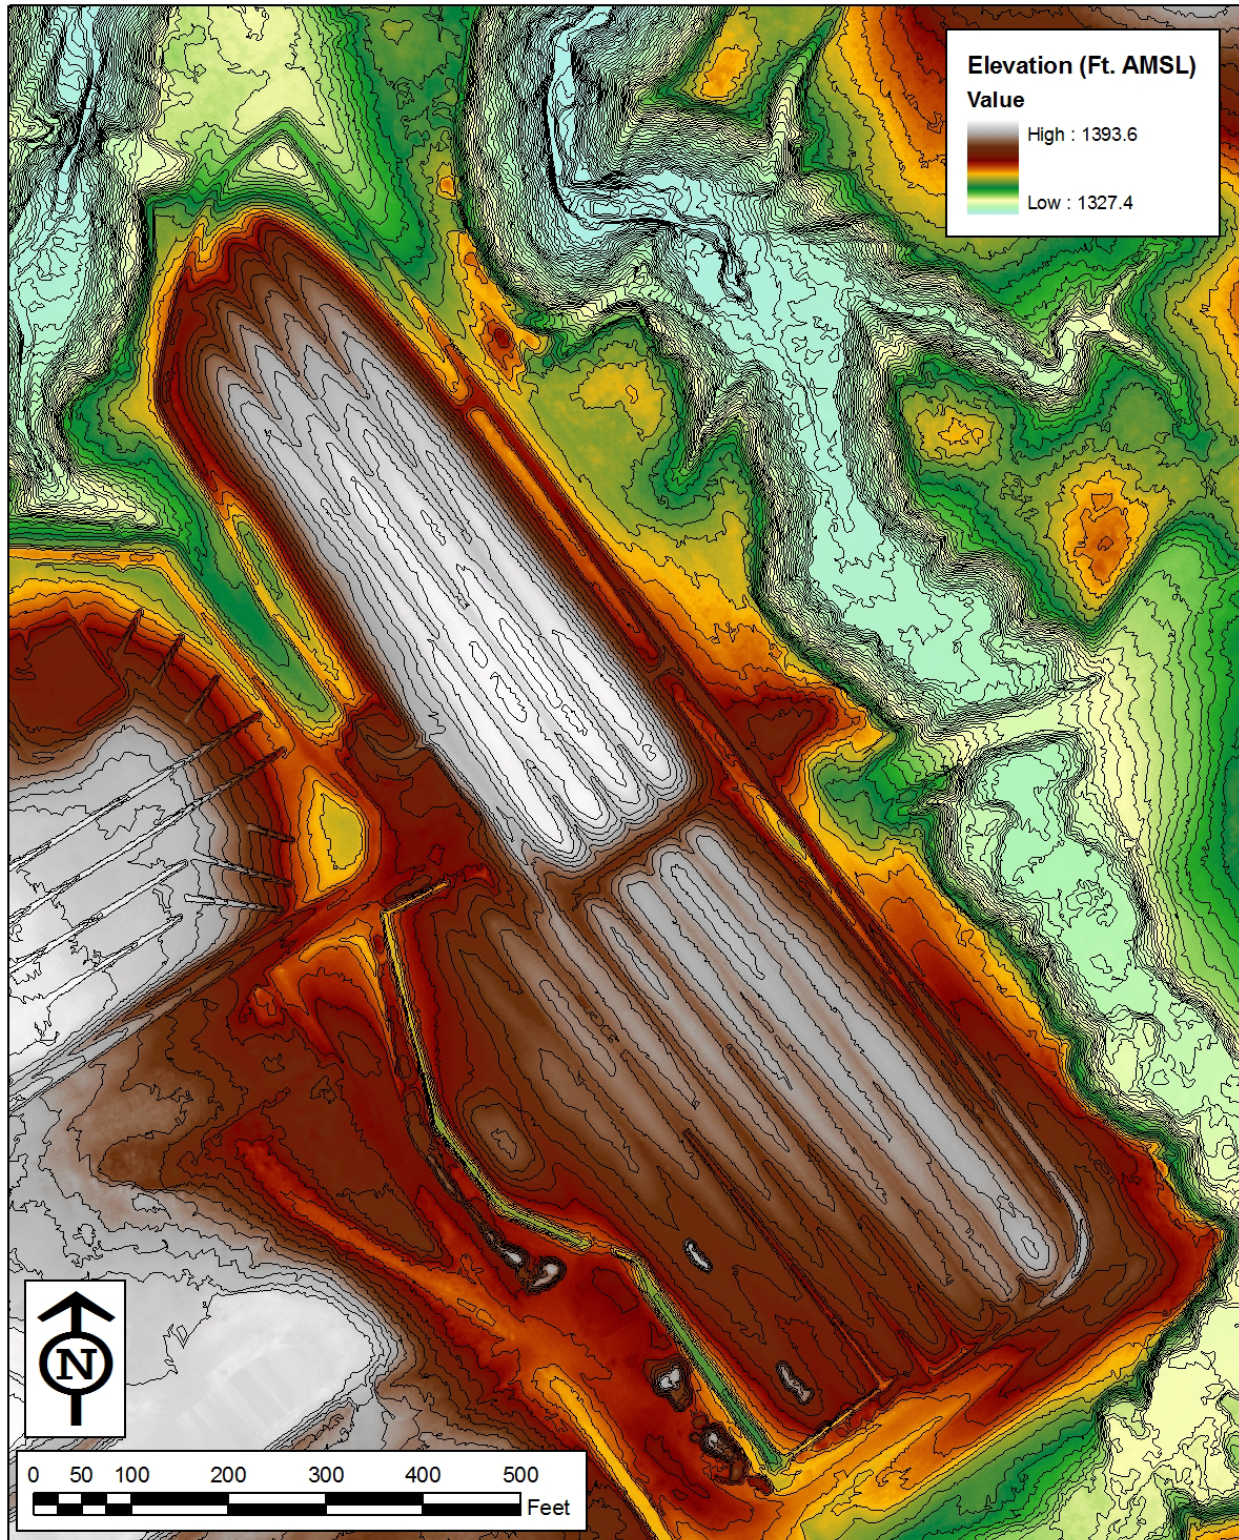
Figure 3-3: LiDAR-Derived Topographic Map of the SDA and Surrounding Area

In 2010, NYSERDA conducted an aerial Light Detection and Ranging (LiDAR) mapping and orthoimagery project. A detailed topographic map of the Buttermilk Creek watershed was developed with a resolution (grid size) of 1.0 meter. For the WNYNSC and the SDA, a resolution of 0.5 meters was achieved. Figure 3-3 is a high quality topographic map of the SDA and the surrounding area that was derived from a subset of the LiDAR data. This project represents the most accurate and comprehensive large-scale topographic mapping of the SDA ever completed. NYSERDA plans to fly a new LiDAR survey in 2015 to update and supplement the 2010 survey of the Buttermilk Creek watershed. The survey will extend to include the neighboring Connoisarauley Creek watershed and the Cattaraugus Creek corridor from the WNYNSC to Lake Erie.

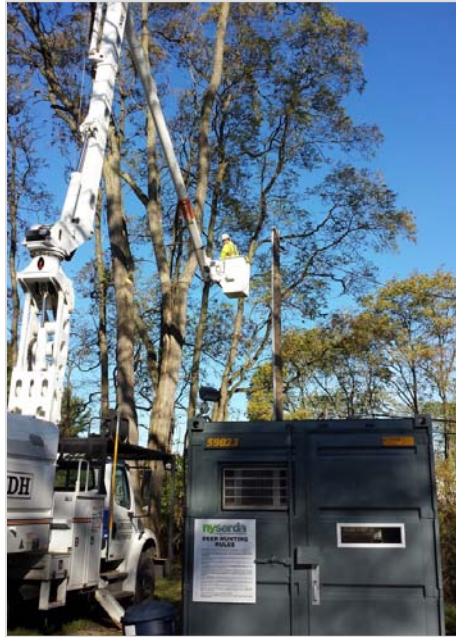
Figure 4-1. Tree Trimming by National Grid

- Repaired miscellaneous punctures and tears on the XR-5 geomembrane covers, including the replacement of several sections of deteriorated walkway.
- Snowplowing and vegetation control at the SDA and Bulk Storage Warehouse.
- Supported tasks for the annual deer hunting program on the WNYNSC (see Figure 4-1).
- Repaired approximately 25,000 ft of barbed wire fencing on the Retained Premises, and posted the perimeter with new “No Trespassing” signs.

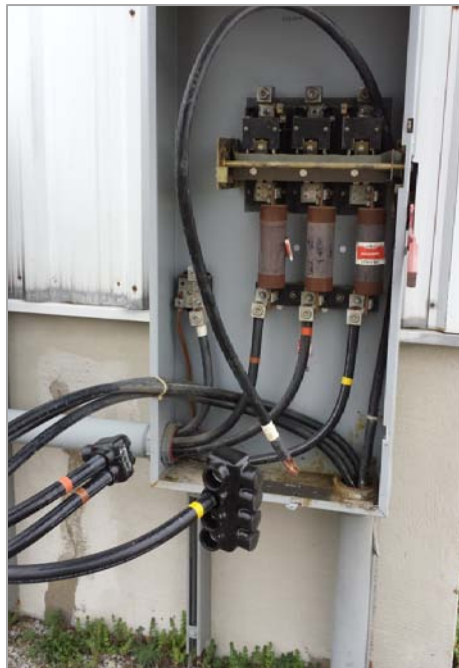
Figure 4-2. SDA Electrical Inspection Repairs

- Diagnosed and repaired the meteorological station.
- Removed obsolete electrical panels and conduit from within the SDA T-1 Building (see Figure 4-2).
- Repaired the roof leak in SDA T-1 Building and installed new insulation.
- Replaced the wooden walkways at the SDA.
- Replaced the nonslip textured walkway on the SDA Geomembrane.
- Leveled the concrete steps at the SDA.
- Extended the stormwater roof leader from the SDA Buildings to provide proper drainage.
- Performed minor maintenance and inspections of the Erdman Brook erosion controls.
- Performed electrical service maintenance at the SDA.
- Performed a Focused Topographic Survey of southern end of Trench 13 geomembrane cap to evaluate Trench 13 subsidence.

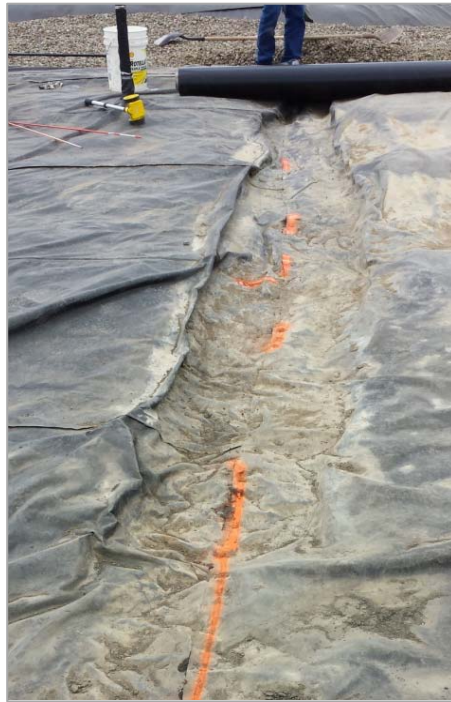
In June 2014, a drainage swale on the SDA geomembrane cover north of Trenches 13 and 14 was inspected for rips and weld integrity. During an inspection, the drainage swale containing stone ballast was emptied of stone and found to contain an open seam approximately eight ft long (see Figure 4-3). It appears that the seam was not properly welded (sealed) at the time this section of the geomembrane cover was installed in 1995; however, it is not possible to determine exactly when this seam failed (see Figure 4-3). The seam does not appear to have been physically disturbed or stressed. The entire 34-ft-long drainage swale was covered with new geomembrane material that was welded to the existing geomembrane in a manner that eliminated the seam in the bottom of the swale.

Figure 4-3. Open seam in SDA geomembrane.

- **Geomembrane Inspection and Repairs** - NYSERDA routinely inspects the entire SDA geomembrane cover for rips, tears, boot penetrations and blockage of stormwater detention basins. Any minor tears identified are repaired in a timely manner. In 2014, an open seam approximately eight ft long just north of Trenches 13 and 14 was identified and repaired (see Section 4).
