**State-Licensed
Disposal Area at
West Valley:
2016 Annual Report
Final Report**

March 2017

**New York State Energy Research and Development Authority
West Valley Site Management Program**

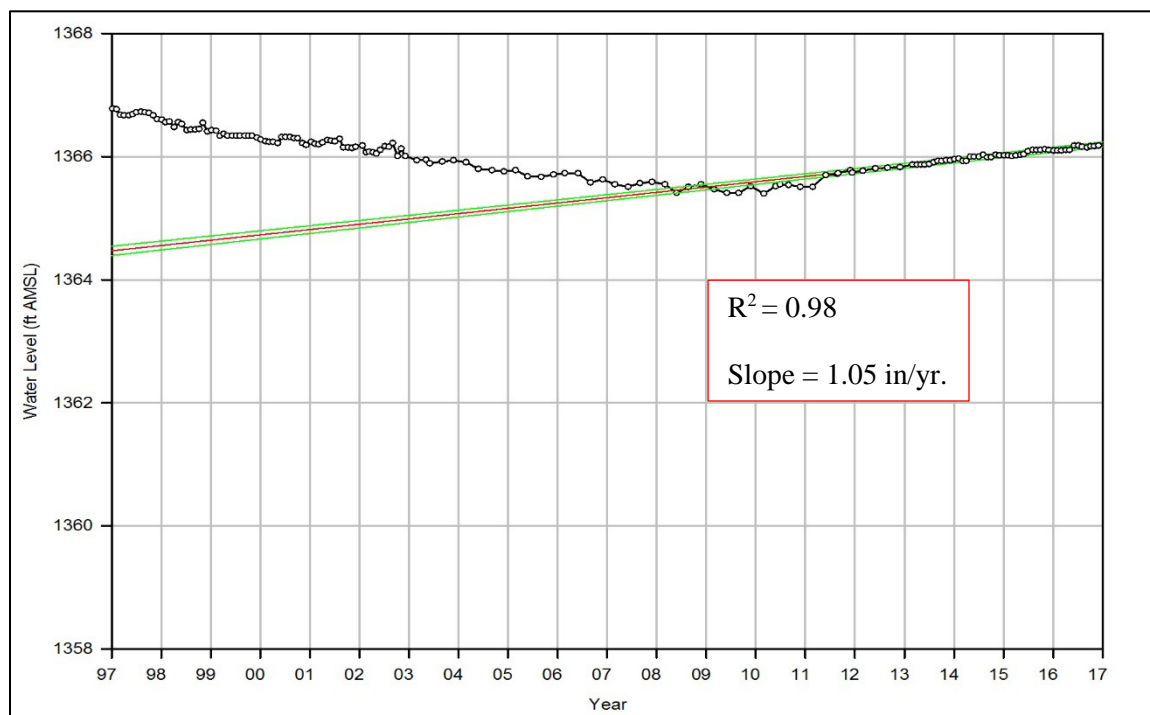
Regression line (red) for data for the period June 2011 to December 2016. 95% Prediction intervals shown in green.

Small increases and decreases have been observed since 2011, but overall, the Trench 14 leachate elevation has continued to increase each year. Although none of the increases were large enough to trigger regulatory reporting requirements, the 2016 data set shows that the small increases have been continuing, and have been consistent and predictable since mid-2011 (Figure 2-4). During 2016, the leachate in Trench 14 increased by 0.08 ft (0.96 inches). None of the nearby trenches are showing a similar increase.

The highest leachate elevation observed in Trench 14 was in 1992 (1367.46 ft) above mean sea level (AMSL), when it was 1.28 ft higher than it is today. Even at this higher elevation, there was no release of leachate from the trench. As such, this current leachate elevation increase in Trench 14 does not present a threat to public health and safety, or the environment; however, NYSDERDA is investigating the increase.

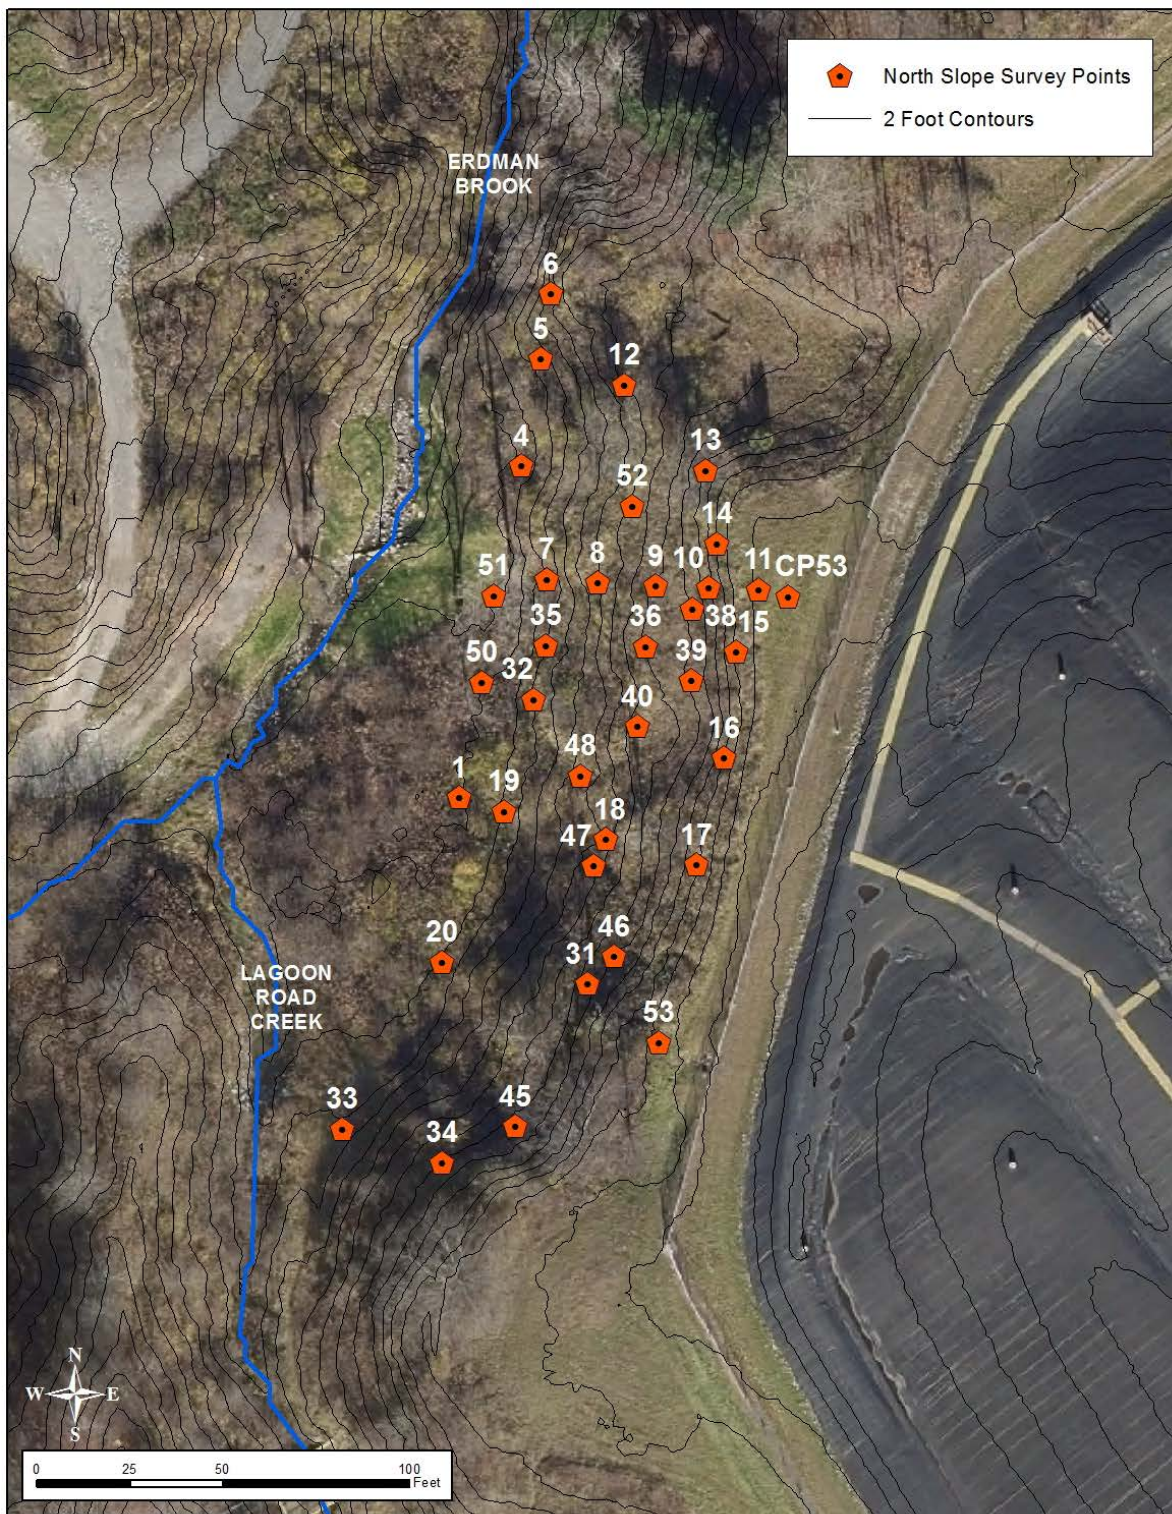
Figure 3-1. North Slope Ground Surface Elevation Survey Points

The 2016 elevations of the north slope monitoring points (see Figure 3-1) are provided in Table F-1. A comparison of the 2016 elevation data with the 2015 data did not show any reportable changes (>0.5 ft) in the elevations of the monitoring points. A few of the numeric location points absent from Table F-1 are due to the physical point markers being damaged and removed during erosion mitigation construction activities.

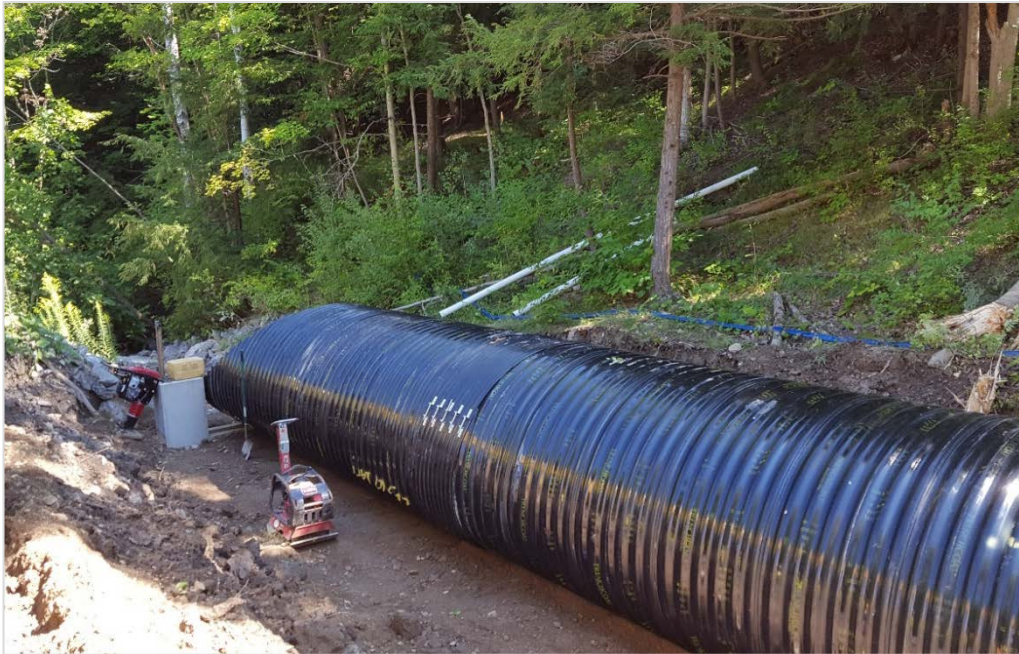
Figure 4-1. Installation of CMPs

Both the Erdman Brook and Frank's Creek erosion controls have been functioning as designed, including the recently installed corrugated metal pipe (CMP) culvert within Erdman Brook. Repairs needed in the DOE-controlled sections of Erdman Brook west of the SDA include re-armoring sections, and replacing or covering exposed geotextile. The maintenance issues involve primarily the smaller diameter armoring (rip-rap) that moved downstream and left exposed stream bank and bed during rainstorms in July 2015. Since the damage occurred, additional erosion of the stream bed and undermining of the geotextile has occurred.

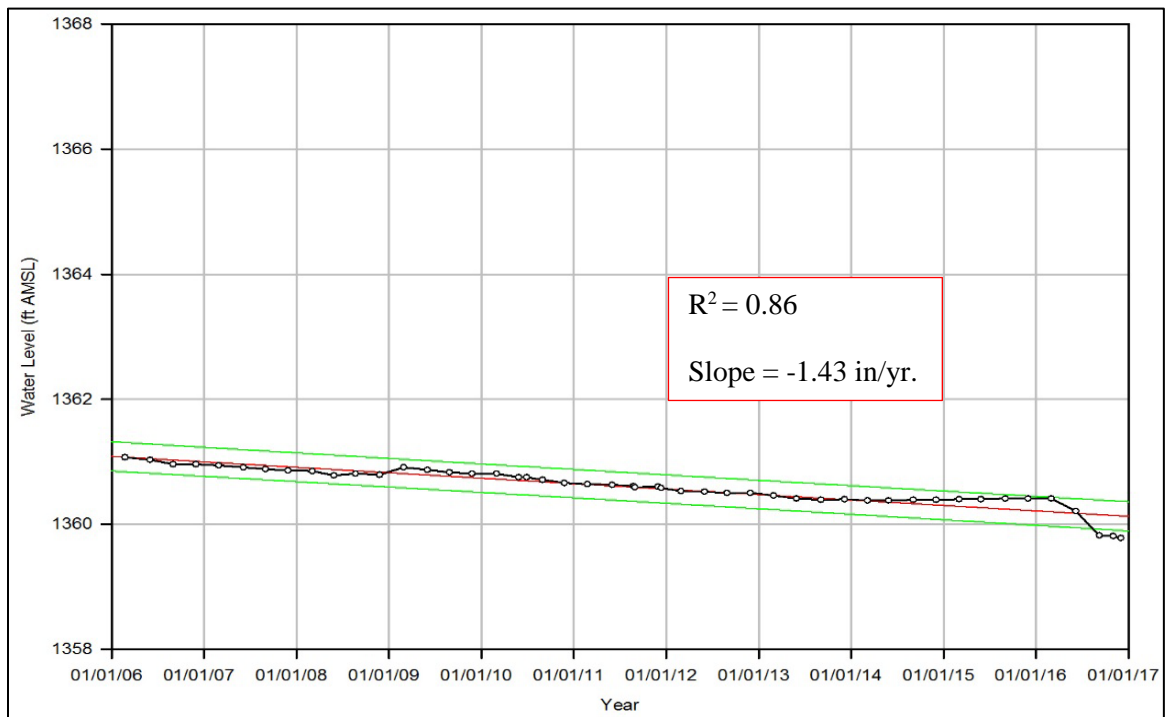
Figure A-3. 2006-2016 Leachate Elevations, Trench 3

In addition to the increasing trends in Trenches 1 and 14, a potential trend change had been noted for Trench 3. A review of recent SDA leachate elevation data had shown that the leachate elevation in Trench 3 exhibited a stable to very slightly increasing trend (0.13 ft) between 2014 and the first quarter of 2016. Prior to early 2014, the leachate elevation had been decreasing. Available data suggests that the leachate elevation in this trench may be near the trench bottom, or possibly even below (within the trench sump). During the second quarter 2016 measurement, it was noted that the water level indicator appeared to be malfunctioning. A new indicator was installed in the third quarter of 2016, with the initial result a 0.20 ft decrease from the second quarter 2016 result; and, the third quarter 2016 measurement a decrease of 0.37 ft. The fourth quarter 2016 measurement showed a decrease of 0.04 ft from the previous quarter. The measurements with the new indicator show that the leachate level is back on line with the long-term

historical decreasing trend, suggesting that the malfunctioning measurement probe was responsible for the apparent deviation from the historical trend (see Figure A-3).

The potential increase in Trench 3 identified in the 2015 State-Licensed Disposal Area (SDA) Annual Report,¹ was likely the result of a malfunctioning measurement probe. This probe was replaced in July 2016, and the results have decreased since the probe replacement and are consistent with the long-term decreasing trend for Trench 3.
