Ecosystem disturbance in Catskill Mountain streams: Coincidence or indicators of climate change?

Barry Baldigo
US Geological Survey, New York Water Science Center

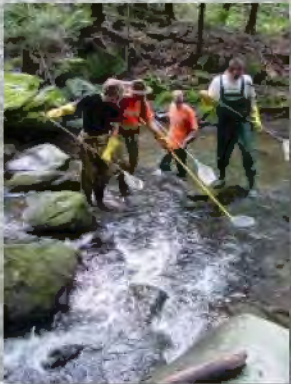
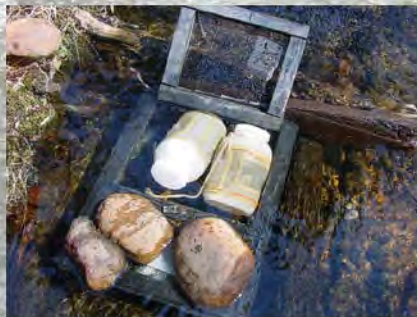
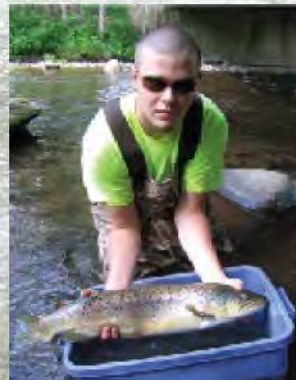
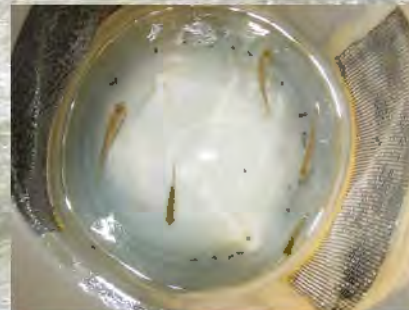
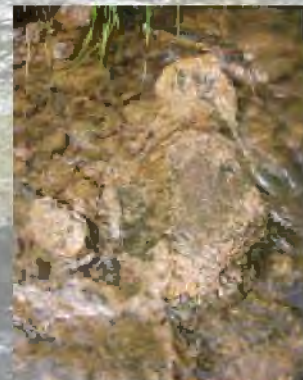
Catskill Stream Survey: ANC (N=180)

Acid Neutralizing Capacity

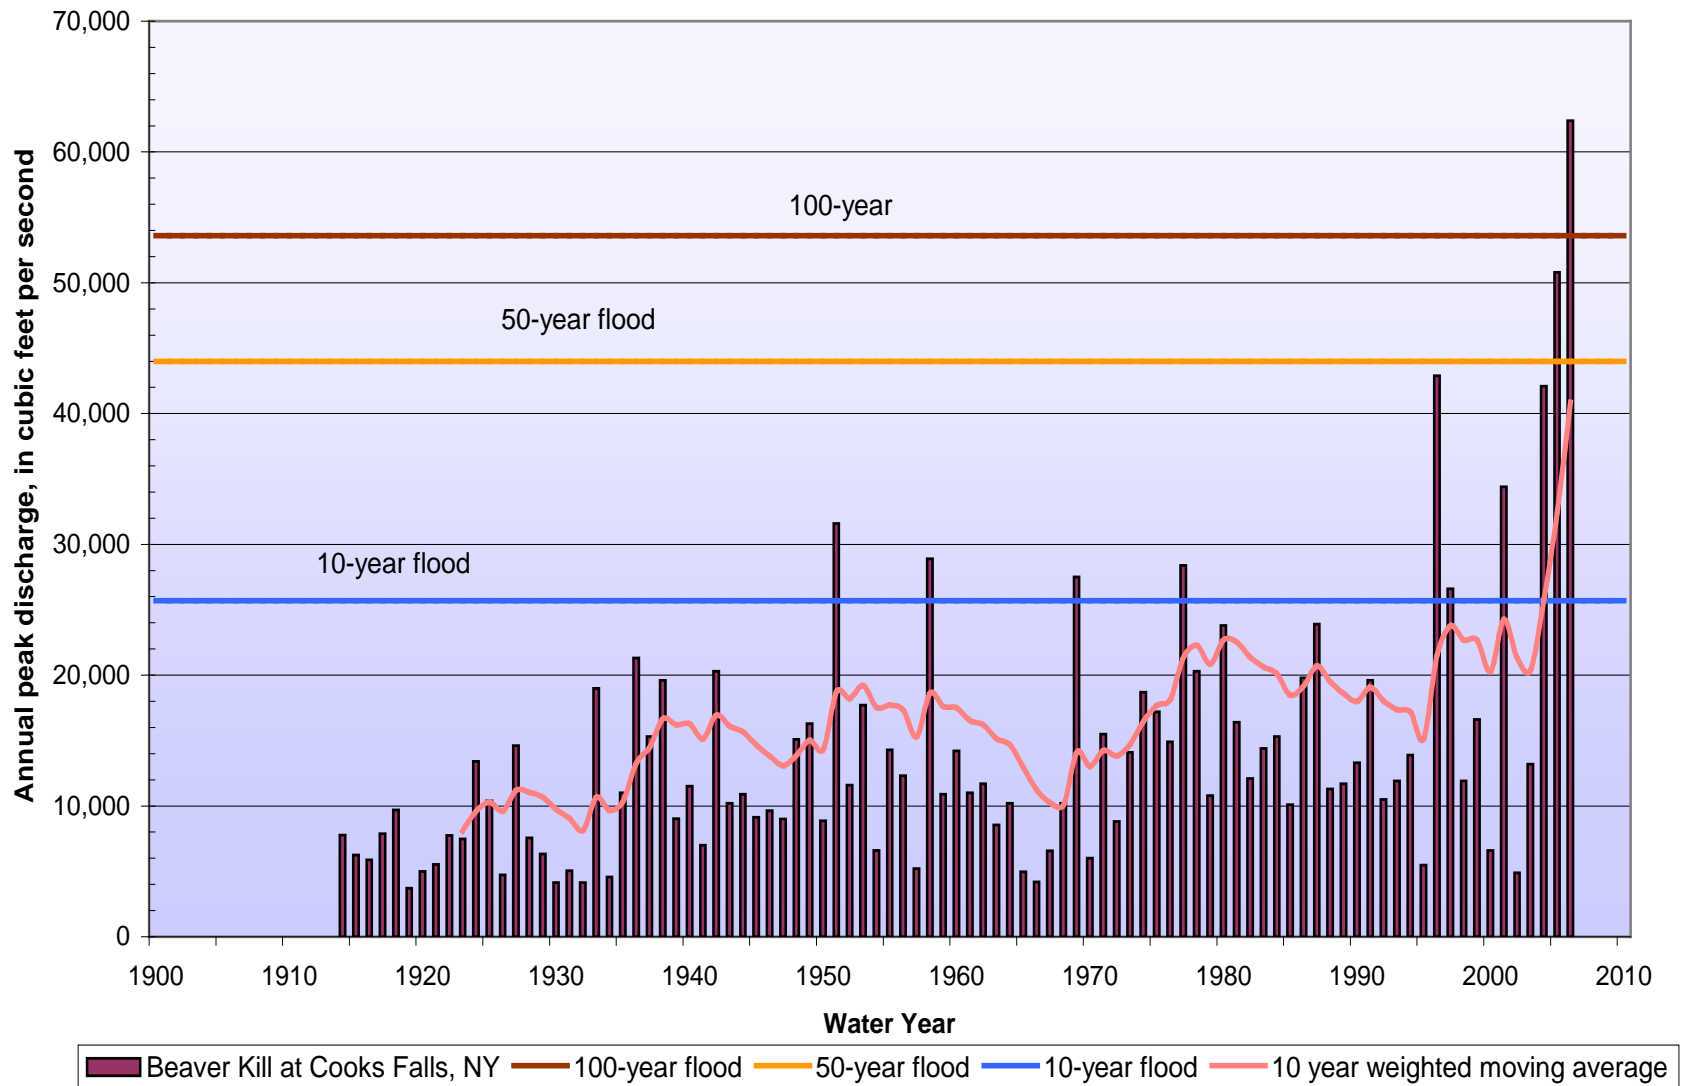
Flow regime is changing in some rivers

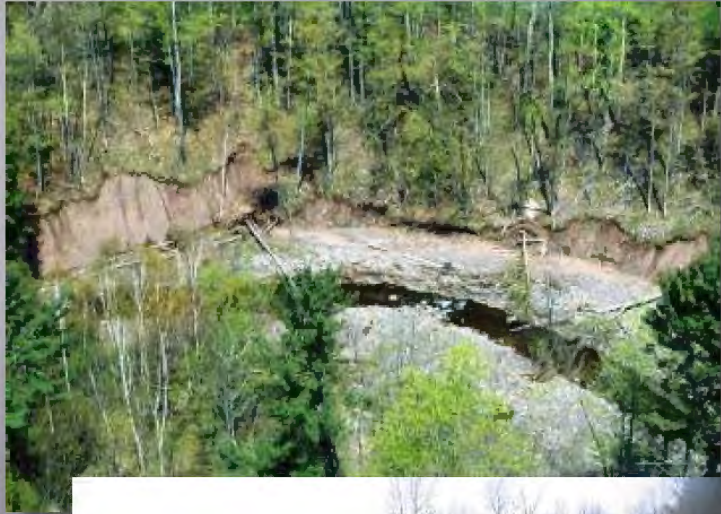
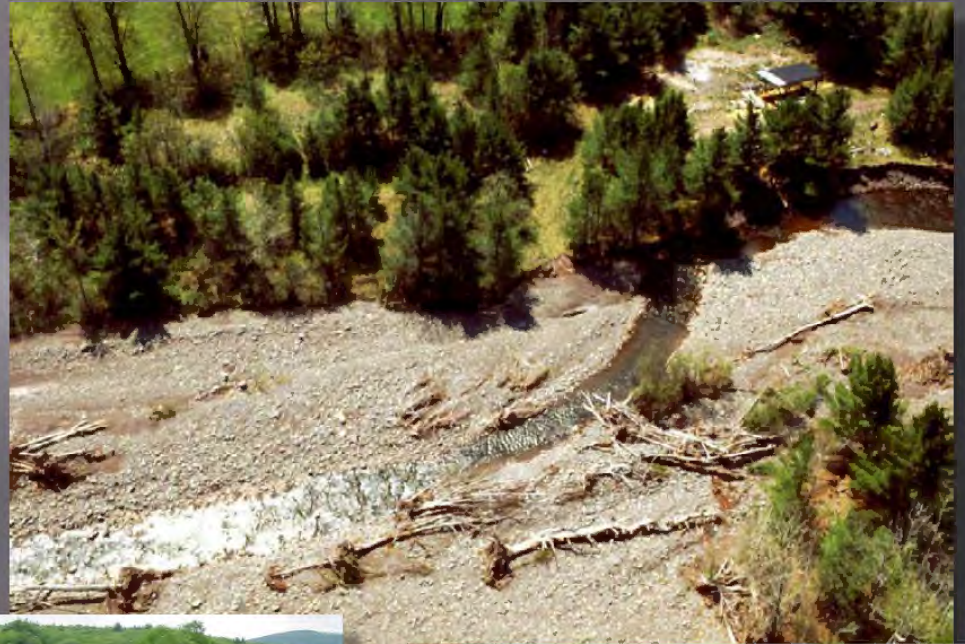
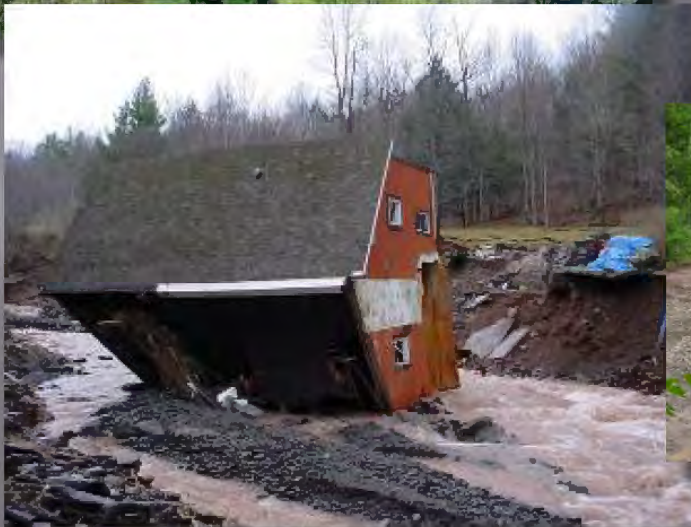
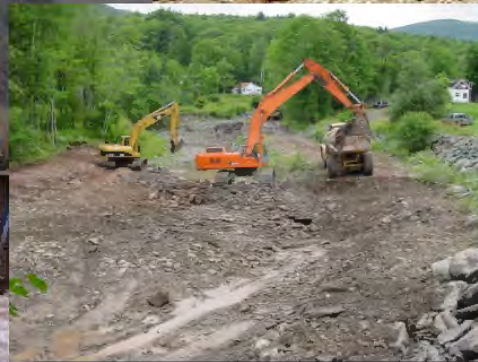
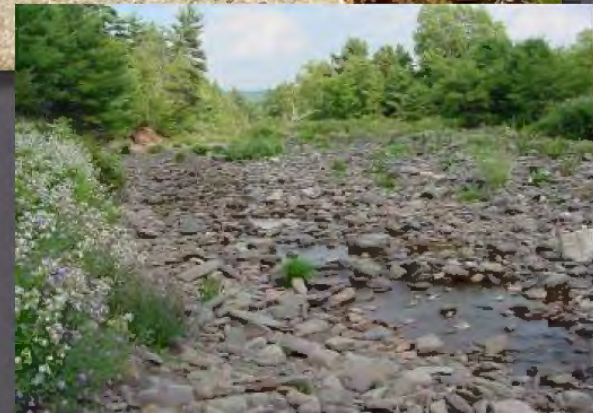
Implications: Channel Instability - flooding, property damage, turbidity, erosion, aggradation, & habitat degradation

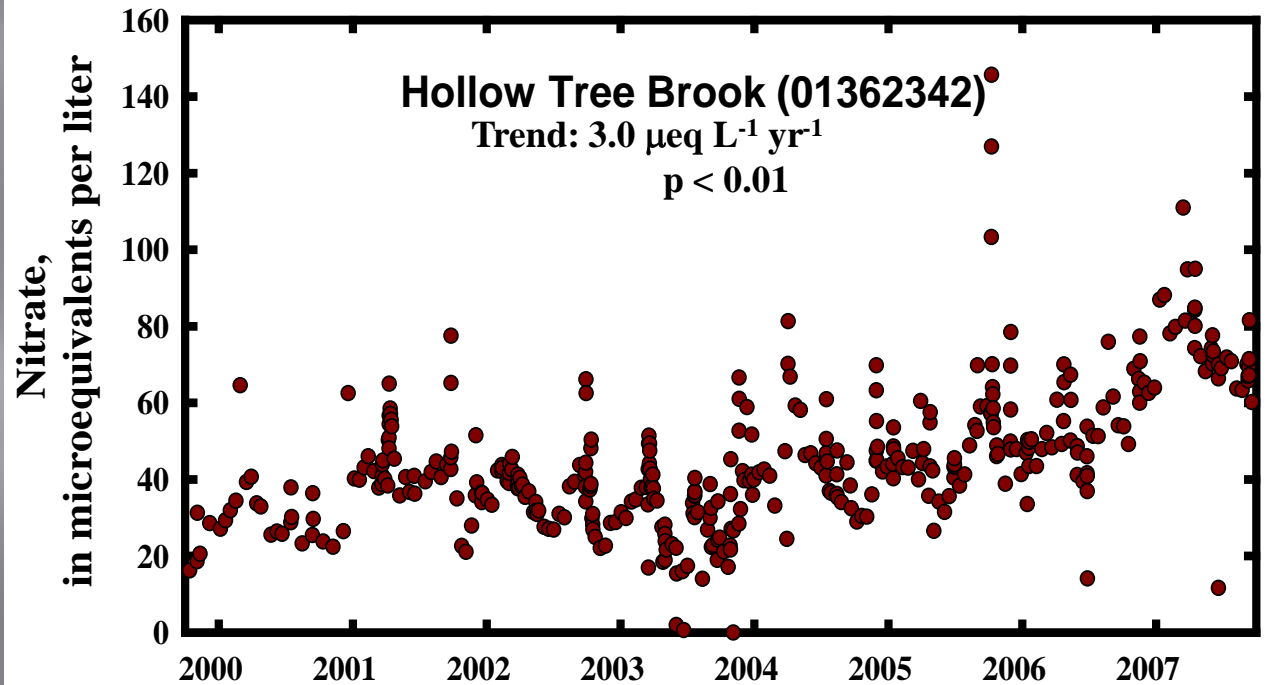
Nitrate trends in two tributaries to the Upper Esopus Creek, 2000- 07

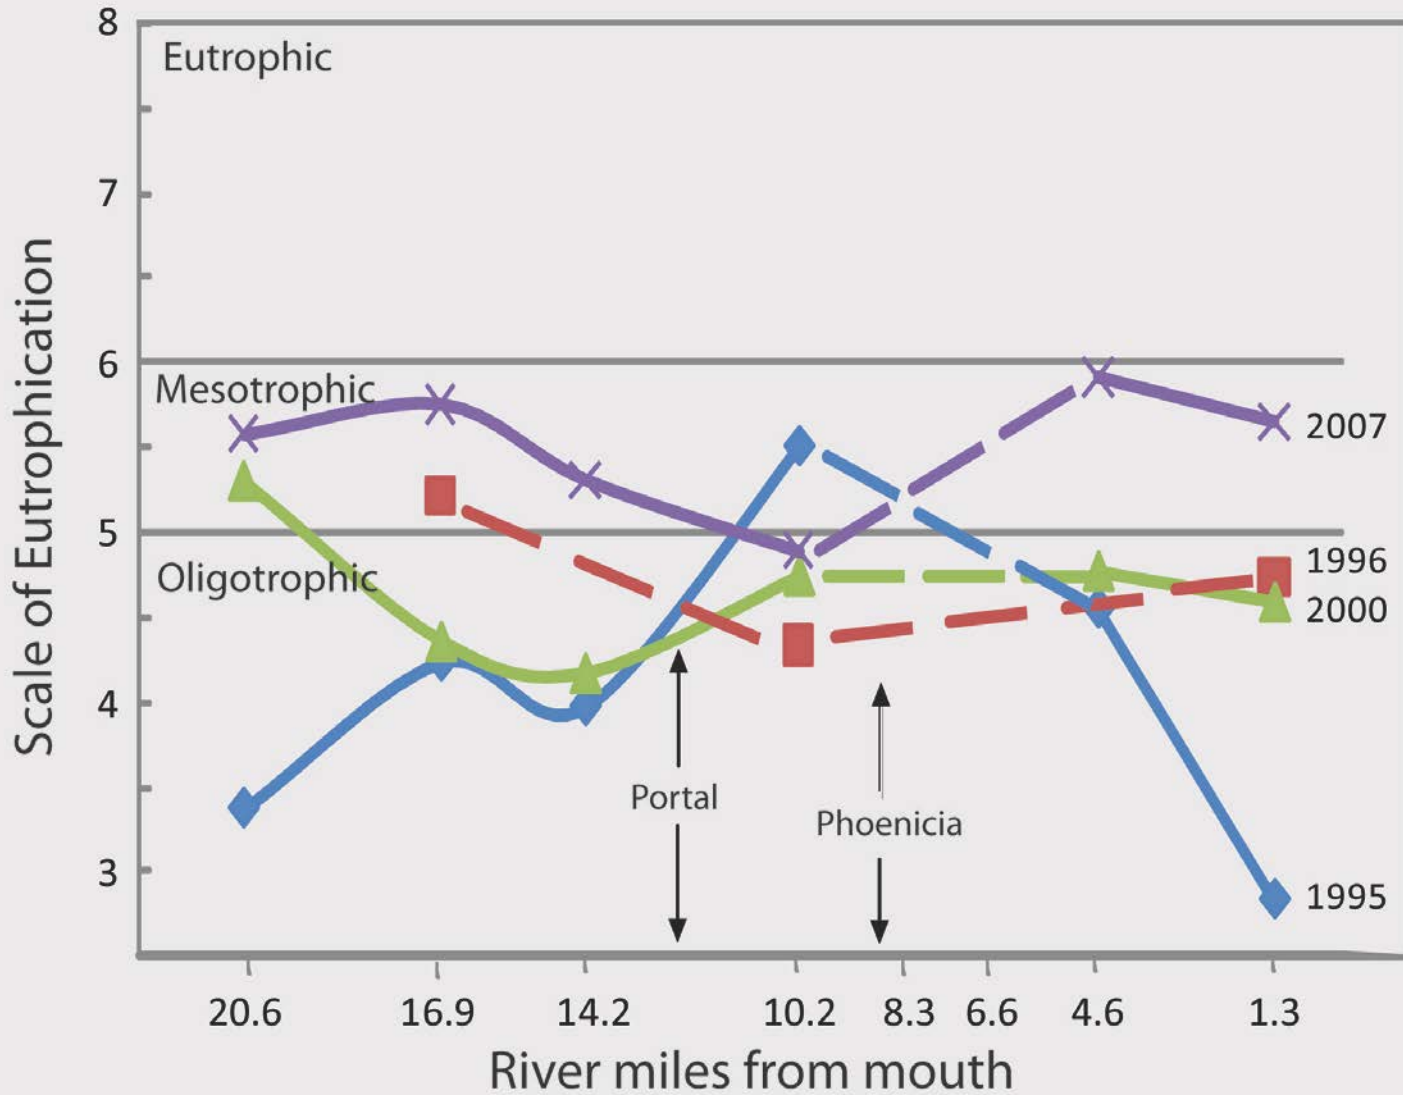
Nutrient Biotic Index, Upper Esopus

(Macroinvertebrate data from the NYSDEC Stream Biomonitoring Unit)

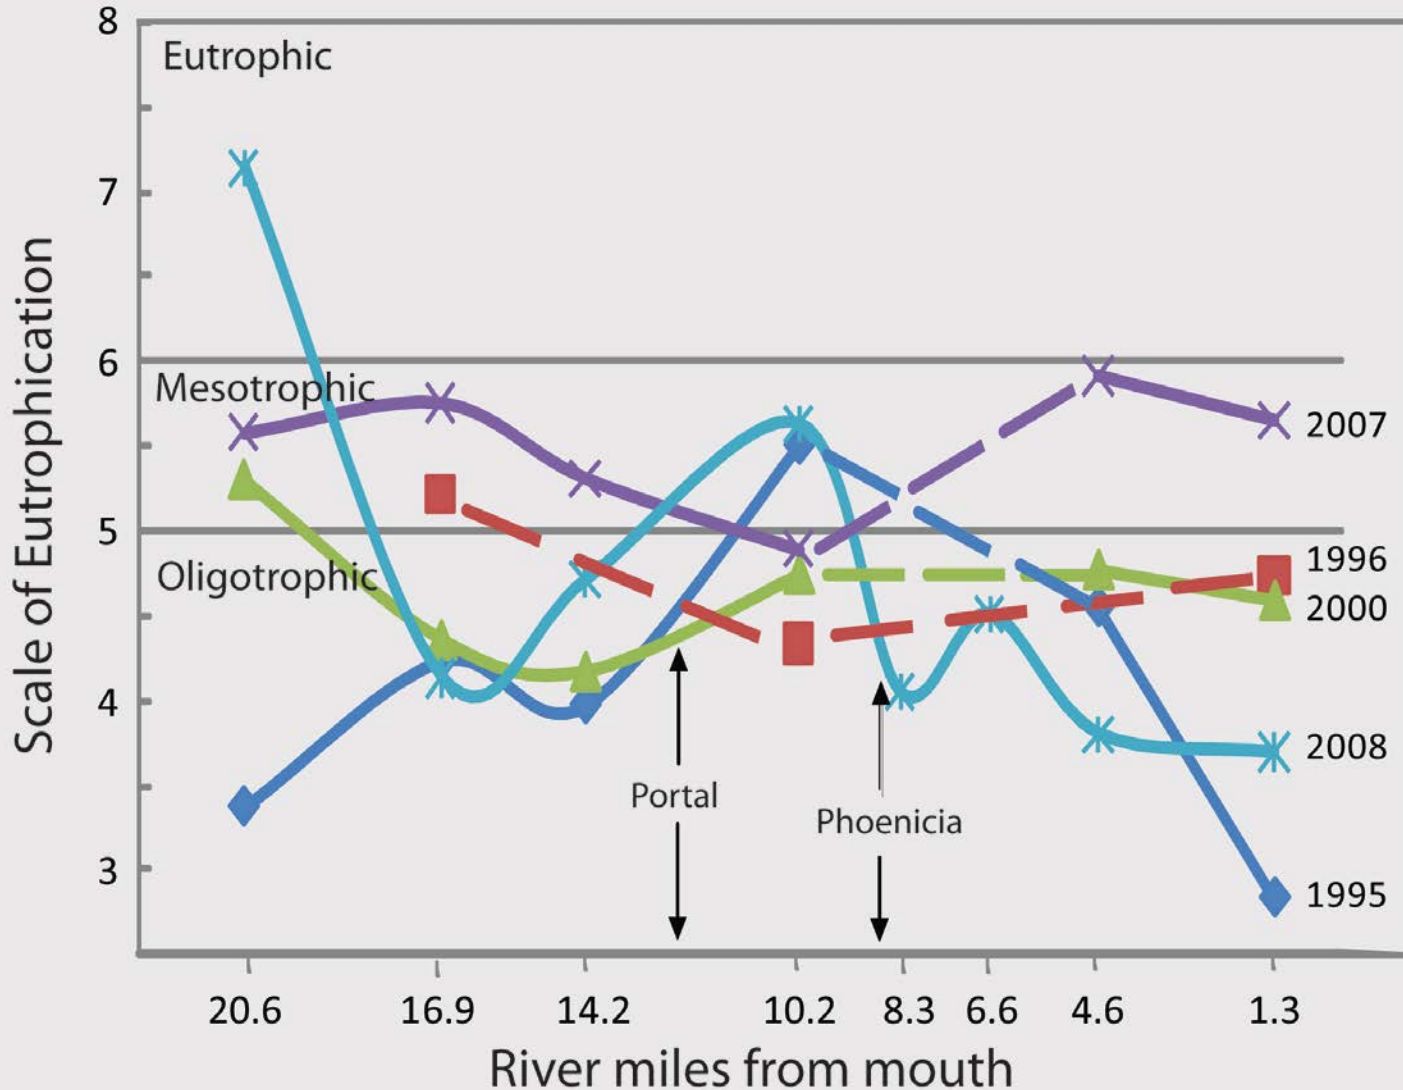
Nutrient Biotic Index, Upper Esopus

(Macroinvertebrate data from the NYSDEC Stream Biomonitoring Unit)
