Performance and Efficiency of the Solar Thermal System at Riverside Laundromat and Carwash

**Final Report**

**Report Number 15-23**

#### E2G Solar: Custom Thermal Systems

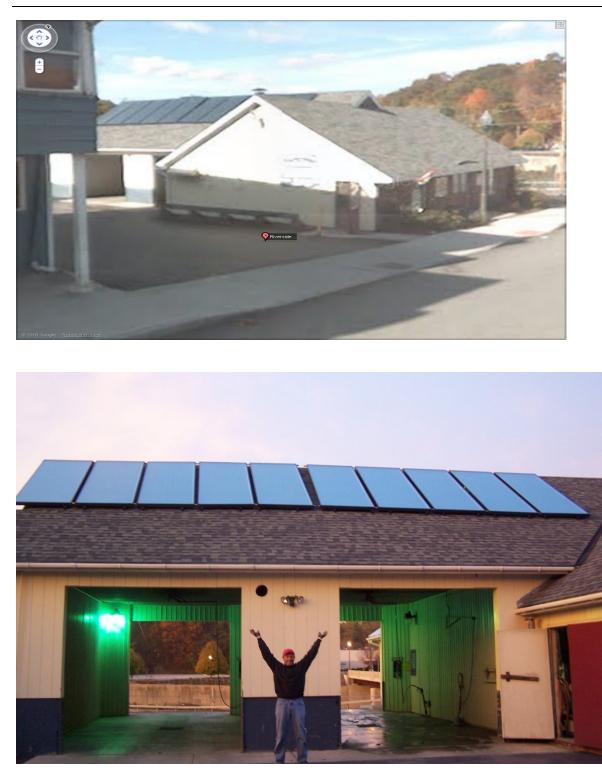
## Appendix A: Site Photos

# 6 ATTACA AND A DECIMAL OF A DECIM • 0 0 AC PANEL COVER Solar pump
