Evaluating Exterior Insulation and Finish Systems for Deep Energy Retrofits

Final Report | Report Number 18-06 | November 2017

The Levy Partnership, Inc.

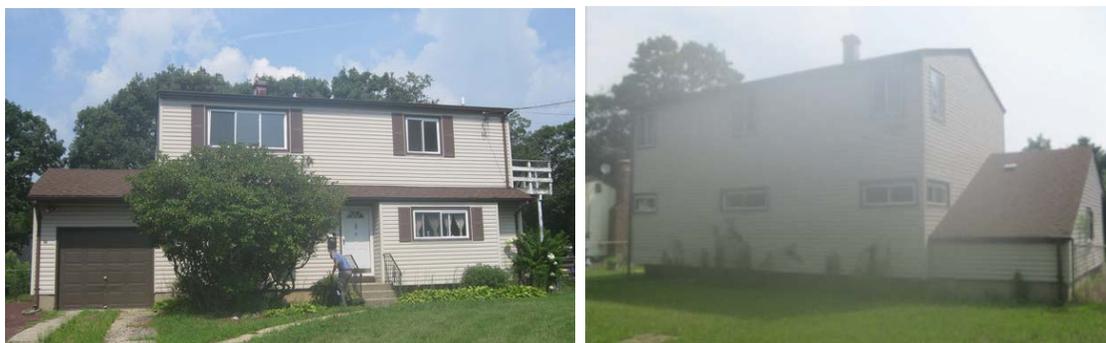
Figure 2. Front and rear elevations of the pre-retrofit home

Building Type	Single-family detached home
Conditioned Floor Area	2,200 ft ²
Foundation	Full unconditioned basement
Structure	2x4 wood frame
Gross Wall Area	2,122 ft ²
Net Wall Area	1,680 ft ²
Exterior	Vinyl siding—retrofit to 4-inch EIFS
Height	Two stories above grade

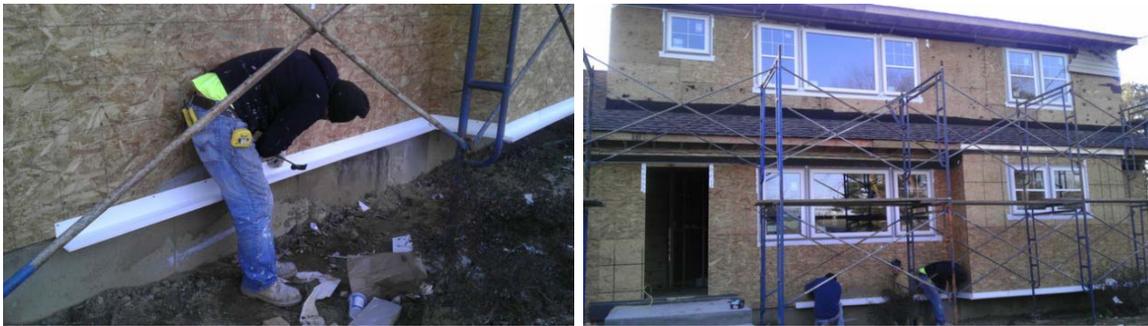
Figure 3. After scaffolding is set up, a bottom track is attached to the base of the sheathing to accept the bottom of the EIFS

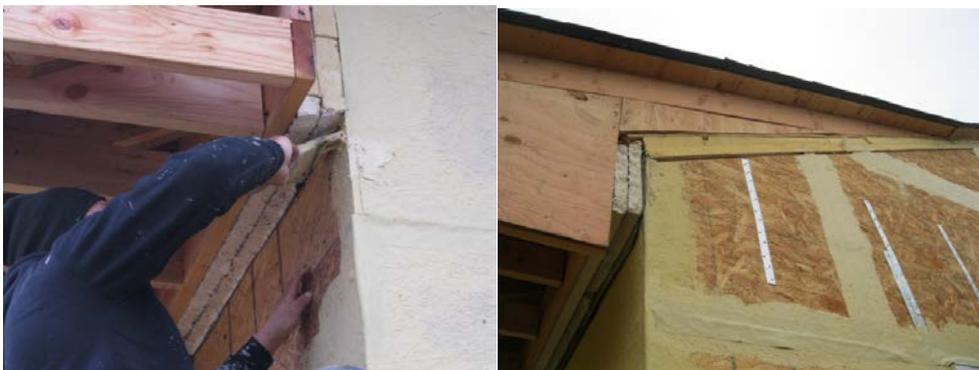
Figure 4. The water resistive coating is brushed onto the sheathing with a layer of reinforcing mesh embedded at sheathing joints

Next, a liquid water resistive barrier (WRB) is brushed onto the sheathing; a layer of reinforcing mesh is embedded into the coating at the sheathing joints (Figure 4). Overhangs at eaves were removed and added back on over rigid insulation to match the 4-inch EIFS thickness. At the gable ends, the roof deck was extended where necessary to match the 4-inch EIFS depth. A metal drip edge was added to direct water away from the rake.

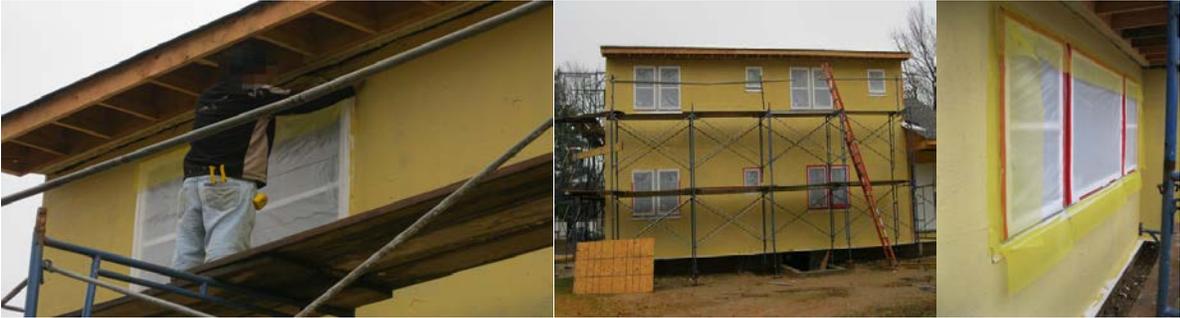
Figure 5. Reinforcing mesh is affixed around the newly installed windows

After the coating is complete, more reinforcing mesh is affixed around the newly installed windows; it will be used to wrap the edges of the insulation.

An approximately 12-inch wide strip of reinforcing mesh is left hanging at all four sides of the window openings (Figure 5). It will later be wrapped around the edges of the EPS panels, protecting them at all exposed edges. This obviates the need, in standard installations, for any additional window trim to be built out to the thickness of the added EIFS, thus eliminating a step required for other wall insulation retrofit techniques that use built-up insulation and siding.

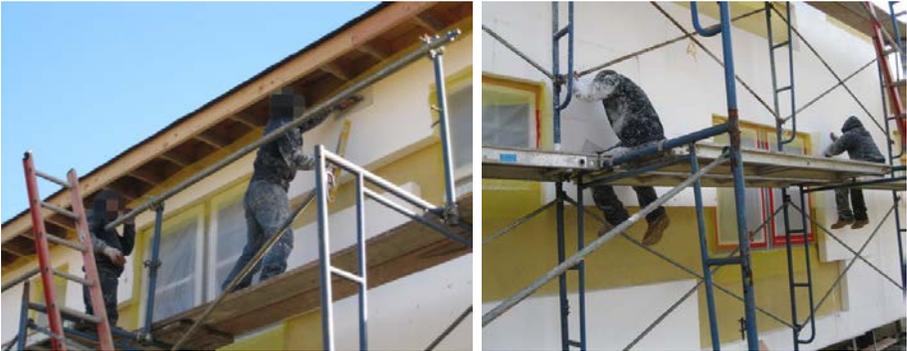
Figure 6. Smoothing joints between EPS panels

Sections of EPS insulation, 4-inches thick and measuring 2×4 ft, are adhered to the walls. Where necessary, the backside of the panels are rasped to conform to irregularities in the substrate wall. The EPS joints are smoothed out (Figure 6). Smoothing the joints between EPS foam panels is essential for getting an even finish coat that avoids telegraphing joint lines.

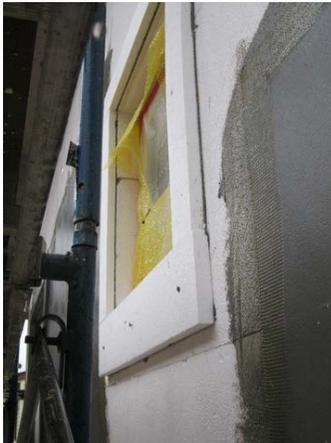
Figure 7. EPS used to form window trim

An additional one-inch thick by four-inch wide layer of EPS is used to form window trim (Figure 7). This was done primarily for aesthetics, but also to help improve R-value in an area where wall cavity insulation is compromised by additional framing. Other applied shapes can be used to create architectural forms as desired.

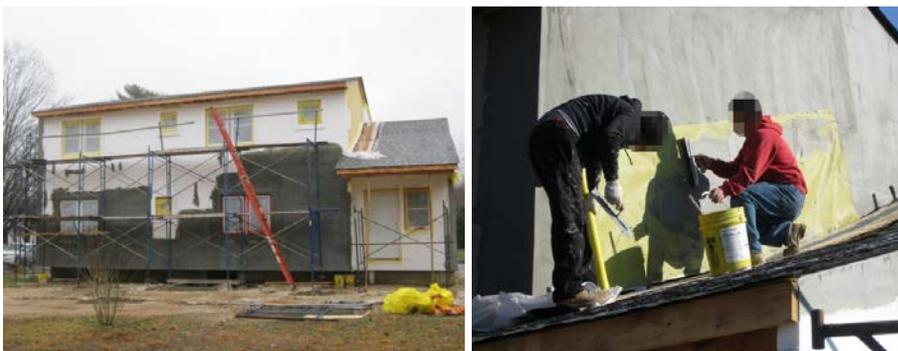
Figure 8. The gray basecoat is troweled on over an embedded layer of reinforcing mesh

The gray basecoat is troweled on over an embedded layer of reinforcing mesh, which provides a durable surface (Figure 8). Additional layers of mesh can be added to increase impact resistance. The basecoat is applied over the formed window trim and edges of the EPS panels, embedding the yellow mesh around windows and other penetrations (Figure 9).

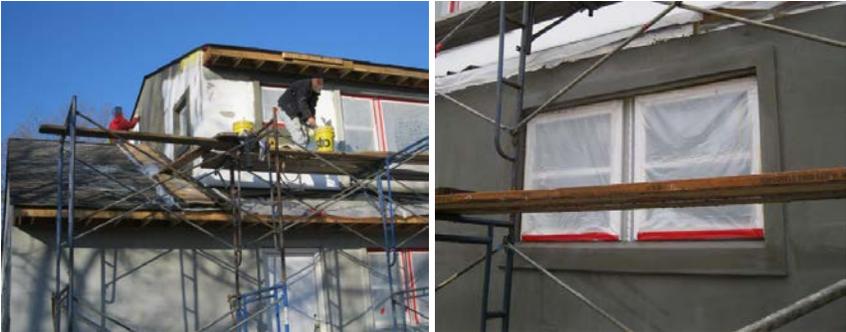
Figure 9. Basecoat is applied over window trim and edges panels

The basecoat is applied over the formed window trim and edges of the EPS panels, embedding the yellow mesh around windows and other penetrations

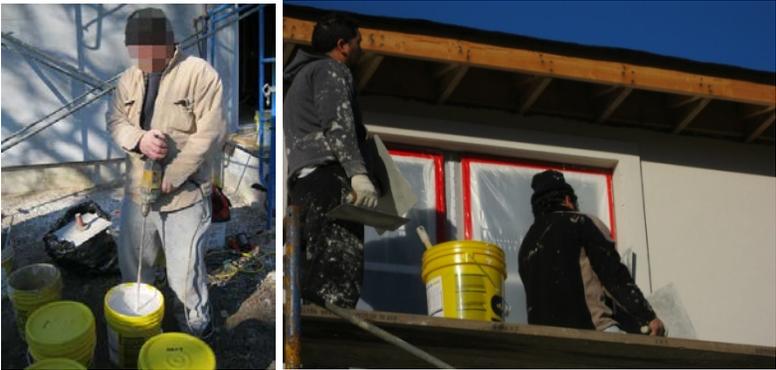
Figure 10. The finish coat is mixed and applied with trowels

The final step is to apply the finish coat, which includes the color and texture. The material arrives in pails and is first mixed and then troweled on (Figure 10). The final product is shown in Figure 11.

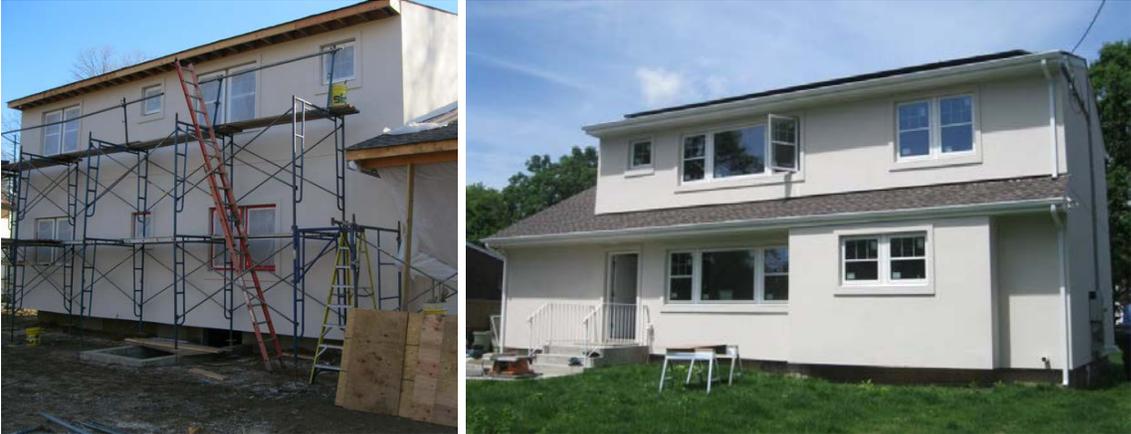
Figure 11. The finished system

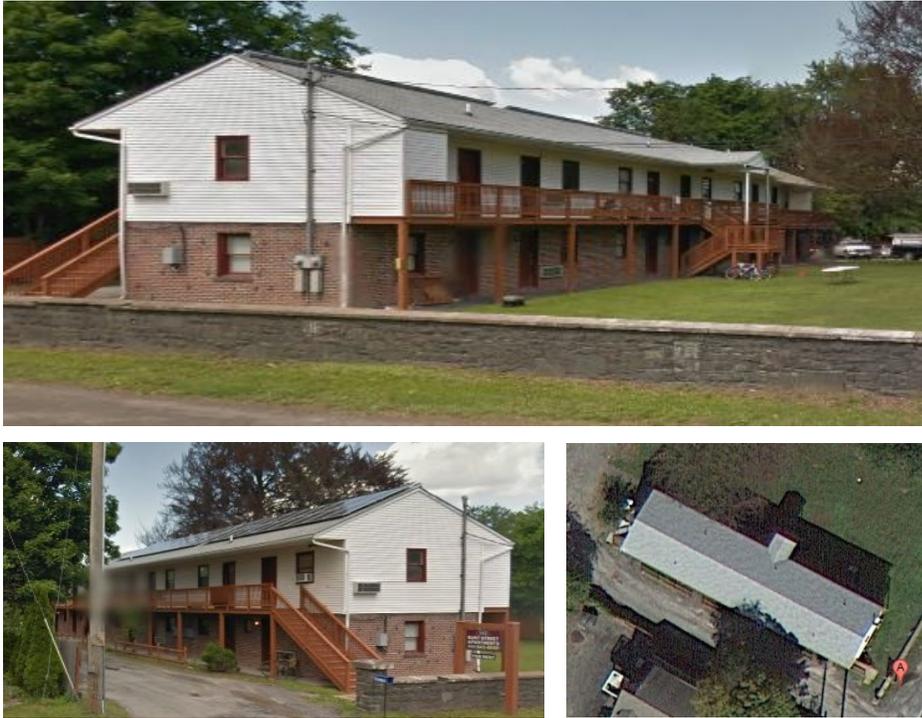
Figure 15. The pre-retrofit building

The site in Saugerties, NY is a 12-unit, two-story affordable housing apartment building. Walls are 2x4 wood frame with 1.5 inches fiberglass batt insulation in poor condition; the lower floor has brick cladding; the upper floor has vinyl siding. Apartments are entered directly from the outside at grade level or along an elevated walkway on the second floor. All apartments are through-building, meaning they can be entered from either side of the building. At the onset of work, the building was fully occupied. Apartments are heated and cooled by individual through-wall heat pumps in each apartment. Water heating is via a central system with heat generated by solar thermal panels and supplemented by a gas fired boiler. Previous energy retrofit measures completed in September 2012 include mechanical equipment replacement, air sealing, crawl space floor insulation, ceiling insulation, and PV system. Notably, the previous retrofit did not address windows or walls, because the owner did not have a cost-effective solution despite their poor thermal performance. Because the building is master metered, and the building owner pays for all utilities, the owner was highly motivated to implement energy efficiency measures, as demonstrated by the previous retrofit.

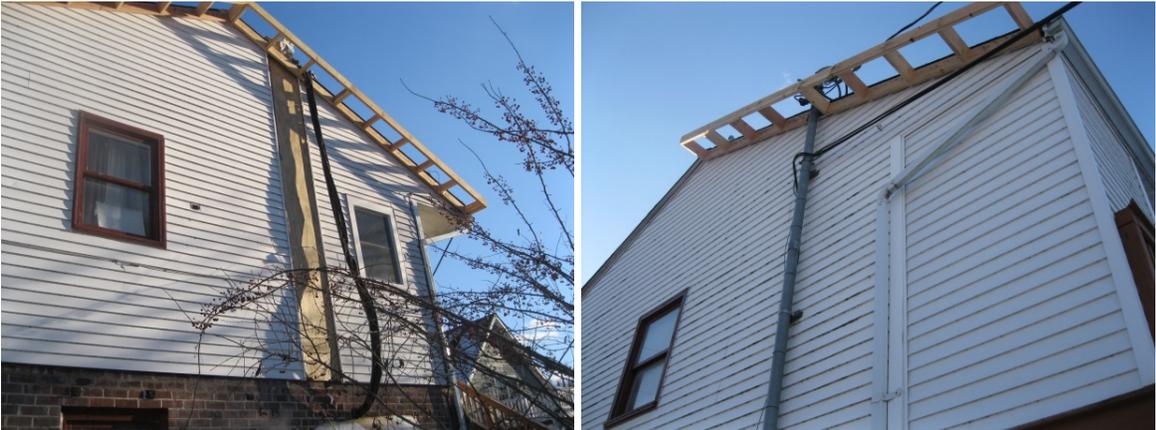
Figure 16. The chimney was removed, and roof extended to accommodate panels

The gable end roof overhang was built out to protect the EIFS panels from weather and prevent moisture from infiltrating behind the panels, reducing the likelihood of moisture-related structural and indoor air quality issues (Figure 16).

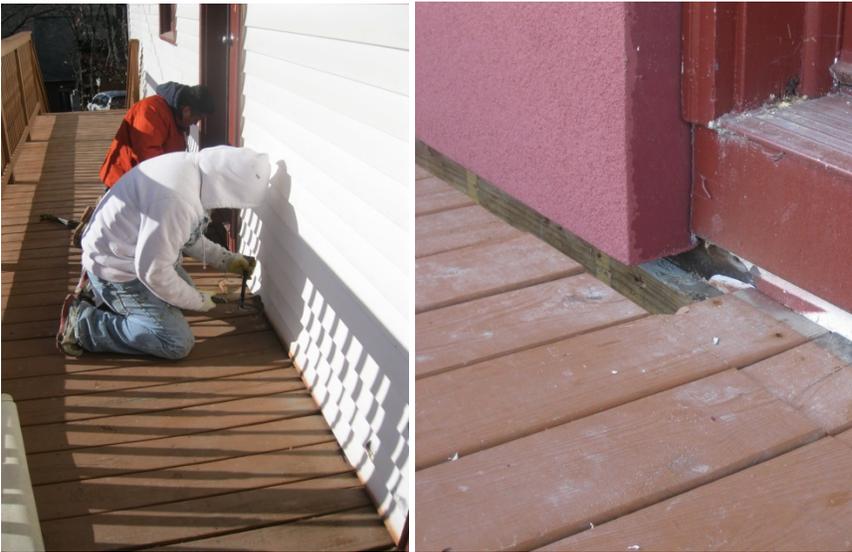
Figure 17. Decking was cut back, and joist moved away from the building

The second-floor walkway deck planks were trimmed back. If left in place, the deck planks would have resulted a thermal bridge along the length of the building between the two floors. By trimming the planks back, the EIFS ran continuously behind the deck, resulting in an uninterrupted thermal barrier. The deck joist against the building was moved out approximately four inches so that the panels could fit behind and remain flush at joints and seams (Figure 17).

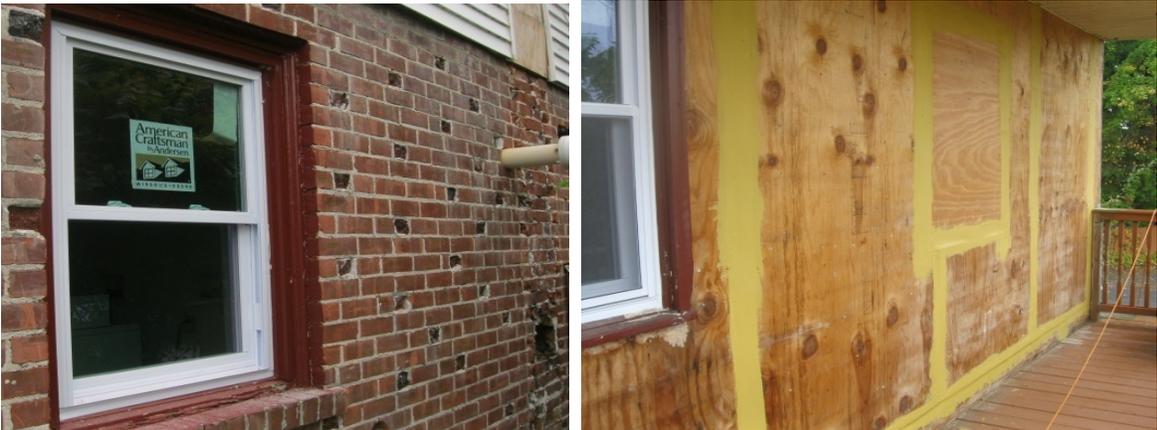
Figure 18. Brickwork and vinyl siding

Protruding brickwork at first floor is notched back and vinyl siding at second floor is removed

At the first-floor masonry, all brick protrusions were chiseled back, creating a level surface upon which to install the EIFS. Existing vinyl siding and weather-resistive barriers were removed from the second-floor, exposing the exterior sheathing beneath. Prior to the full application of the liquid WRB, a separate coating, embedded with reinforcing mesh, was brushed into the sheathing joints, as was done at Central Islip (Figure 18).

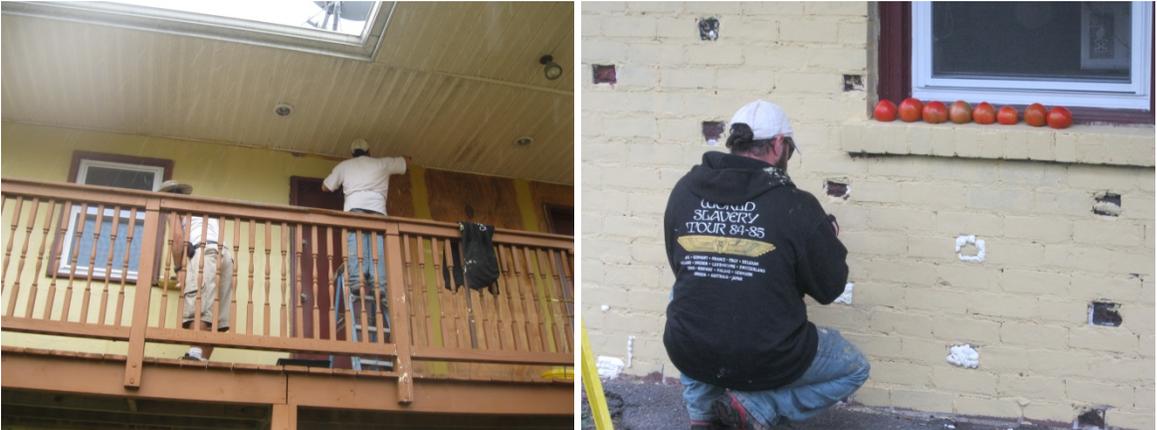
Figure 19. The liquid-applied water-resistive barrier is applied and gaps are filled with spray foam

A liquid water-resistive coating was applied to the entire building to prevent moisture from soaking through the brick and entering the interior wall assembly. Once the coating dried, gaps in the brickwork from the chipping of protrusions were filled with spray foam (Figure 19).

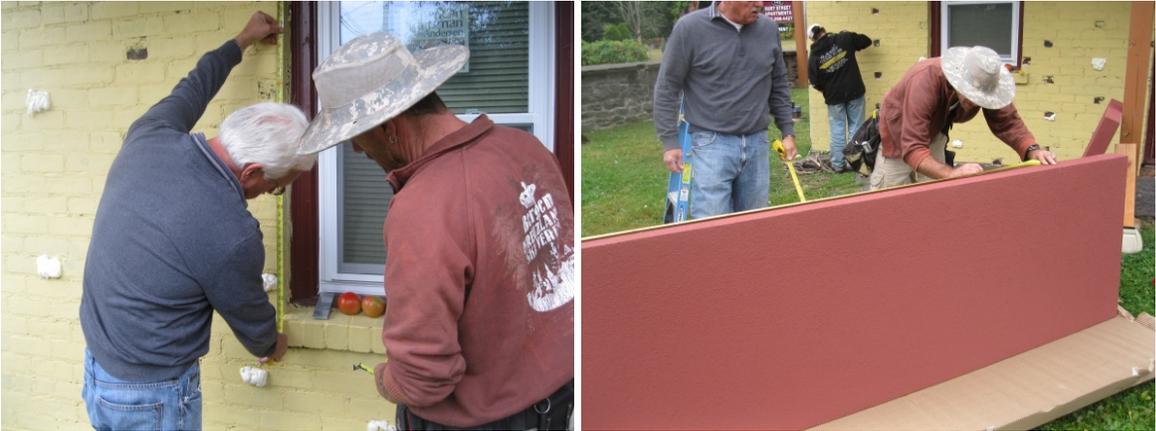
Figure 20. Fitting Panels

The panels are field-notched to ensure an adequate fit around fenestration and other difficult areas

The nature of the retrofit process necessitated on-site modification of the panels at uneven or protruding portions of the building facade, such as window sills. This was necessary to allow electrical wiring to run through the panels at existing light fixture locations. Therefore, the panels and façade were carefully measured prior to application (Figures 20 and 21).

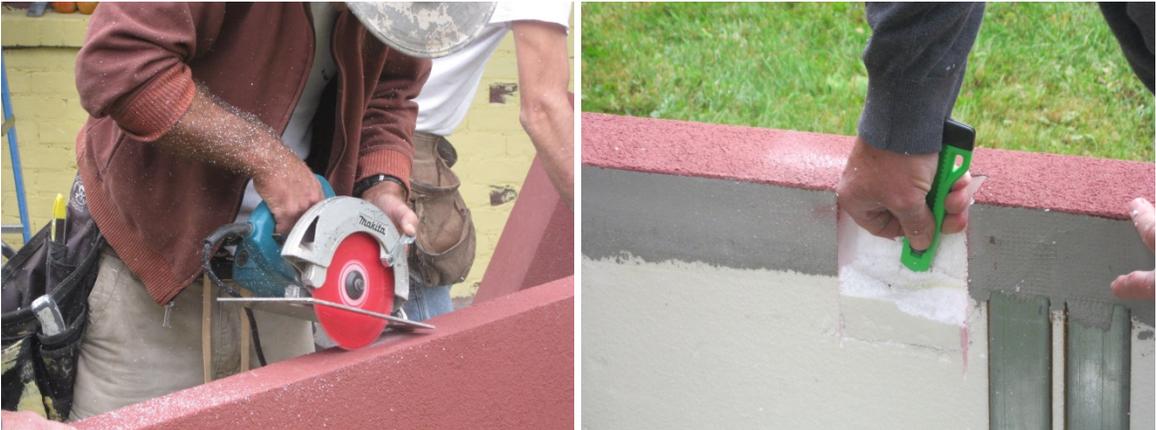
Figure 21. Notches are cut with a circular saw and adapted to fit protrusions using a boxcutter

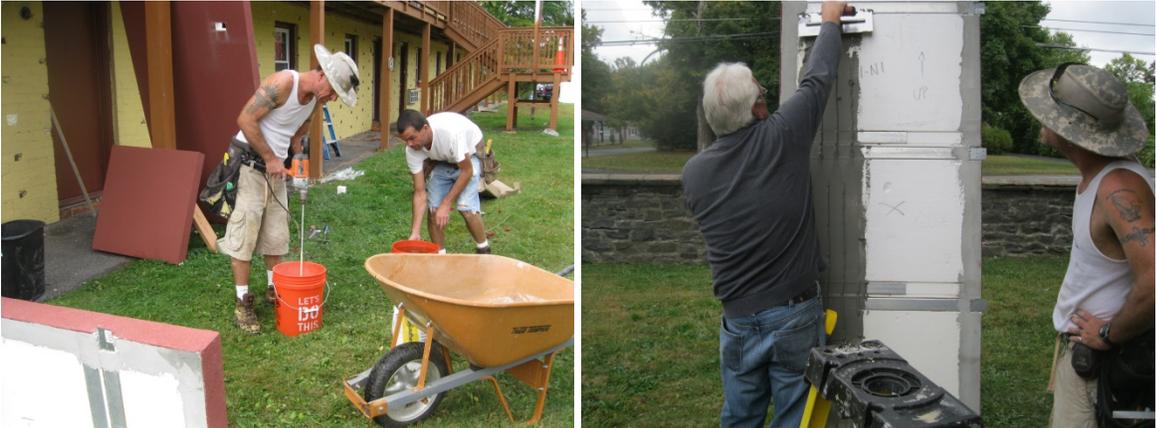
Figure 22. Panel adhesive is mixed on-site and applied with a notched trowel

When applying the adhesive, all trowel notches were made vertically to allow water behind the panels to drain down and exit near the bottom of the wall. Having a way for the water behind the panels drain helps avoid moisture-related issues. In this building decking at the first-floor and eaves at the second-floor provide additional moisture protection (Figures 22 and 23).

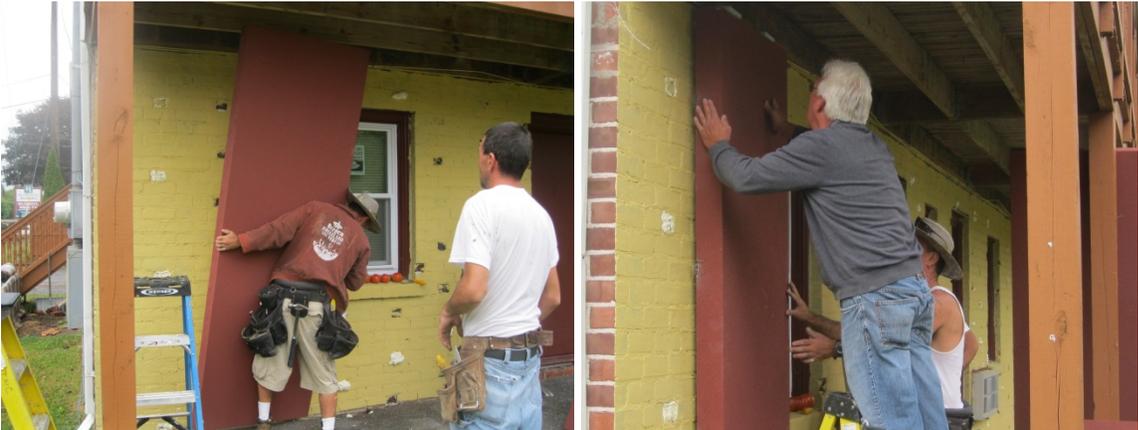
Figure 23. The lightweight panels are lifted into place by hand and pressed to the wall

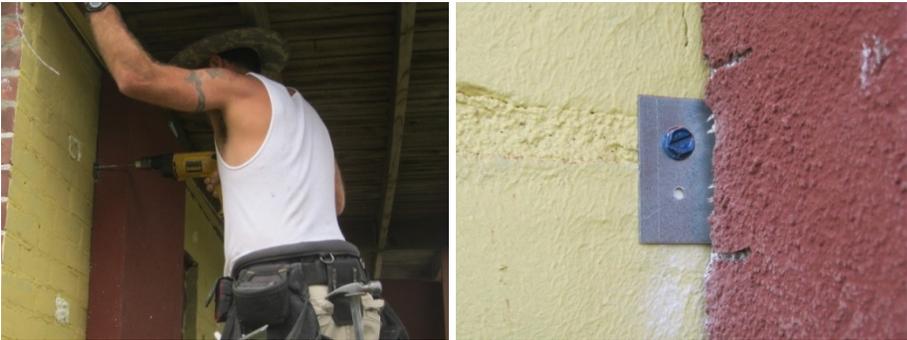
Figure 24. Panels are temporarily held in position while the adhesive sets using screws

Each panel was prefabricated with metal tabs that can be modified to extend approximately three-quarters of an inch from the edge of the panel and screwed in place. This allows for provisional panel support during the adhesive curing period (Figures 24 and 25).

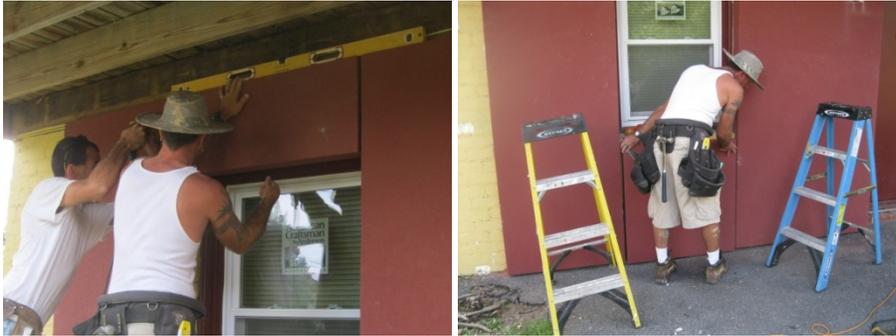
Figure 25. As panels are applied, they are scrutinized to ensure a close, level fit

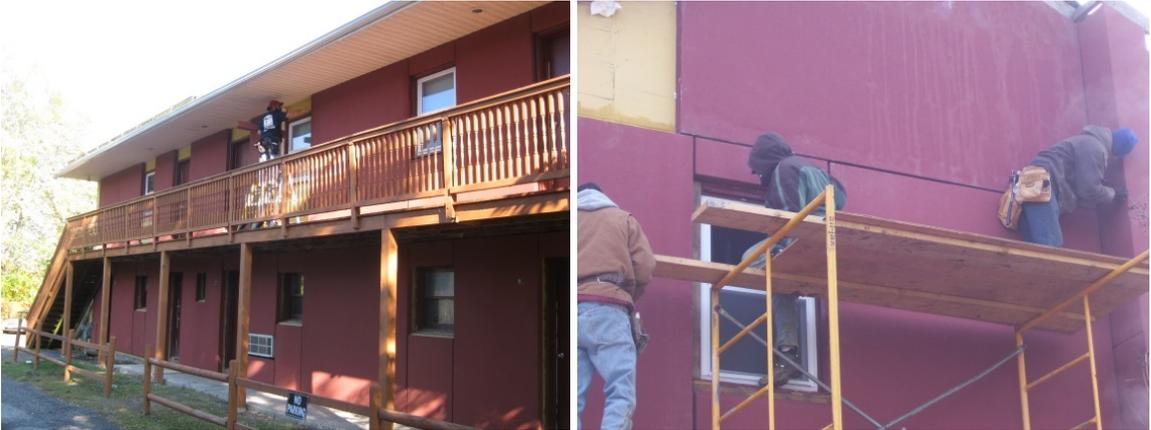
Figure 27. The process continued around the building to create a continuous thermal boundary

Panels were installed across the entire building, including the solar PV closet and solar thermal tank enclosure to produce a uniform thermal barrier and appearance across the entire building façade (Figures 27, 28, and 29).

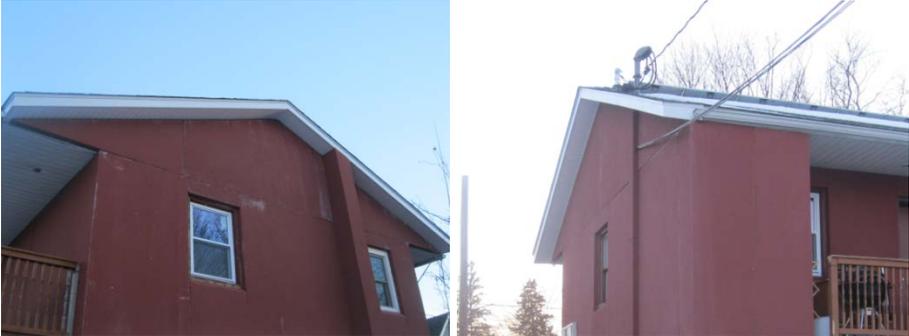
Figure 28. Following installation of the panels, the roof extension is shingled and finished

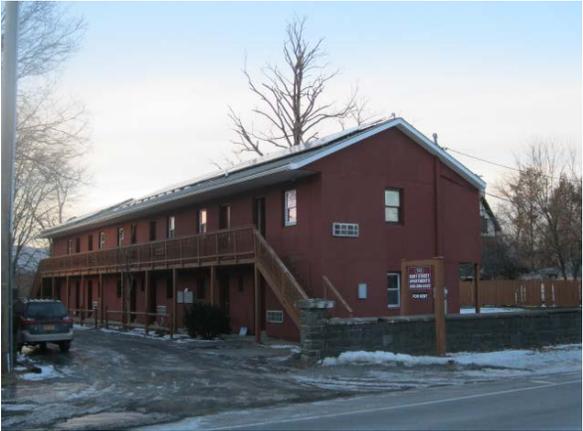
Figure 29. The finished system

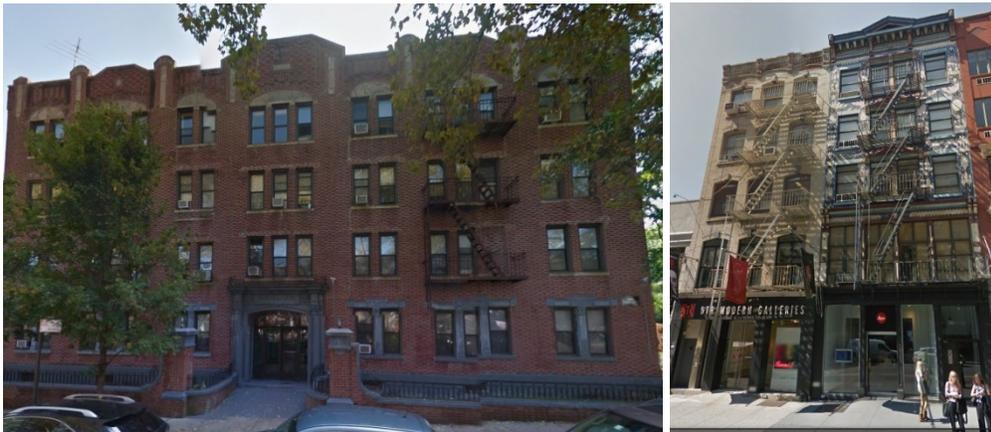
Figure 37. Poor demonstration candidates due to intricate facades

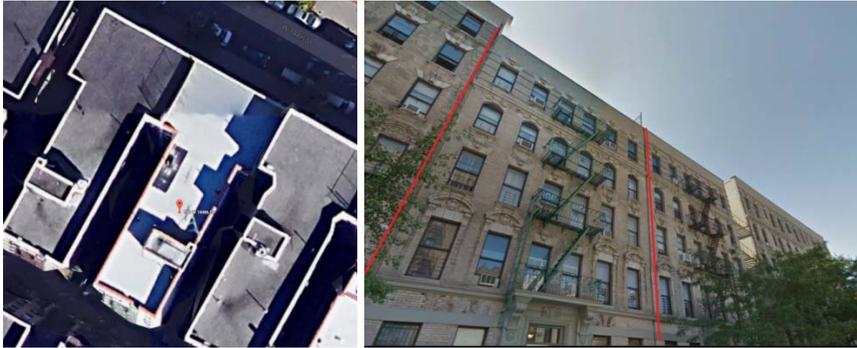
Figure 38. Candidate building with difficult to access rear and side walls

The building in Figure 38 is a better candidate for the EIFS wall system. Approximately 80% of its exposed wall area is coated with plain concrete stucco with no ornamentation or insulation. The rear wall does have a fire escape, but that represents a small portion of the 80%. A major obstacle here is the difficult access to the work area. All materials would need to be lifted over the roof or through neighboring property, and the narrow sideyards would make work difficult, especially if equipment had to be kept on the subject building's side of the property line. These obstacles could be overcome, and often are managed when necessary repair work must be completed on the many buildings of this type; however, they significantly add to costs and contribute to making elective work such as an energy retrofit cost prohibitive.

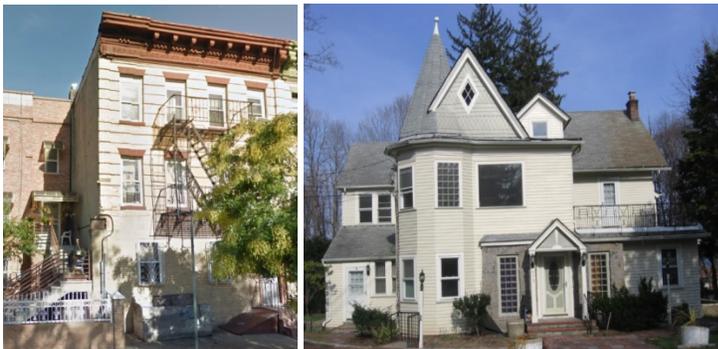
Figure 39. Two candidate buildings that would benefit from exterior wall insulation

The two buildings in Figure 39 would benefit from an exterior wall insulation retrofit and were presented as candidates. The structure on the left has a large blank sidewall area shown in shadow. The wall is uninsulated and unadorned and would be a simple retrofit with EIFS panels. However, it is built on the lot line and adding exterior panels would encroach into the neighbor's property. This is a common condition in New York City. The building on the right is in a suburban area and was slated for a significant retrofit. While very suitable for a site-installed EIFS, the geometry of the building is too complex to merit pre-fabricated panels.

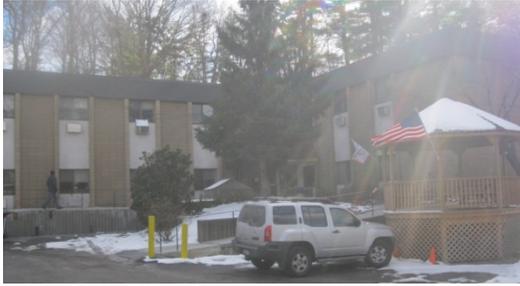
Figure 40. Ideal candidate building for retrofit

While many buildings were presented to the project team with physical attributes that made them difficult demonstration sites, others were physically suitable, but did not participate due to financial or other issues. For example, the building in Figure 40 would have been an ideal demonstration site. It has uninsulated masonry walls, a repetitive façade design that could easily be broken down into panel modules, easy access to all facades, and few site complications. Packaged terminal air conditioner penetrations were slated to be covered over, which could easily have been accomplished with panels

and the wall retrofit could have been integrated into other planned renovation work, including window replacement. Nevertheless, despite being deemed cost effective the EIFS panels would have increased first costs and the owner was only concerned with a short-term financial horizon. For investors with a longer-term outlook, this would have been an attractive retrofit.
