**GREEN ROOF THERMAL AND STORMWATER
MANAGEMENT PERFORMANCE: THE GRATZ
BUILDING CASE STUDY, NEW YORK CITY**

**FINAL REPORT 09-05
DECEMBER 2010**

This report summarizes the findings for data collection from October 2006 to September 2007 on the Gratz Industries Green Roof Research Station. Notable for its large-scale innovative research design, this project addresses the deficiency in green roof thermal and stormwater data specific to the New York City region. In conjunction with the in-situ monitoring data and analysis, this report also includes thermal modeling of the Gratz building given conventional and green roof scenarios as well as runoff water quality results. The results of the monitoring during this period showed that green roofs are capable of lowering the maximum conventional roof membrane (surface) temperatures by as much as 35°C and reduces diurnal temperature fluctuations by as much as 30°C. While the conventional roof membrane temperatures frequently exceeded 70°C in the summer months, for the green roof the temperatures were consistently below 50°C. Reductions in temperature fluctuations decrease the stress on roof membranes thereby extending its useful duration. I

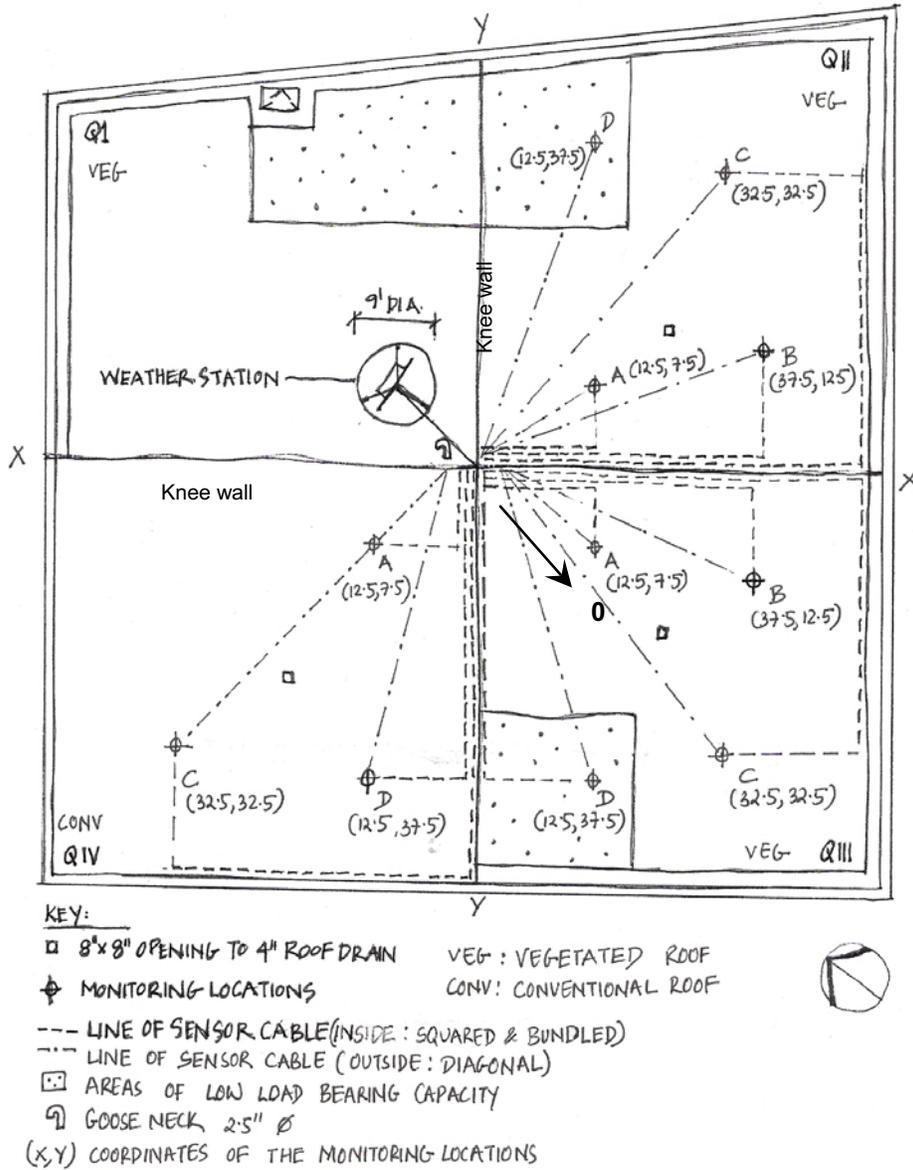
Figure 1: Roof plan and horizontal monitoring locations. The numbers are absolute values, in feet, from the origin '0'.

A weather station was installed on a tripod secured to the knee walls at the center of the roof (*Figure 1*). The three legs of the tripod sit on top of the three knee-walls facing east. The weather station contains a temperature/relative humidity probe, pyranometer, precipitation gauge, and an anemometer, which collected data on air temperature/relative humidity, solar radiation, rainfall, and wind speed/direction, respectively. The weather station provides the baseline data as a point of comparison for the thermocouples, heat flux sensors and flow meter readings. The weather station also contains a modem for remote data collection. A line sharing switch device (*TELTONE LLS, Model #394-B-01*) was installed at the site to share the Gratz fax line with our modem line. The fax line is set as the primary line in ports 1 and 2 of the switch device, and port 3 is used for our modem (see *Annex II - List of instruments and sensors*).

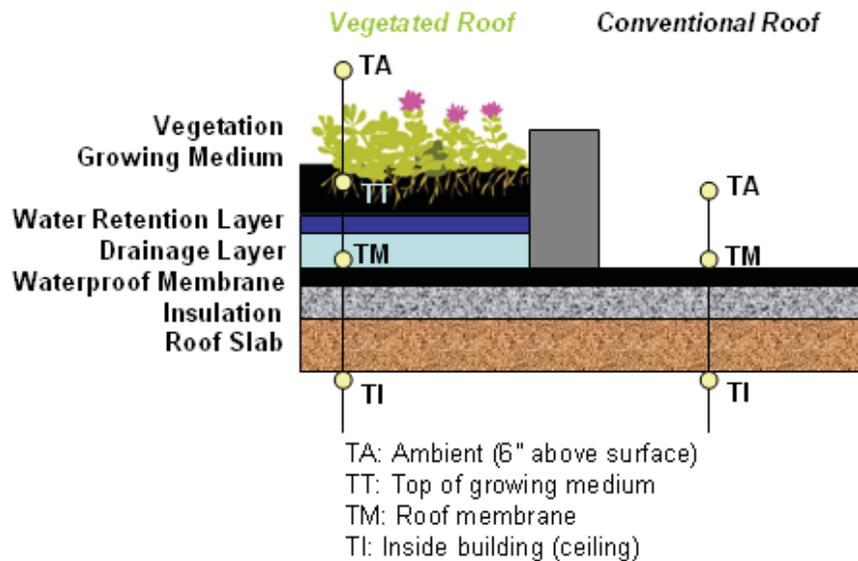
Figure 2: Vertical placement of thermocouples.

The TI thermocouples were installed on March 28, 2006; TM thermocouples were installed on May 2, 2006; and TT thermocouples were installed on June 1, 2006. The TA thermocouples along with the radiation shields were installed on August 7, 2006.

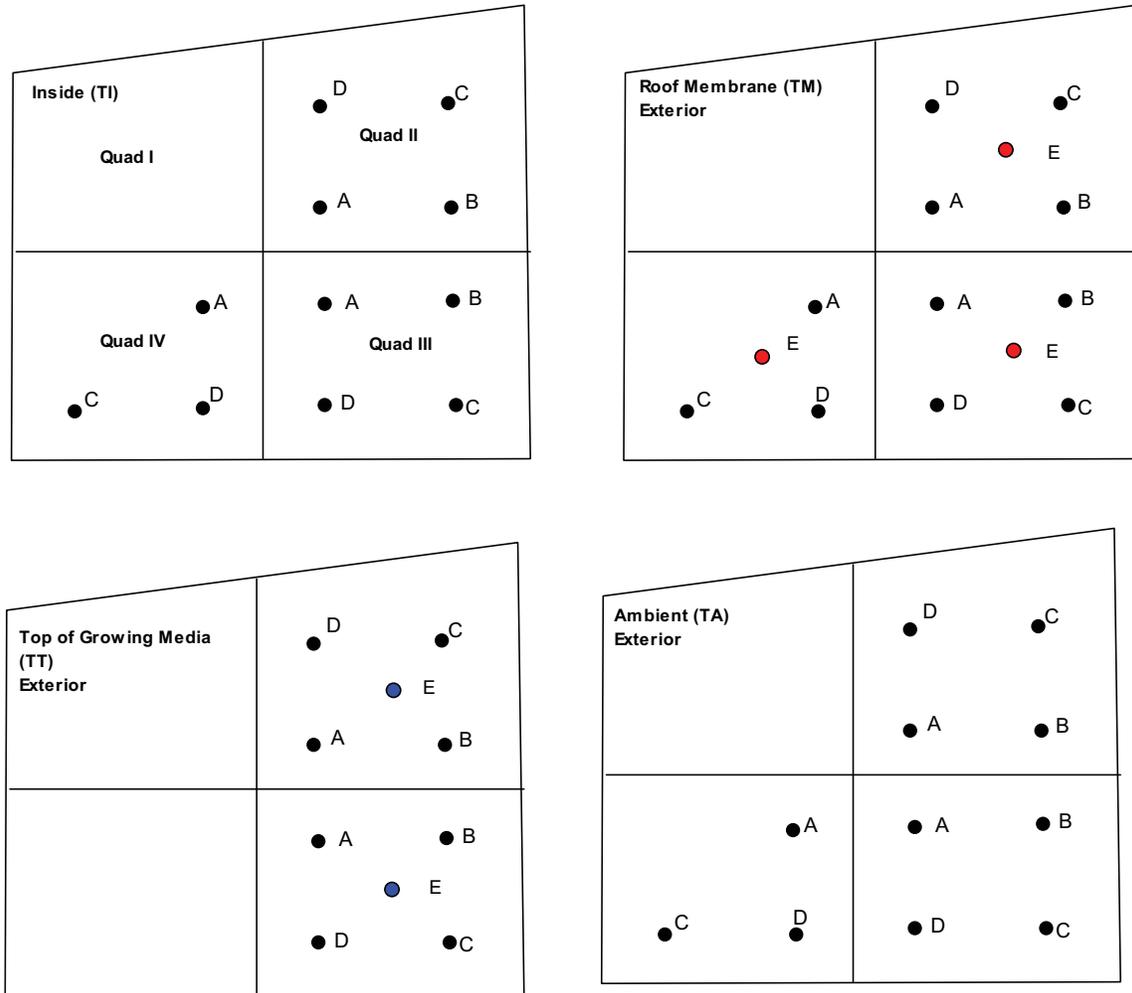
Figure 3: Sensor placement. Layout of thermocouples (●): exterior, interior and vertical locations in the quadrants (A, B, C, & D). E is the location for heat flow sensors (● - on the roof membrane) and in the vegetated quadrants, the water content reflectometers (● - in the growing media).

One heat flow sensor was installed in each of the three monitored quadrants (Quadrants II, III and IV), at location E, on top of the roof membrane (*Figures 3*). They were installed about 2-3 ft. away from the drain to avoid trampling due to any potential maintenance activity in the drain area. The heat flow sensor at the non-vegetated quadrant was covered with a patch of the roofing material, as was also done for the conventional membrane thermocouples, so as not to directly expose it to the ambient conditions and to more closely follow the placement in the vegetated quadrants.

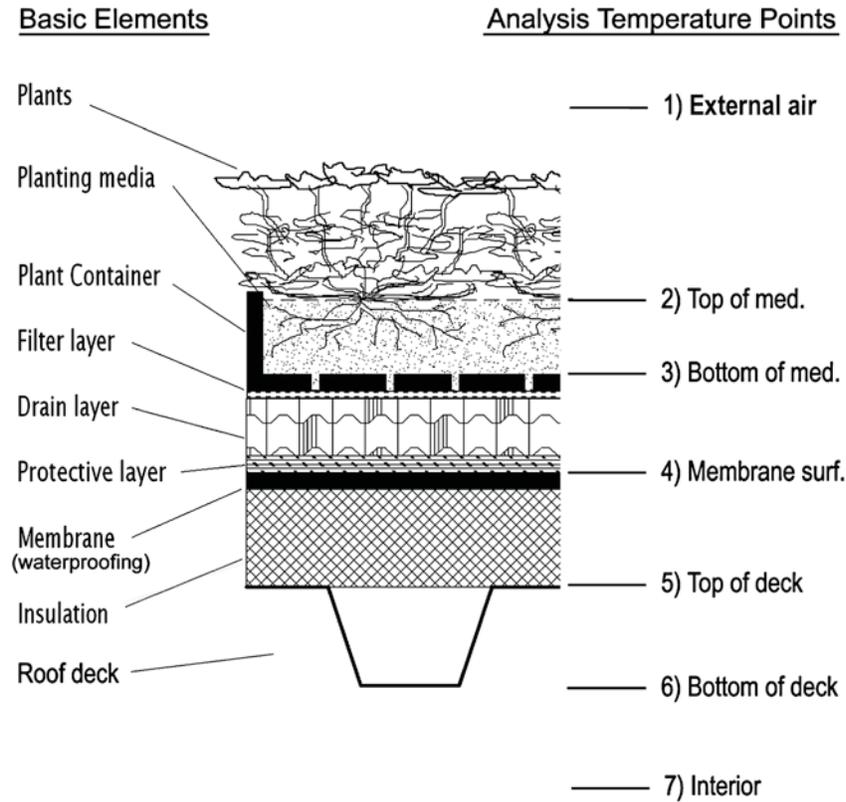
Figure 4: Green Roof Layer Diagram

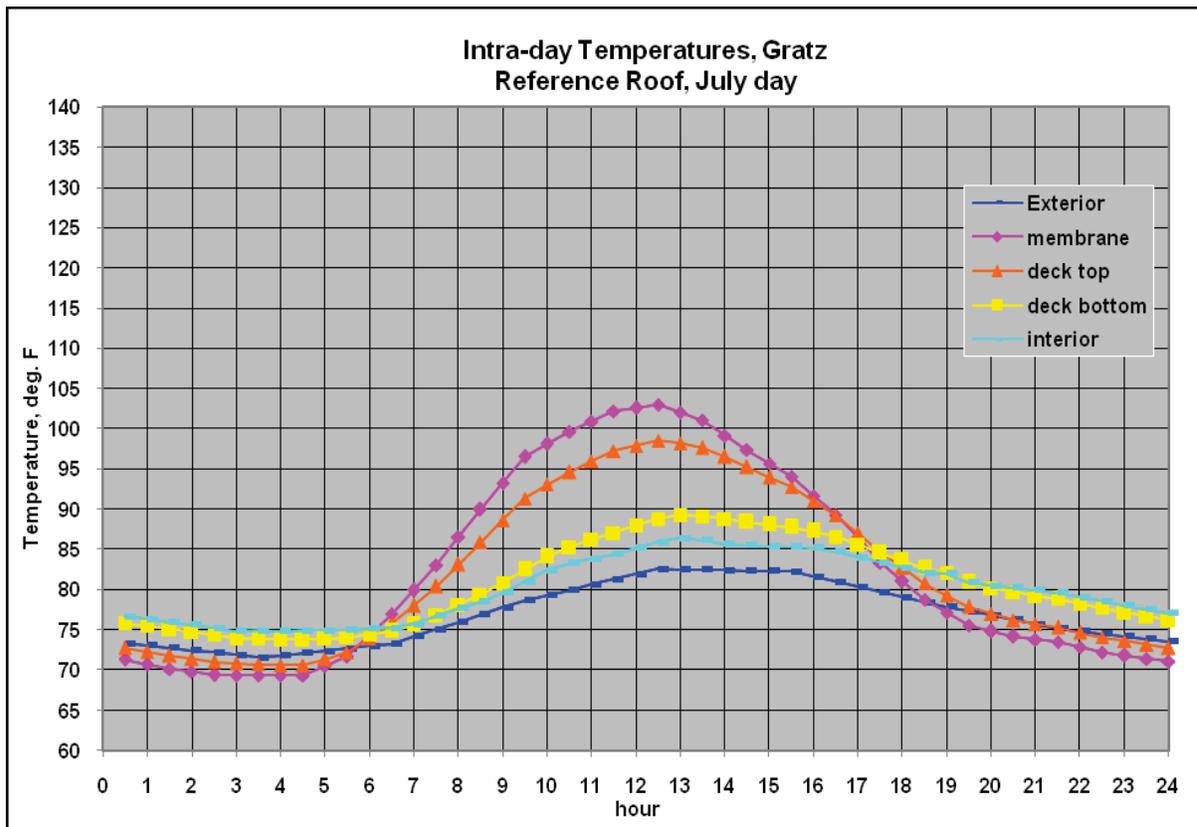
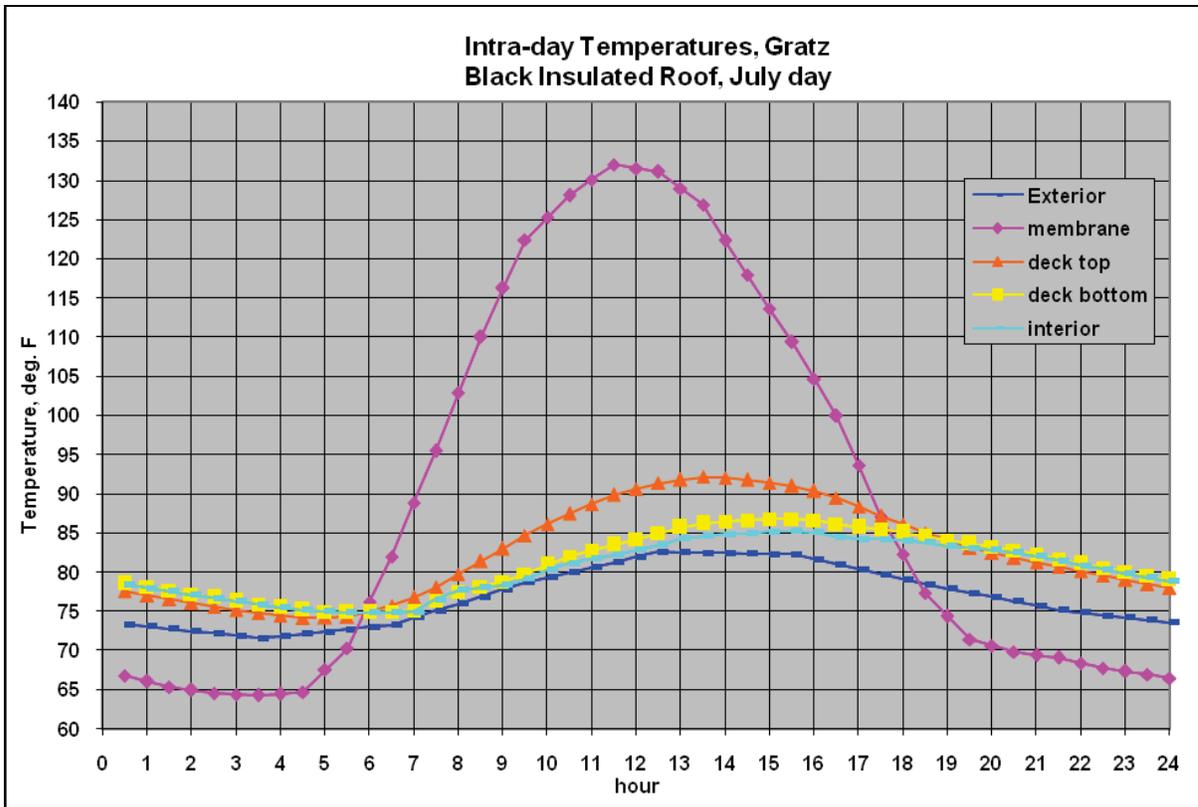
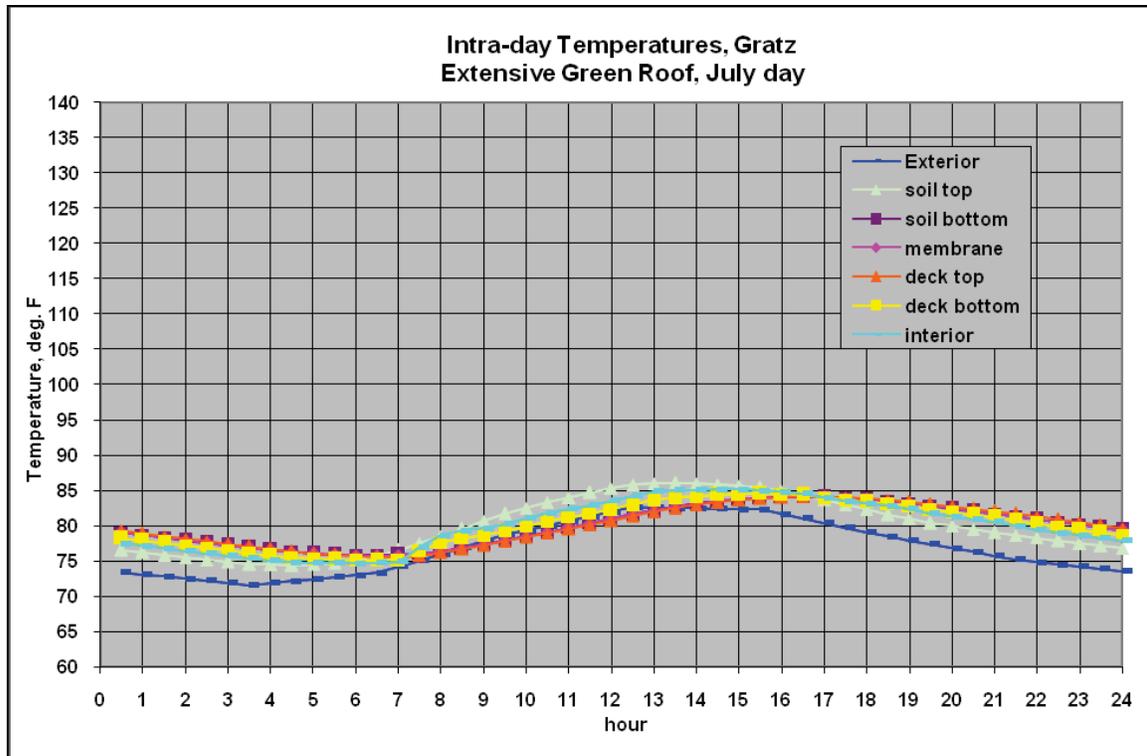
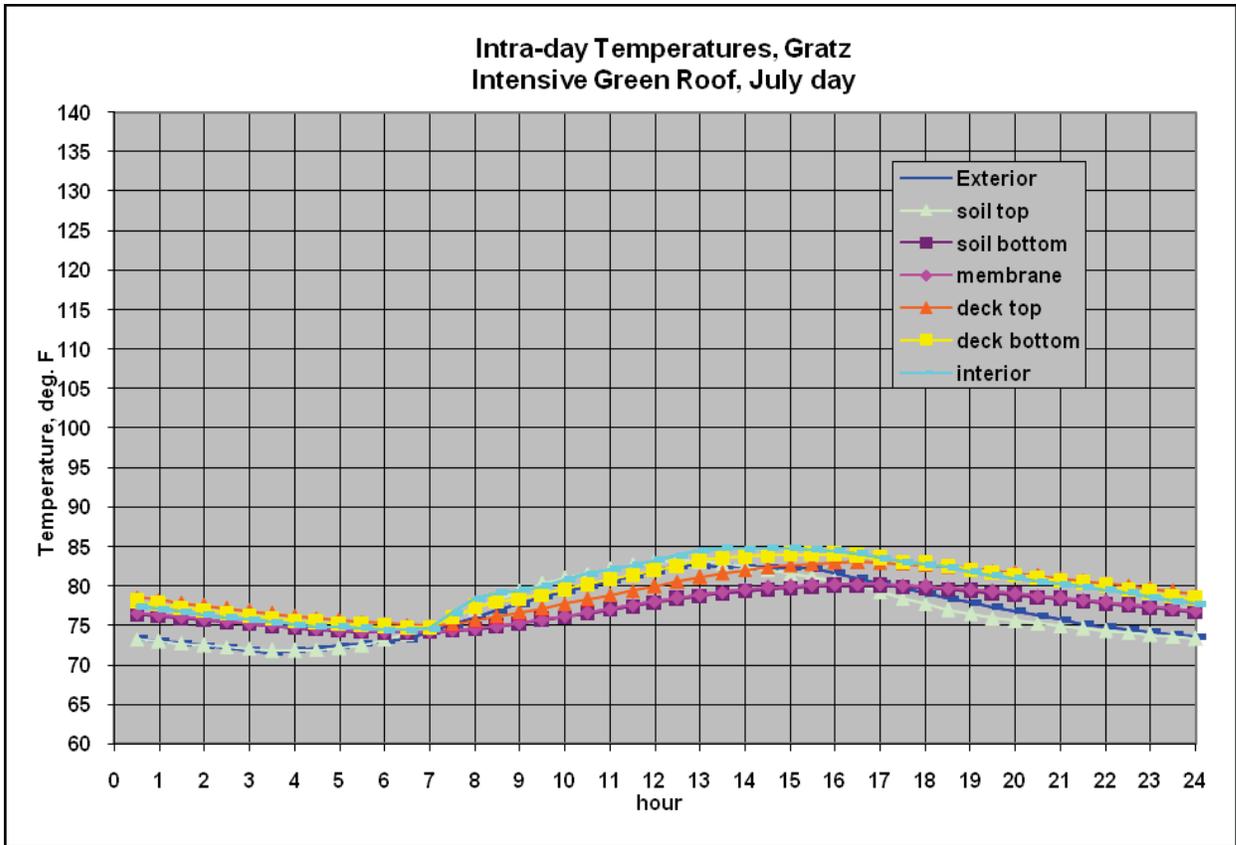
Figure 5: Intra-day Temperatures, Gratz Reference Roof (July)

Figure 6: Intra-day Temperatures, Gratz Black Insulated Roof

Figure 7: Intra-day Temperatures, Gratz Extensive Roof (July)

Figure 8: Intra-day Temperatures, Gratz Intensive Roof (July)

Temperature profile maps for July are shown in Figures 5 to 8. All temperatures are reported in degrees Fahrenheit. The following should be noted regarding these graphs:

- Minimum and maximum membrane temperatures were:
 - Reference Roof: min = 69^o, max = 103^o
 - Insulated Black Roof: min = 64^o, max = 132^o
 - ExtGR: min = 74^o, max = 86^o
 - IntGR: min = 72^o, max = 83^o
- Both green roofs dramatically dampened the daily membrane temperature fluctuations.
- The IntGR was able to absorb more heat than the ExtGR but the effect was dampened by the added insulation.
- Night-time membrane temperatures for the Black Insulated Roof were ~ 6 degrees lower than the outside air temperature due to the high long-wave emissivity of the black surface. This was helped by the indoor heat below the insulation being removed by the fans.
- Night-time rooftop temperatures for the green roofs are also high because of the thermal mass of the planting medium and intermediate insulation.

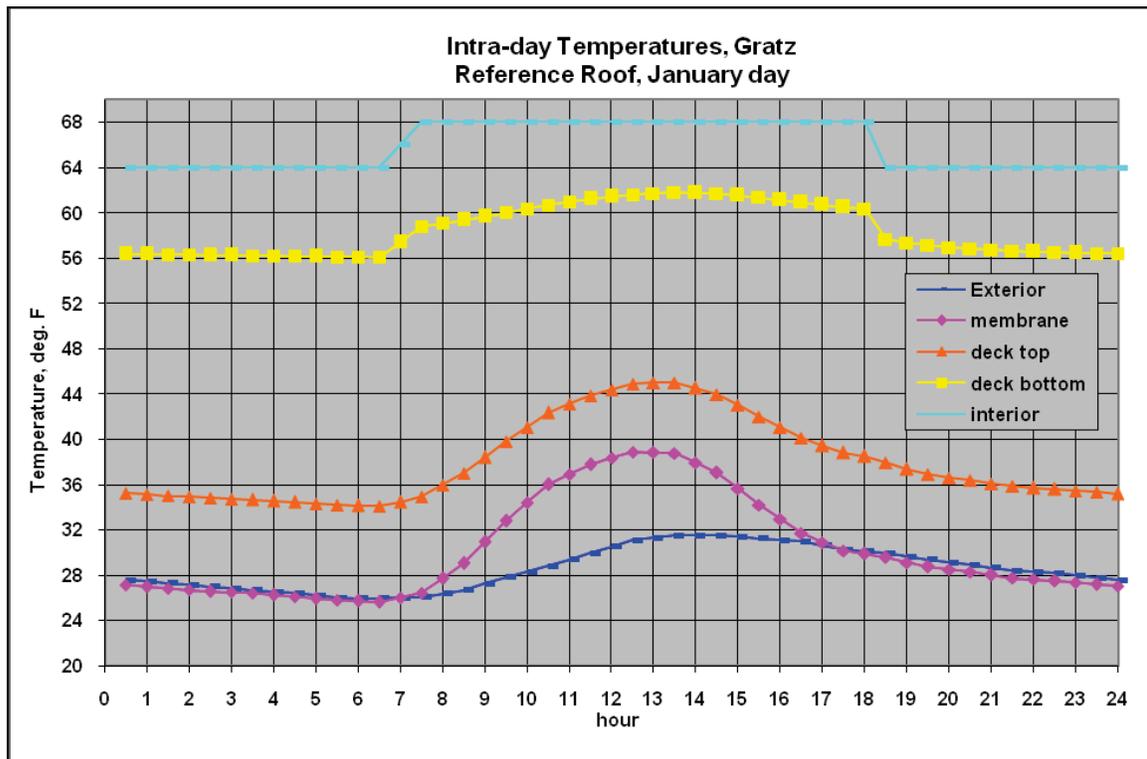
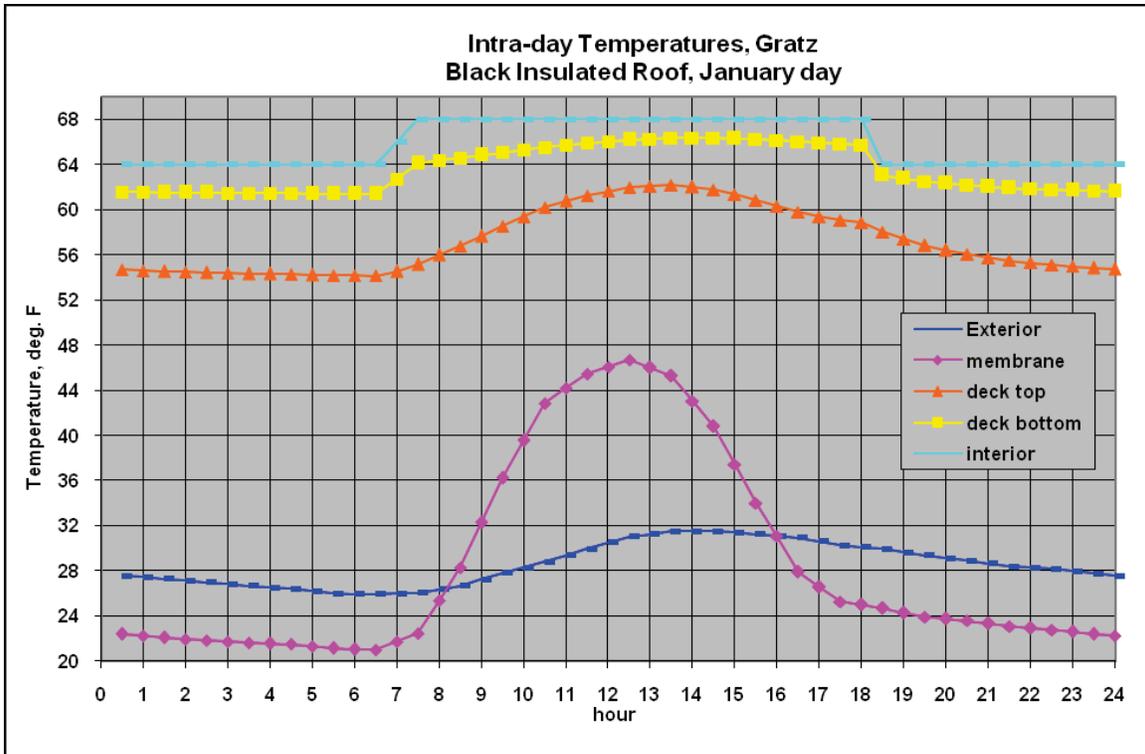
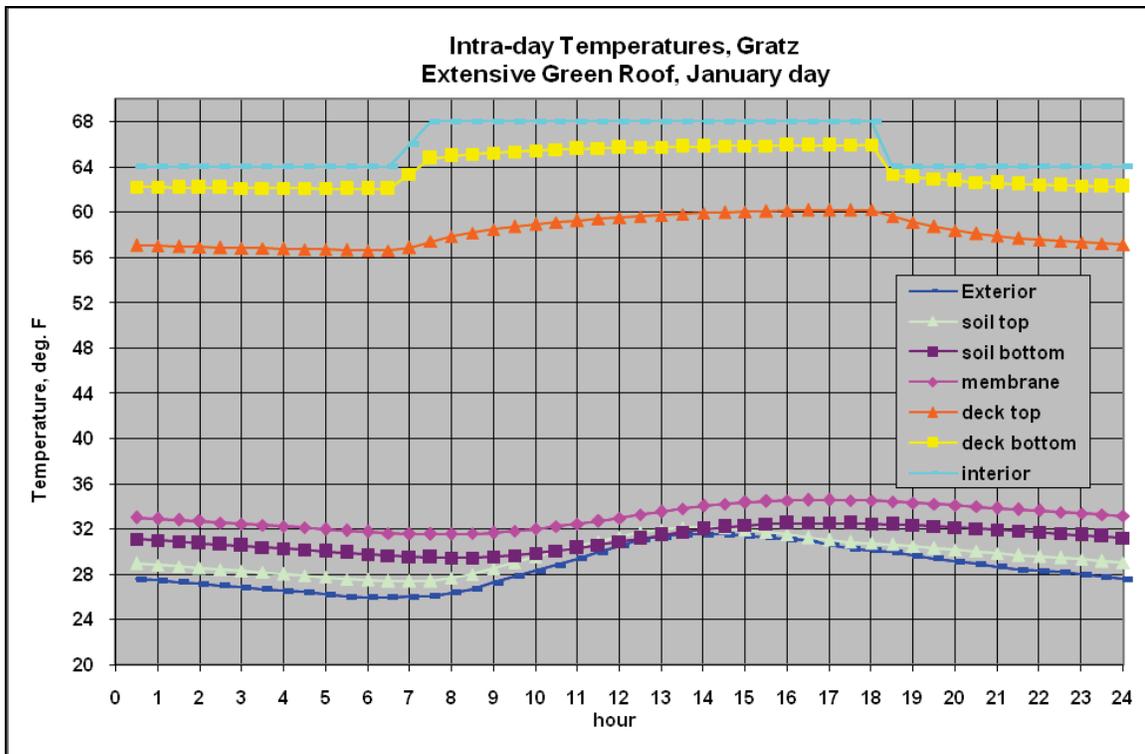
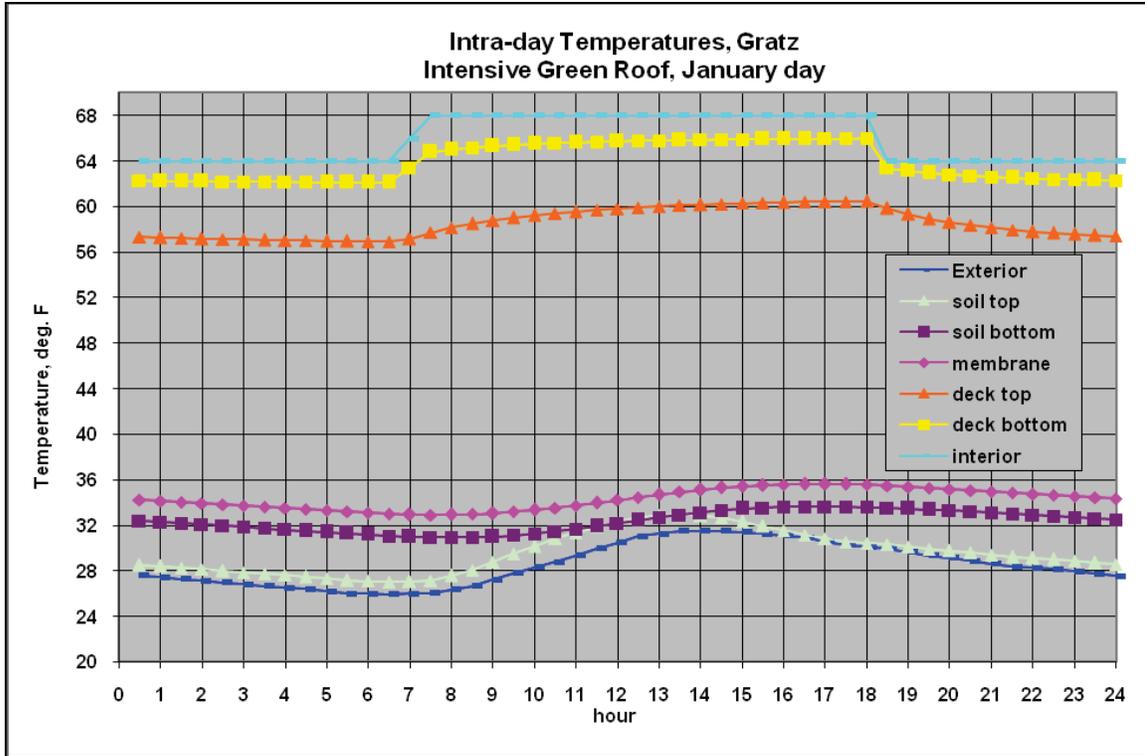
Figure 9: Intra-day Temperatures, Gratz Reference Roof (January)

Figure 10: Intra-day Temperatures, Gratz Black Insulated Roof (January)

Figure 11: Intra-day Temperatures, Gratz Extensive Roof (January)

Figure 12: Intra-day Temperatures, Gratz Intensive Roof (January)

Temperature profile maps for January are shown in Figures 9-12. The following should be noted regarding these graphs:

- Both green roofs dramatically dampened the daily membrane temperature fluctuations.
- The IntGR was able to absorb more heat than the ExtGR but the effect was dampened by the added insulation.
- Night-time membrane temperatures for the Black Insulated Roof were ~ 6 degrees lower than the outside air temperature due to the high long-wave emissivity of the black surface. This was helped by the indoor heat below the insulation being removed by the fans.
- Night-time rooftop temperatures for the green roofs are also high because of the thermal mass of the planting medium and intermediate insulation.

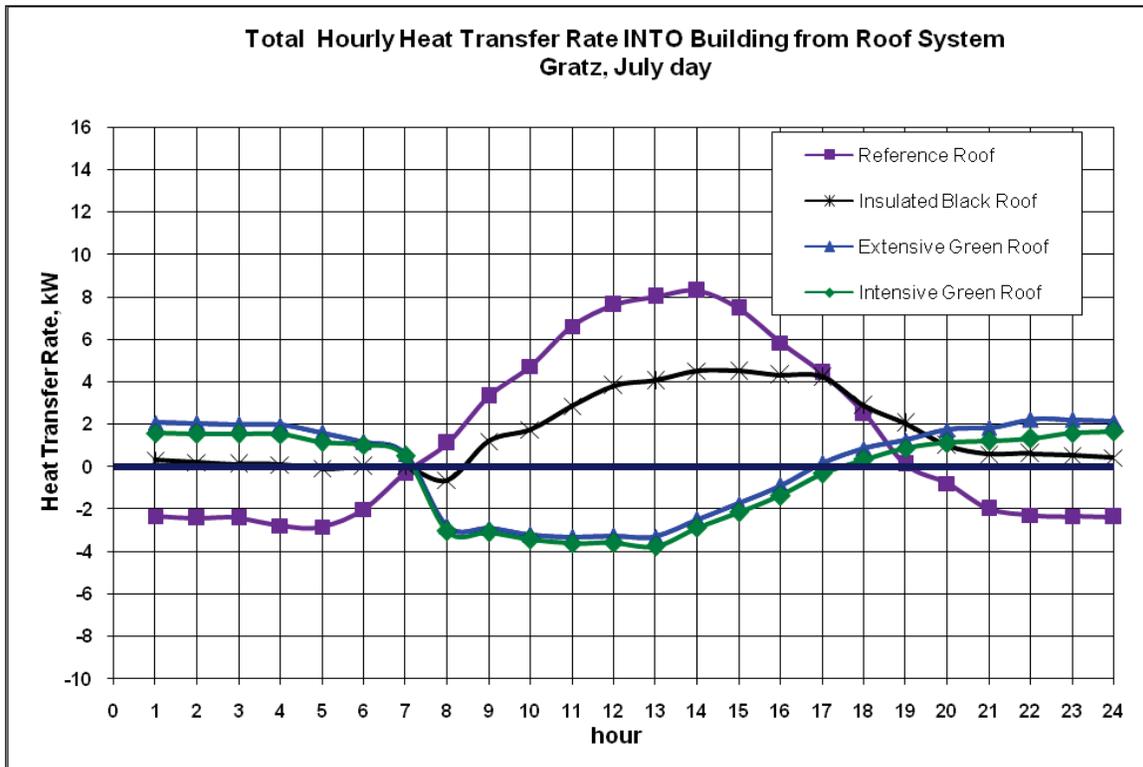
Figure 13: Total Hourly Heat Transfer Rate Into Building, Gratz (July)

Heat transfer rates for an average July day are shown in Figure 13. The following points should be noted from this graph:

- The two green roofs have nearly identical heat transfer characteristics because the radiative and convective properties are very similar. The conductivities are also very similar because of the moisture content of the media and the fact that they both have the same integrated insulation on a roof with no other existing insulation.

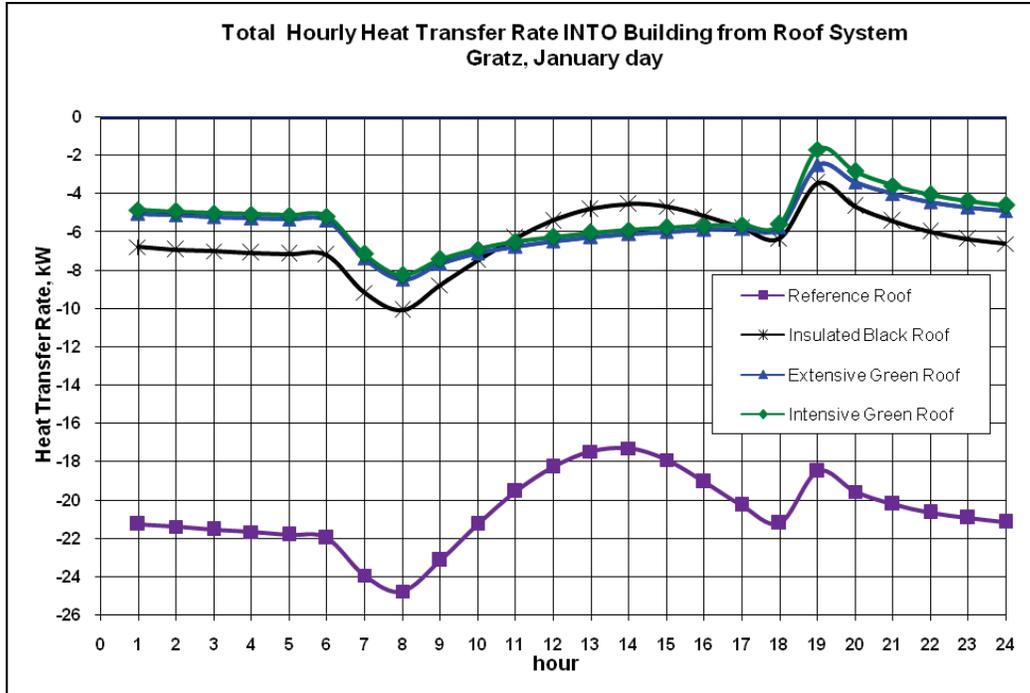
Figure 14: Total Hourly Heat Transfer Rate Into Building, Gratz (January)

Heat transfer rates for an average January day are shown in Figure 14. The following points should be noted from this graph:

- The additional rigid insulation dramatically reduced heat loss.
- The additional thermal mass of the green roofs provided slightly better performance over the Black Insulated roof.
- The heat loss increased suddenly in the morning at opening as the roof absorbed the increased heat generation. Likewise, the heat loss decreased suddenly in the evening at closing as the internal heat generation stopped.
- The two green roofs have nearly identical heat transfer characteristics because the radiative and convective properties are very similar. The conductivities are also very similar because of the moisture content of the media and the fact that they both have the same integrated insulation on a roof with no other existing insulation.

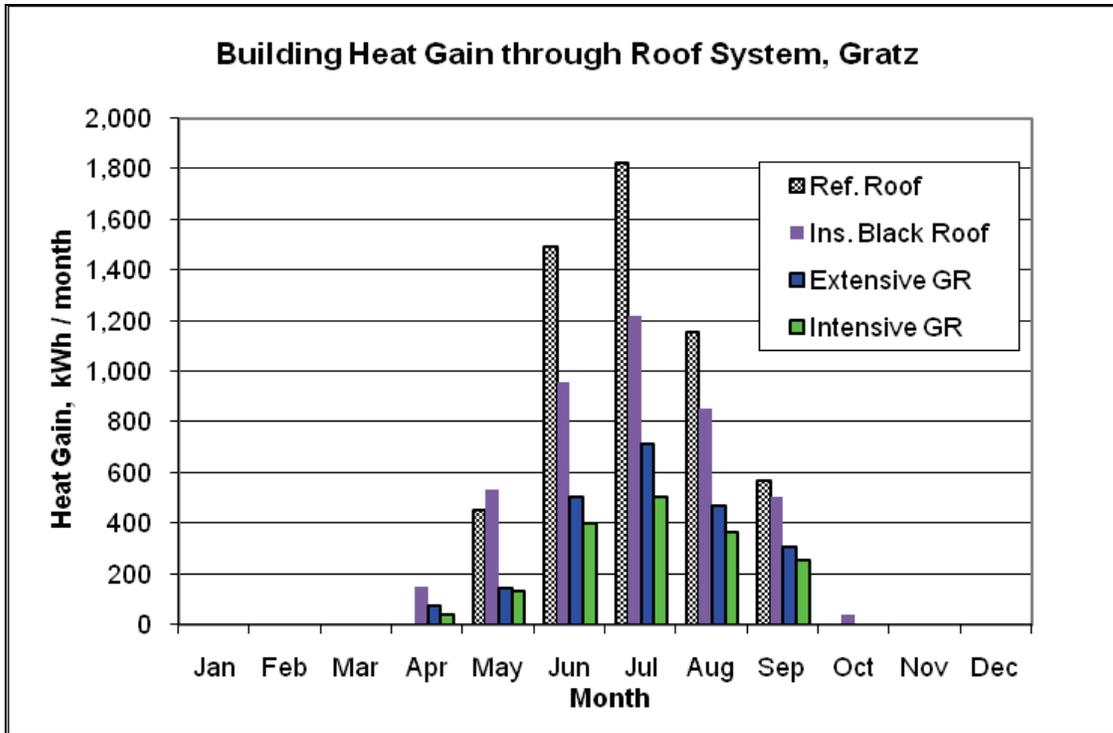
Figure 15: Building Heat Gain, Monthly

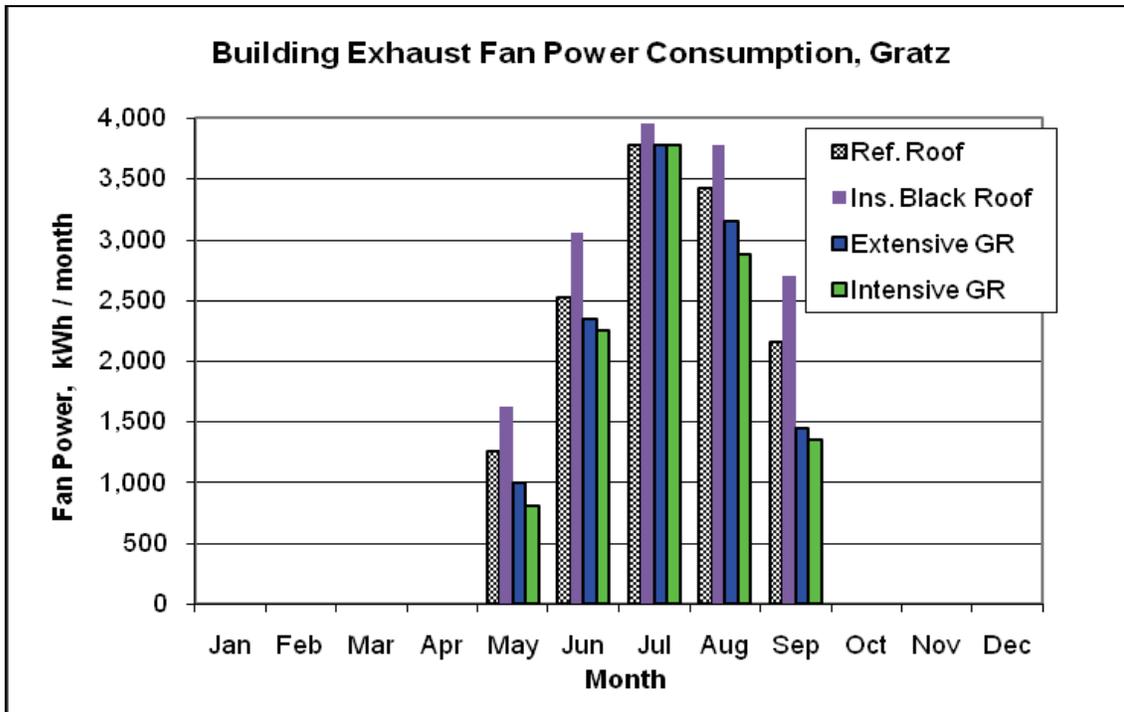
Figure 16: Building Exhaust Fan Power Consumption, Monthly

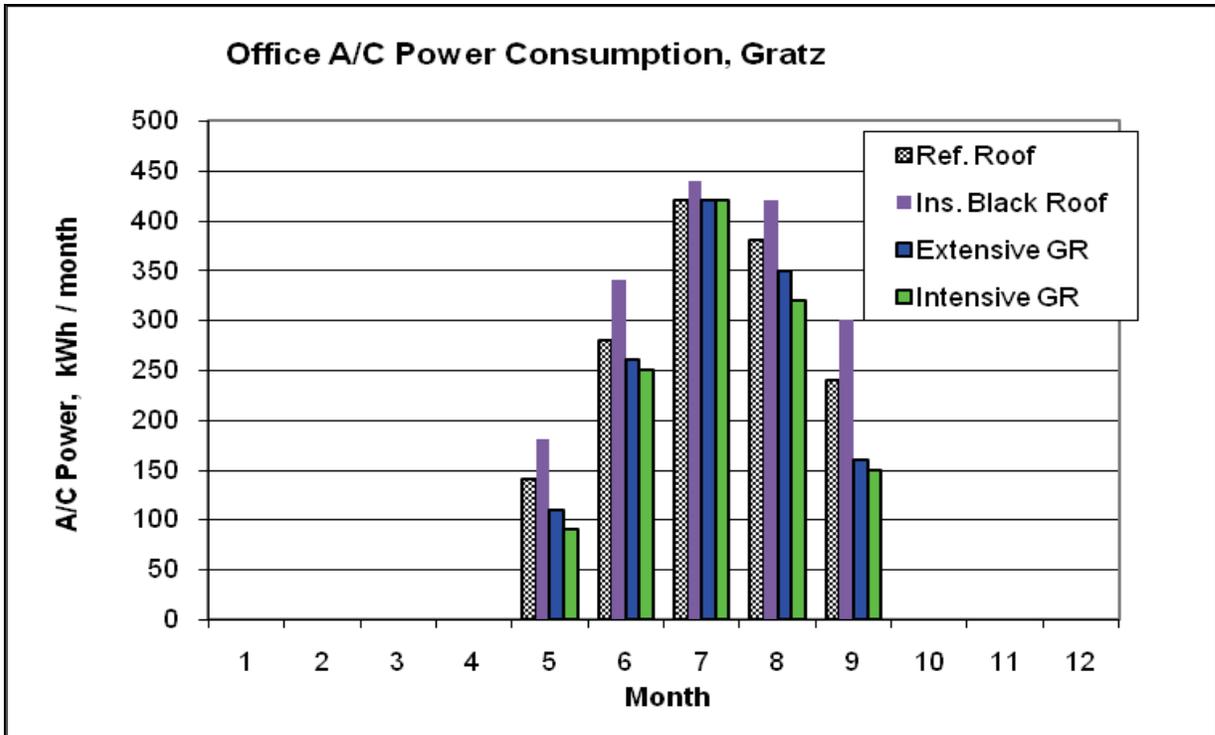
Figure 17: Office A/C Power Consumption, Monthly

Figure 17 shows a summary of the monthly electricity consumed by the office air conditioning. Assuming that some sort of economizing exists (part of mechanical system or manually open windows), the A/C power consumption was typically equal to 11% of the fan power, +/- 1.5%. This is primarily due to the office being exposed to the rest of the building on 3 sides, particularly the ceiling.

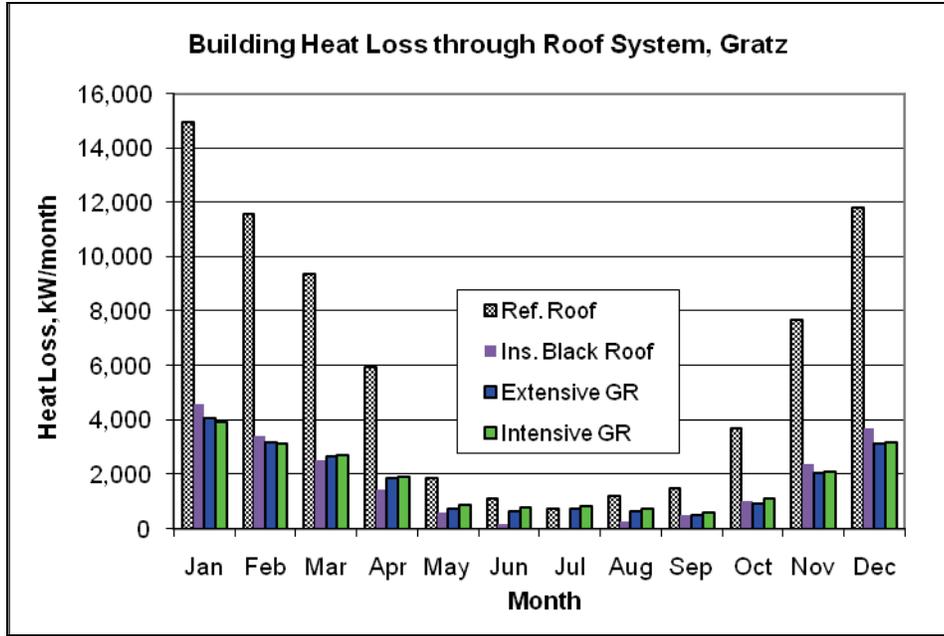
Figure 18: Building Heat Loss, Monthly

Figure 18 is a summary of the monthly heat losses through the roof system. The Black Insulated and Green Roof losses were ~ 60% less than the Reference Roof during the winter because of the increased insulation. The Green Roof heat loss was slightly lower in the winter and slightly higher in the spring-summer than the Black Insulated Roof because of the added thermal mass.

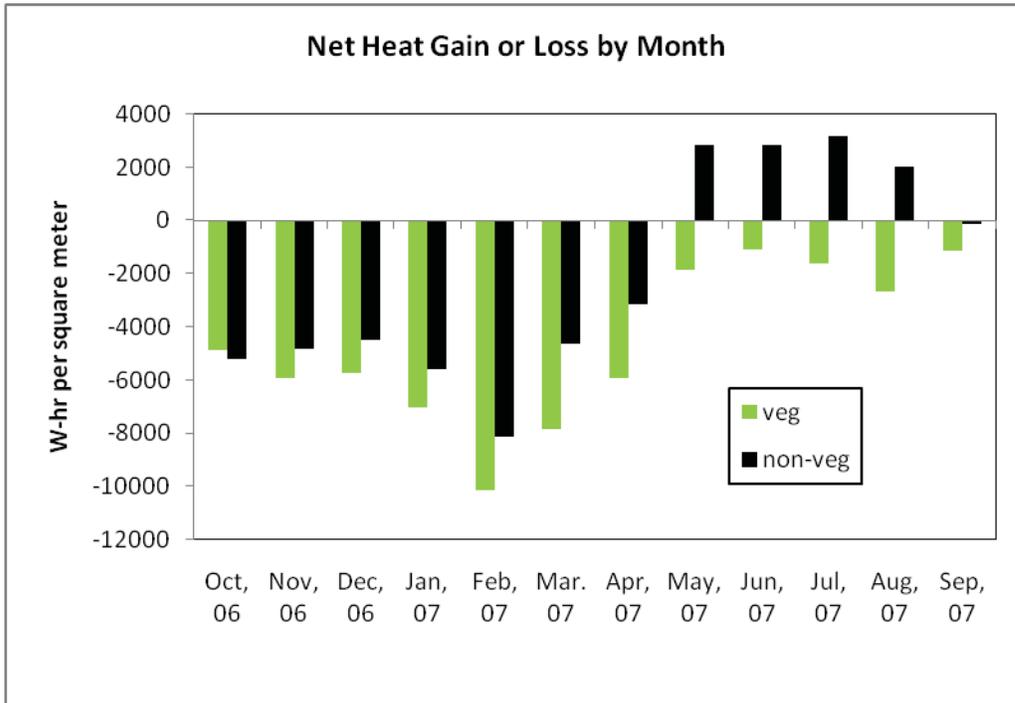
Figure 20: Net heat gain or loss by month for vegetated and non-vegetated roof. Vegetated heat flux sensor averages were used for Oct 2006-May 2007. Due to sensor failure, only VHFQ3E (veg. quad III) data were used for June-September 2007.
