**GREEN ROOF THERMAL AND STORMWATER
MANAGEMENT PERFORMANCE: THE GRATZ
BUILDING CASE STUDY, NEW YORK CITY**

**FINAL REPORT 09-05
DECEMBER 2010**

This report summarizes the findings for data collection from October 2006 to September 2007 on the Gratz Industries Green Roof Research Station. Notable for its large-scale innovative research design, this project addresses the deficiency in green roof thermal and stormwater data specific to the New York City region. In conjunction with the in-situ monitoring data and analysis, this report also includes thermal modeling of the Gratz building given conventional and green roof scenarios as well as runoff water quality results. The results of the monitoring during this period showed that green roofs are capable of lowering the maximum conventional roof membrane (surface) temperatures by as much as 35°C and reduces diurnal temperature fluctuations by as much as 30°C. While the conventional roof membrane temperatures frequently exceeded 70°C in the summer months, for the green roof the temperatures were consistently below 50°C. Reductions in temperature fluctuations decrease the stress on roof membranes thereby extending its useful duration. I

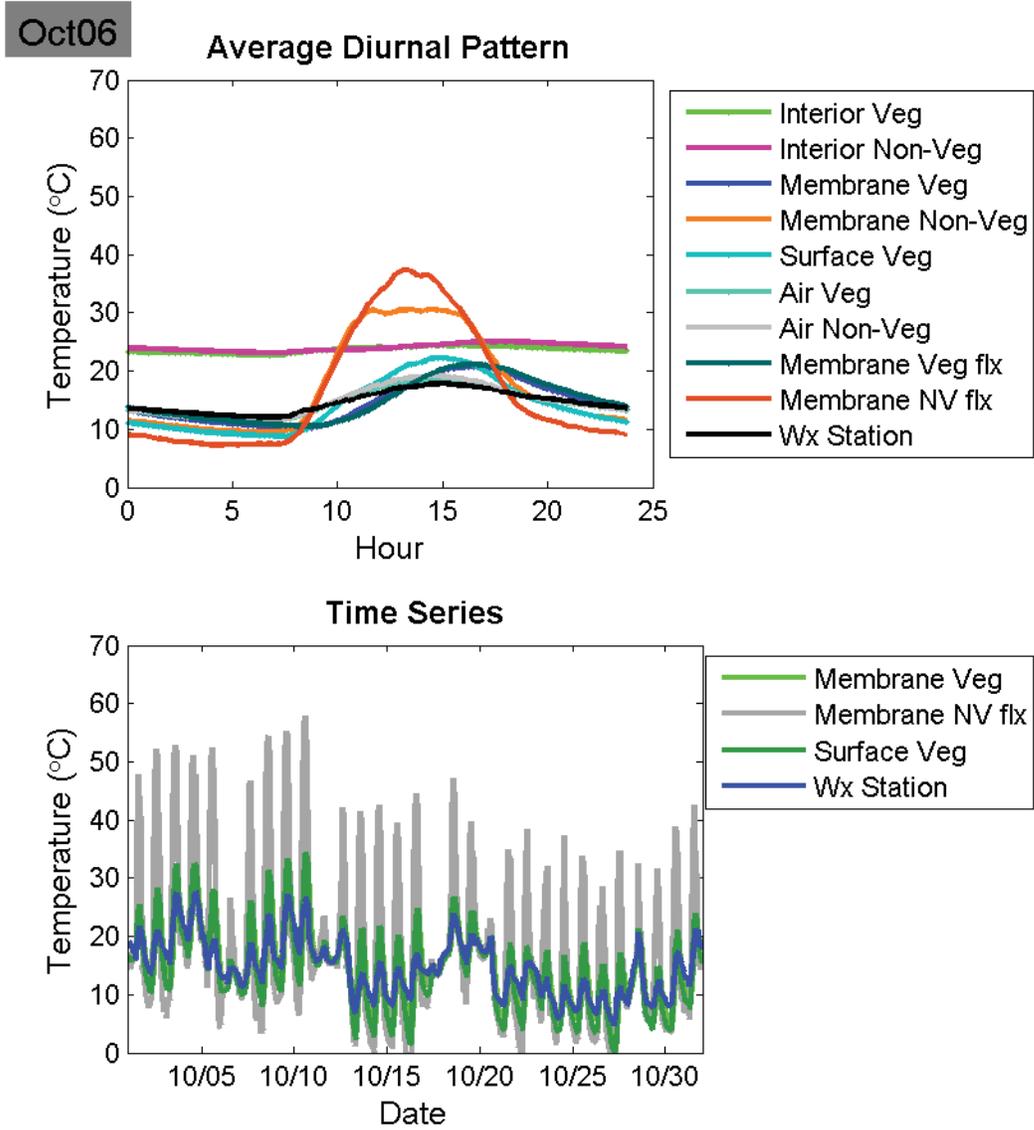
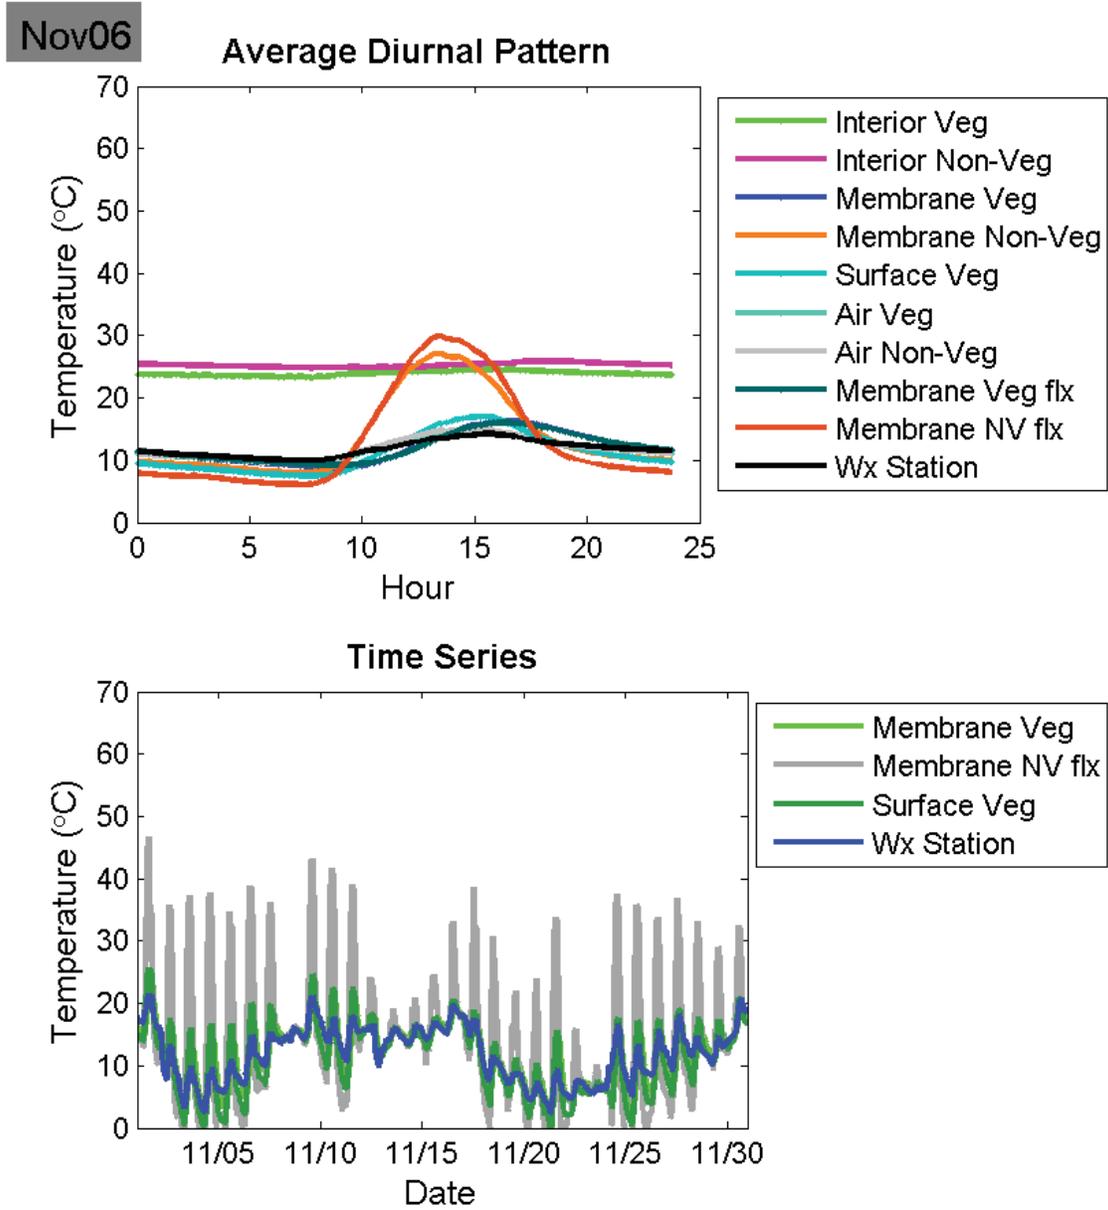
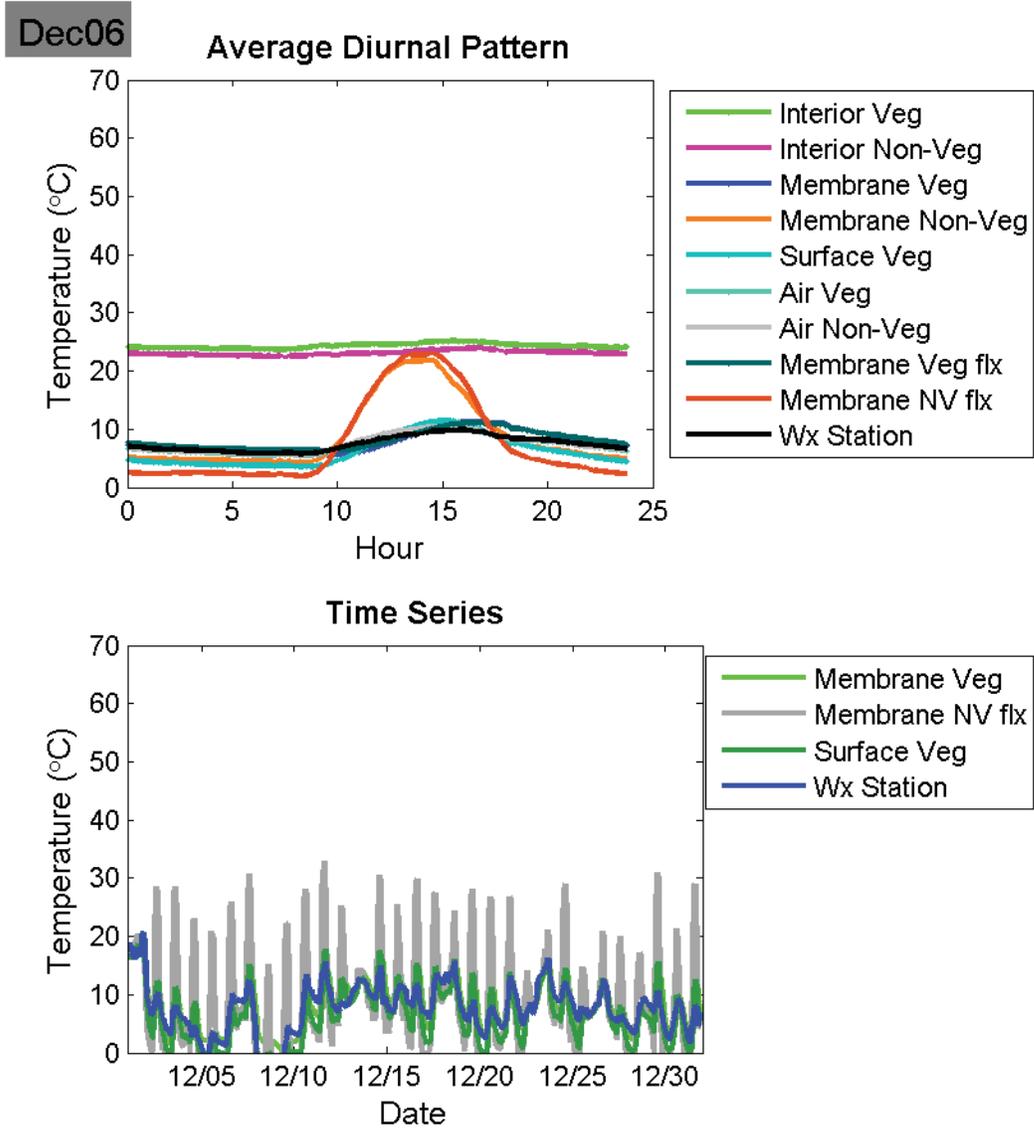
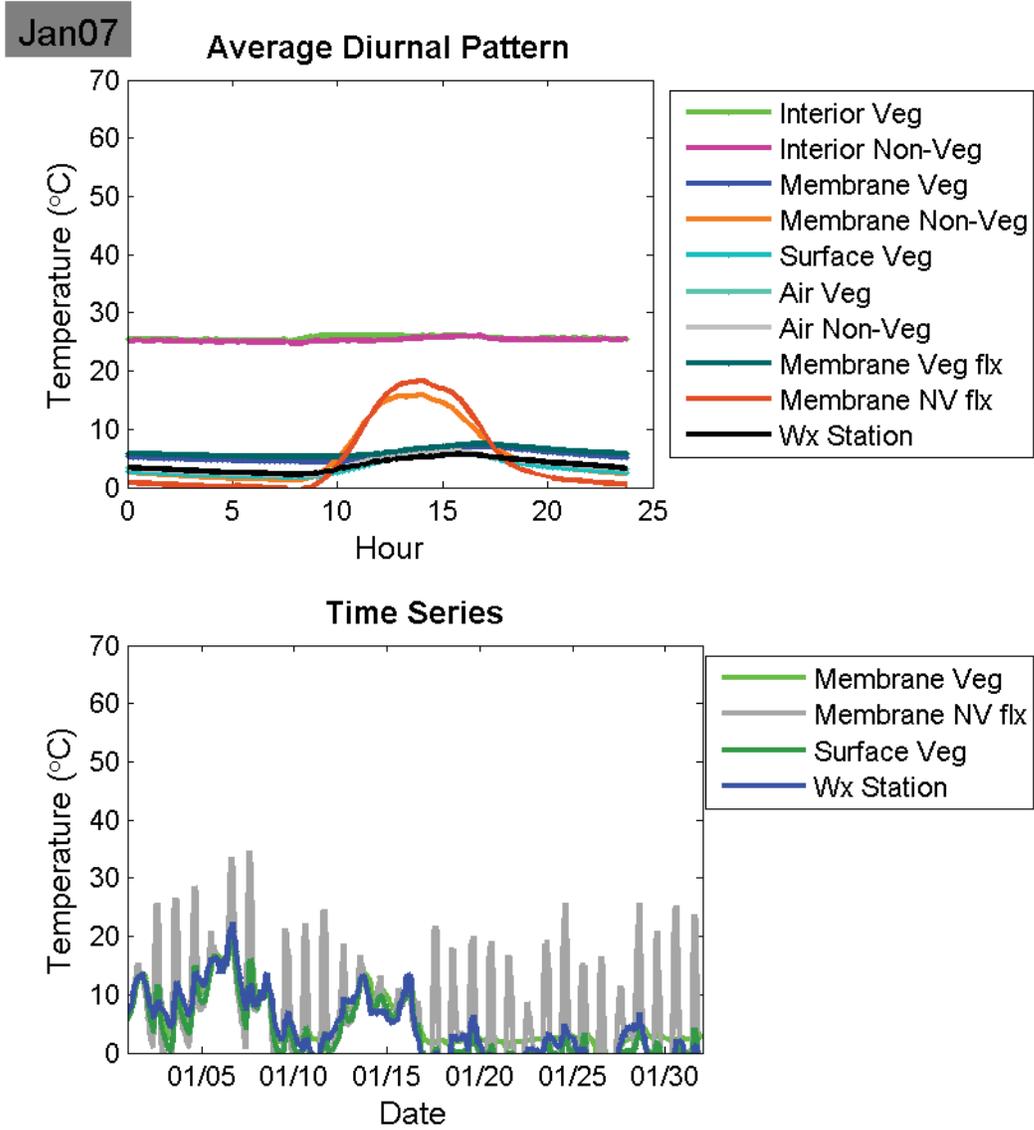
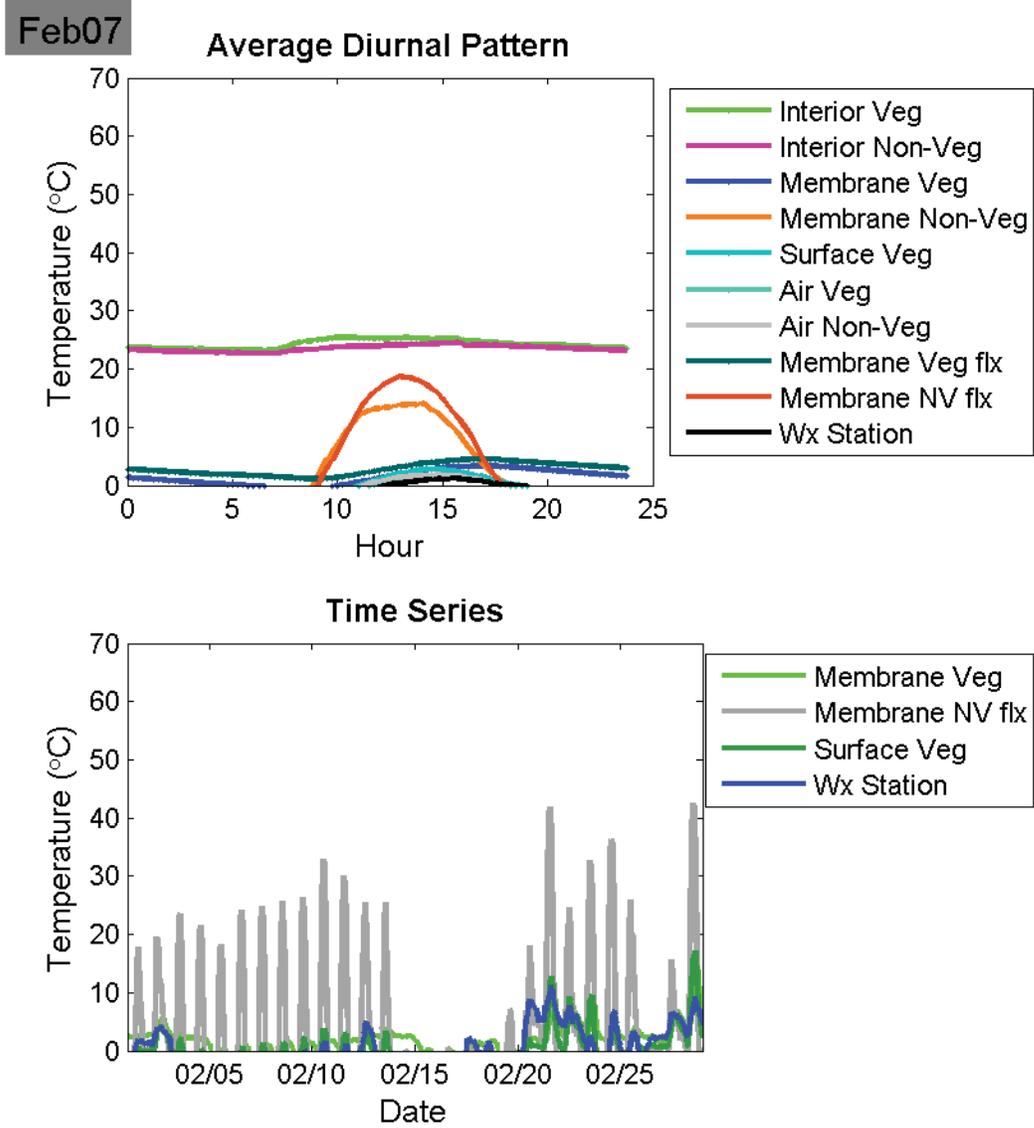
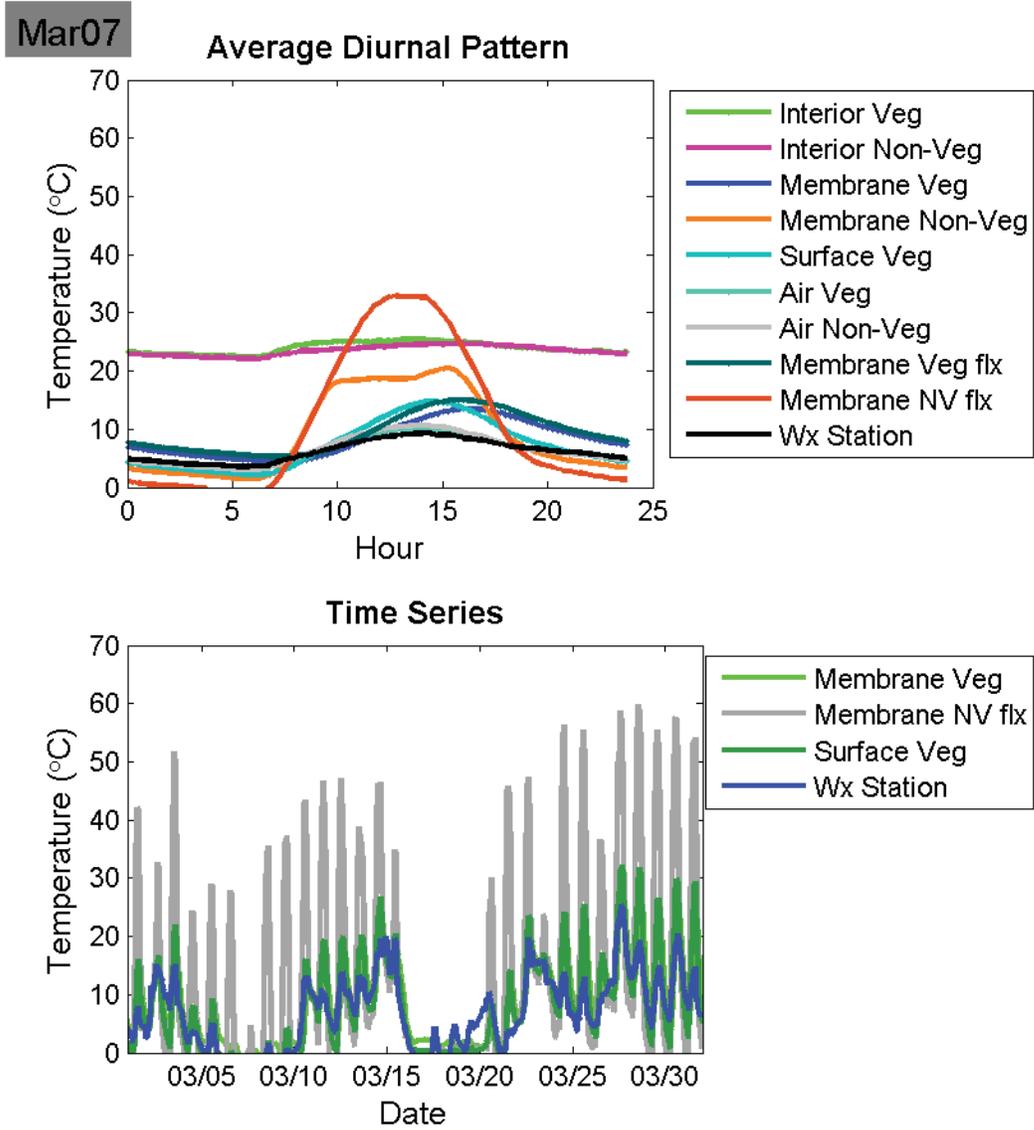
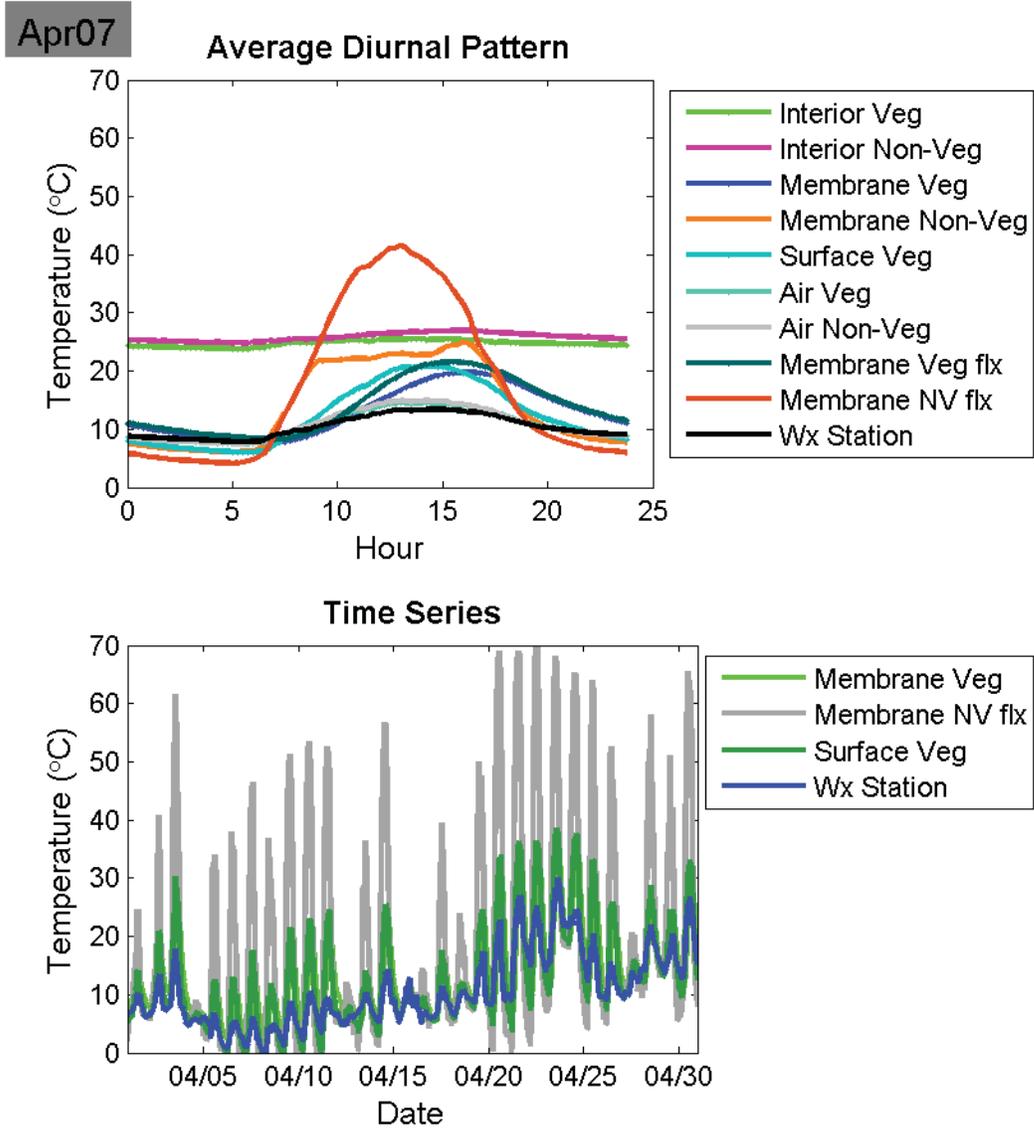
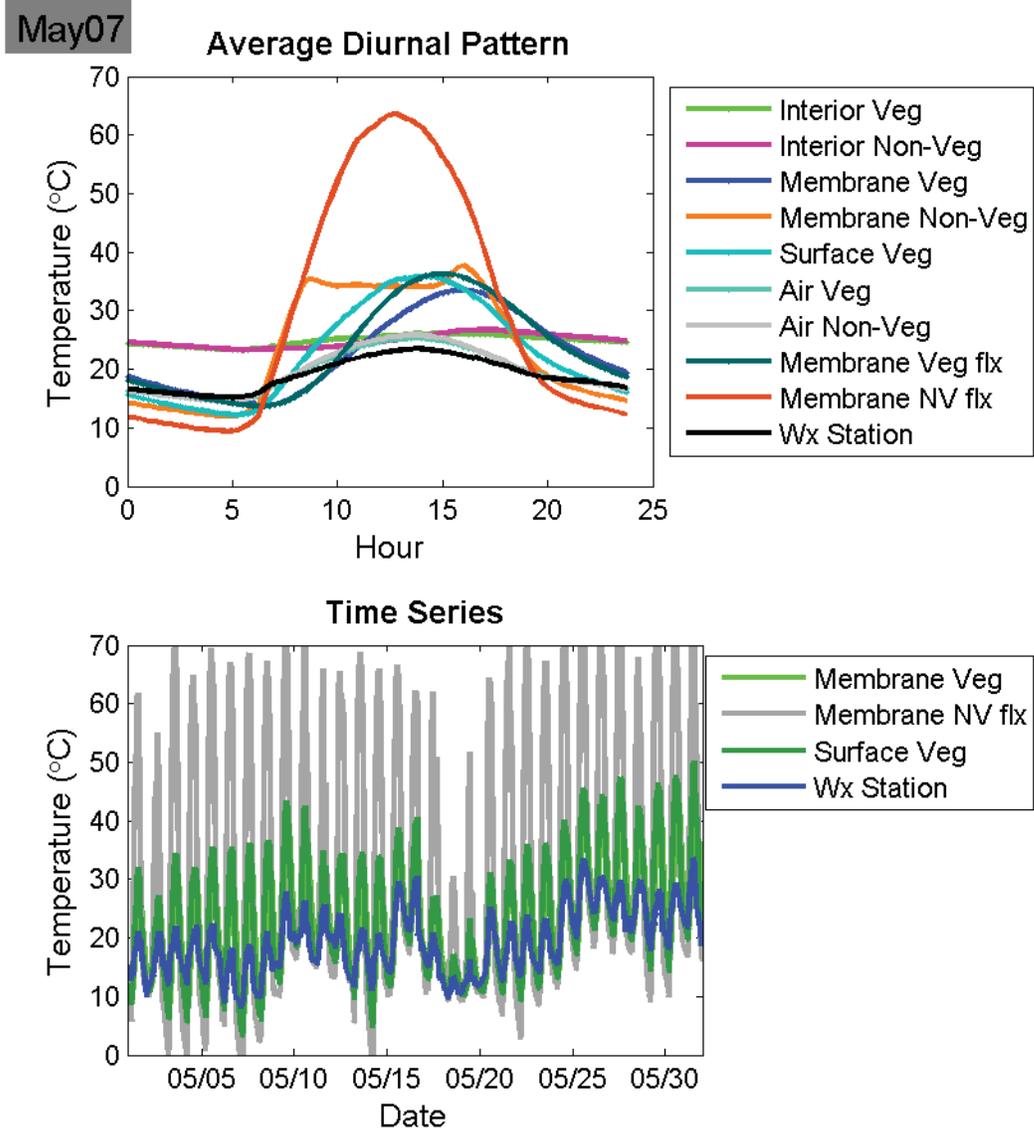
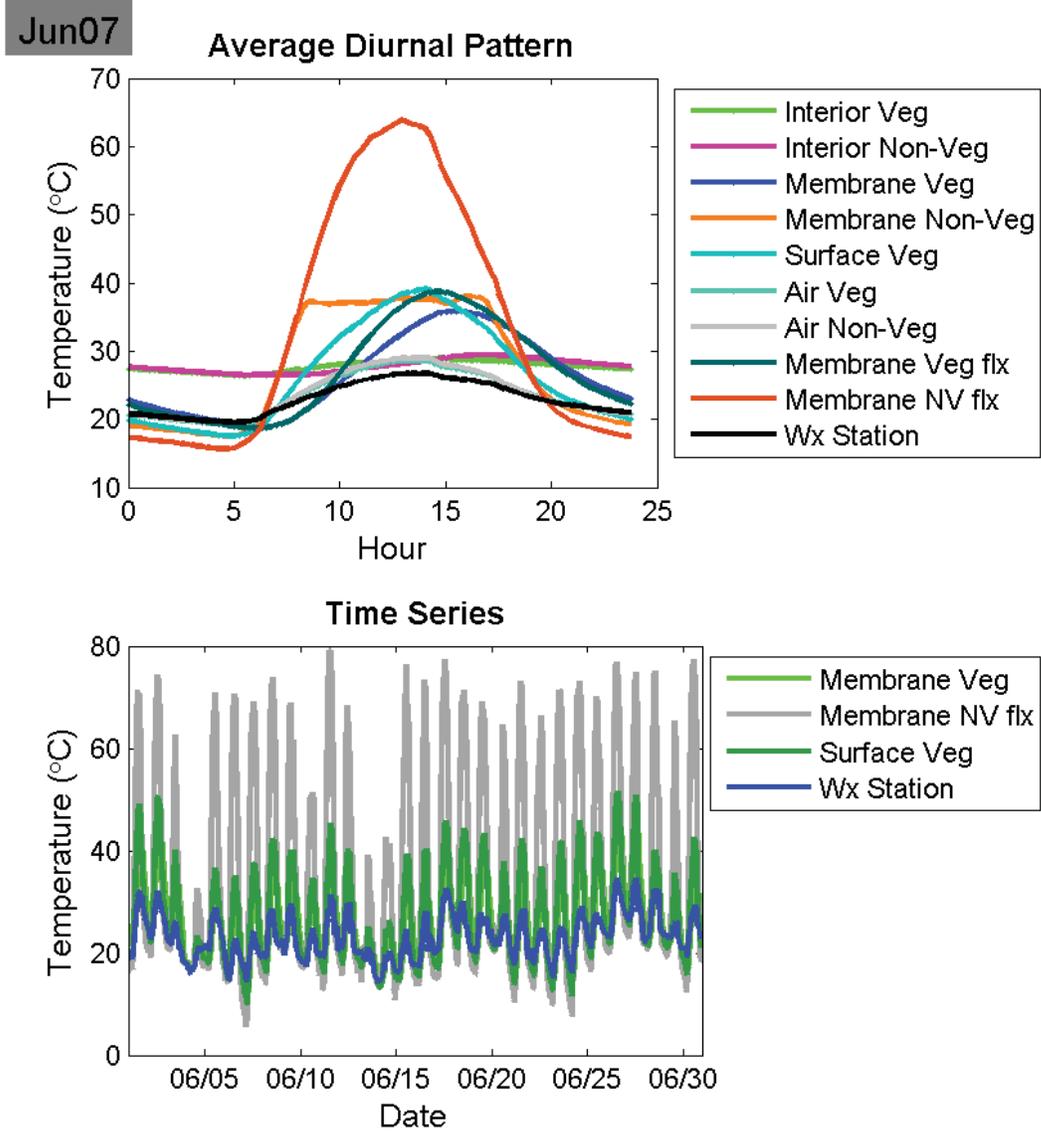
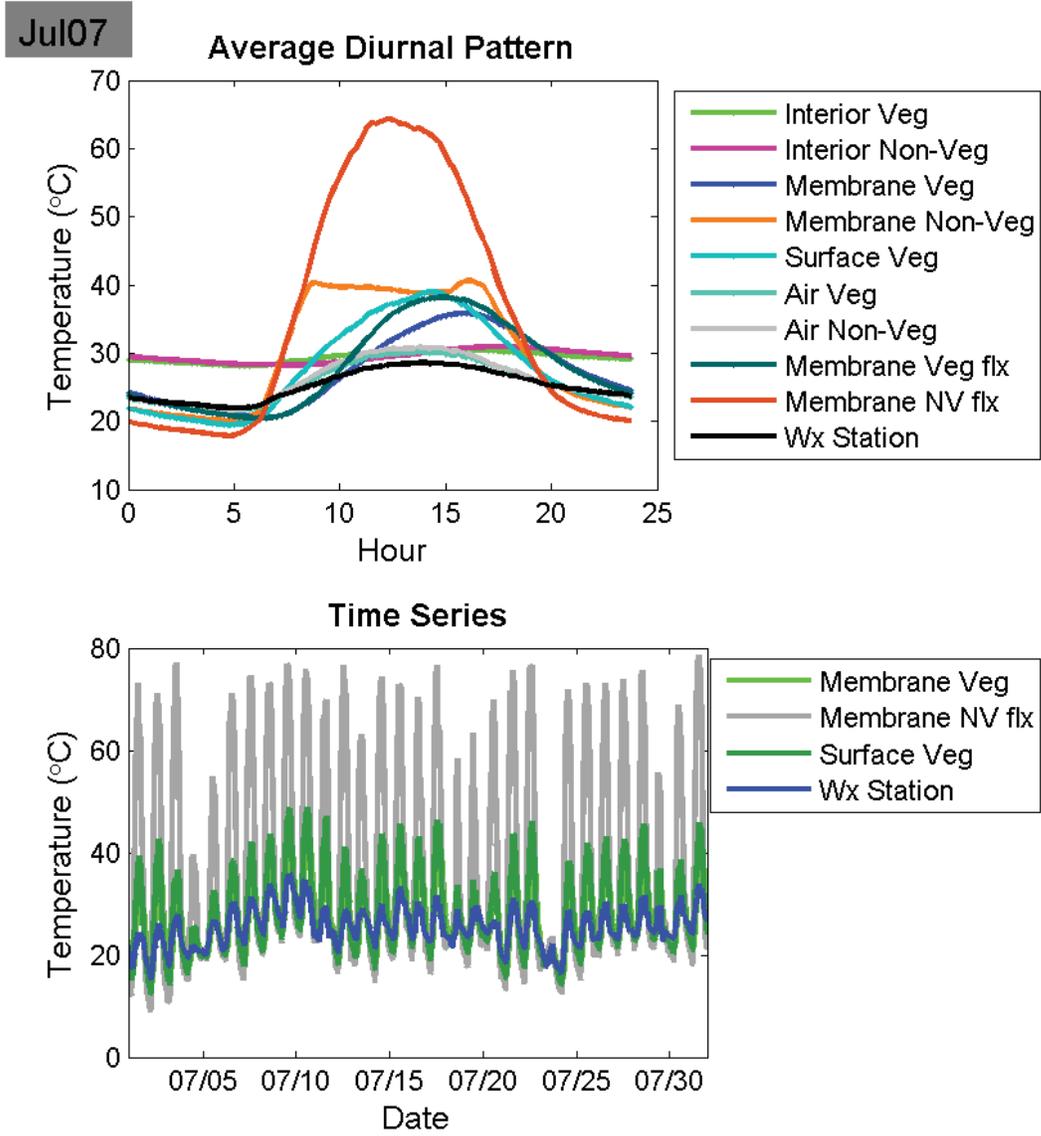
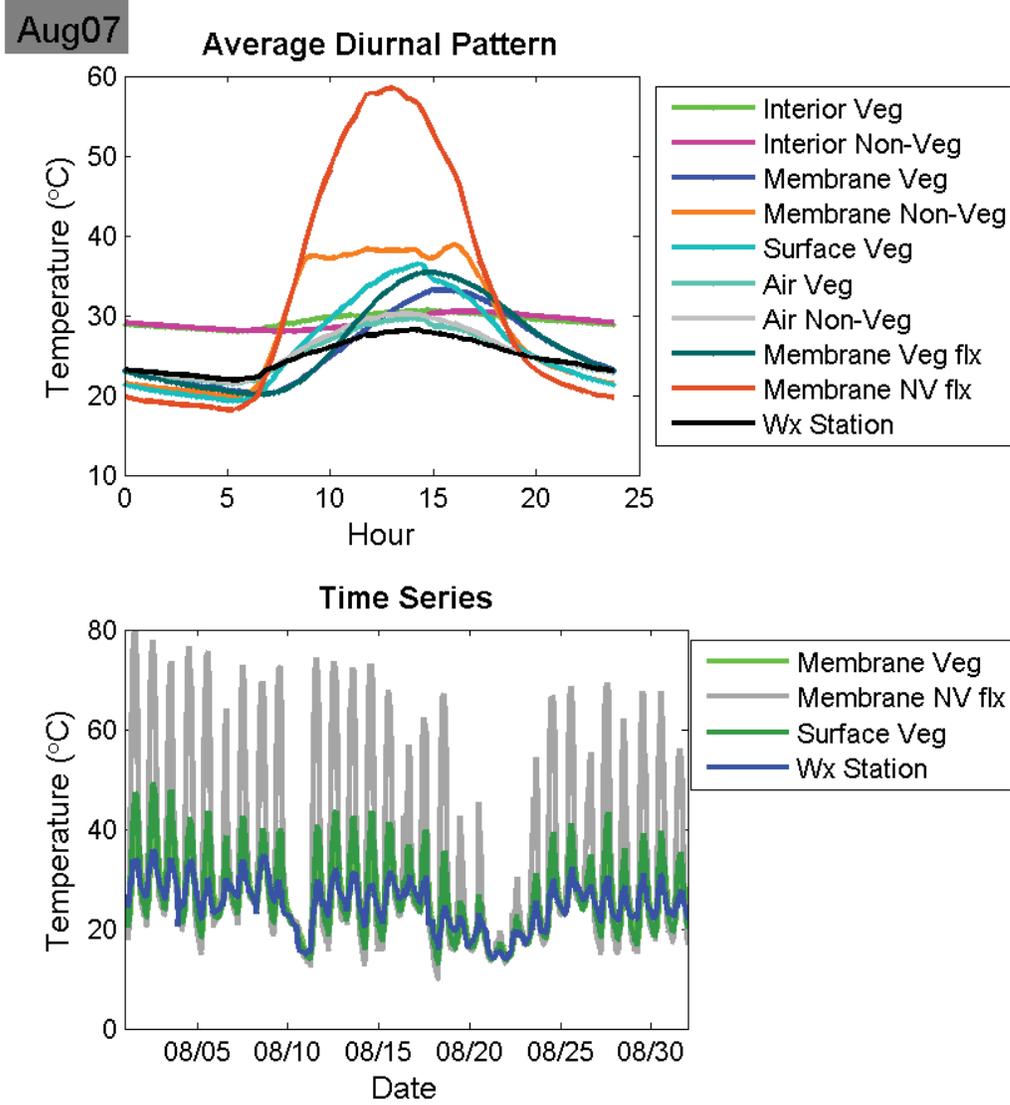
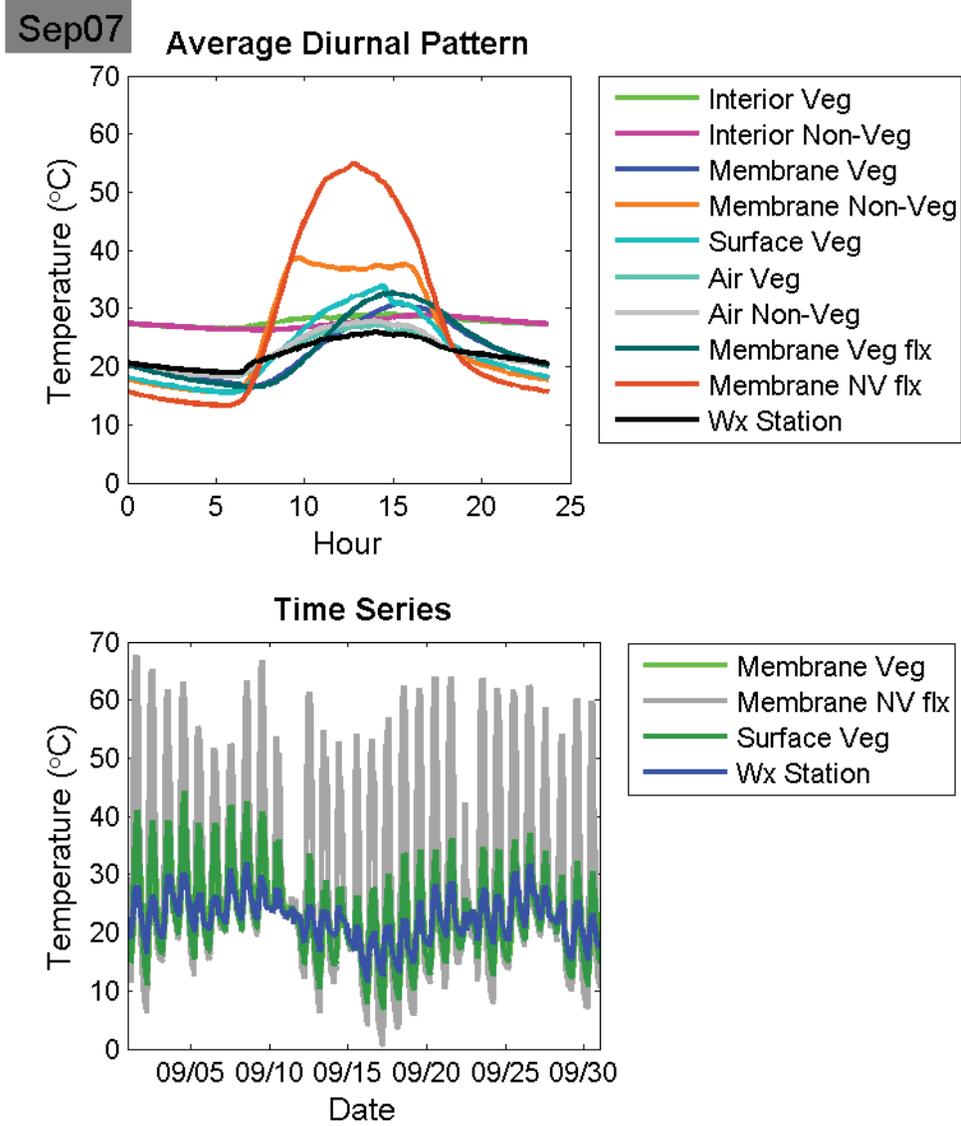
Figure 21: October 2006 Average diurnal temperatures (top) and monthly average temperatures.

Figure 23: November 2006 Average diurnal temperatures (top) and monthly average temperatures.

Figure 25: December 2006 Average diurnal temperatures (top) and monthly average temperatures.

Figure 27: January 2007 Average diurnal temperatures (top) and monthly average temperatures.

Figure 29: February 2007 Average diurnal temperatures (top) and monthly average temperatures.

Figure 31: March 2007 Average diurnal temperatures (top) and monthly average temperatures.

Figure 33: April 2007 Average diurnal temperatures (top) and monthly average temperatures.

Figure 35: May 2007 Average diurnal temperatures (top) and monthly average temperatures.

Figure 37: June 2007 Average diurnal temperatures (top) and monthly average temperatures.

Figure 39: July 2007 Average diurnal temperatures (top) and monthly average temperatures.

Figure 41: August 2007 Average diurnal temperatures (top) and monthly average temperatures.

Figure 43: September 2007 Average diurnal temperatures (top) and monthly average temperatures.
