**GREEN ROOF THERMAL AND STORMWATER
MANAGEMENT PERFORMANCE: THE GRATZ
BUILDING CASE STUDY, NEW YORK CITY**

**FINAL REPORT 09-05
DECEMBER 2010**

This report summarizes the findings for data collection from October 2006 to September 2007 on the Gratz Industries Green Roof Research Station. Notable for its large-scale innovative research design, this project addresses the deficiency in green roof thermal and stormwater data specific to the New York City region. In conjunction with the in-situ monitoring data and analysis, this report also includes thermal modeling of the Gratz building given conventional and green roof scenarios as well as runoff water quality results. The results of the monitoring during this period showed that green roofs are capable of lowering the maximum conventional roof membrane (surface) temperatures by as much as 35°C and reduces diurnal temperature fluctuations by as much as 30°C. While the conventional roof membrane temperatures frequently exceeded 70°C in the summer months, for the green roof the temperatures were consistently below 50°C. Reductions in temperature fluctuations decrease the stress on roof membranes thereby extending its useful duration. I

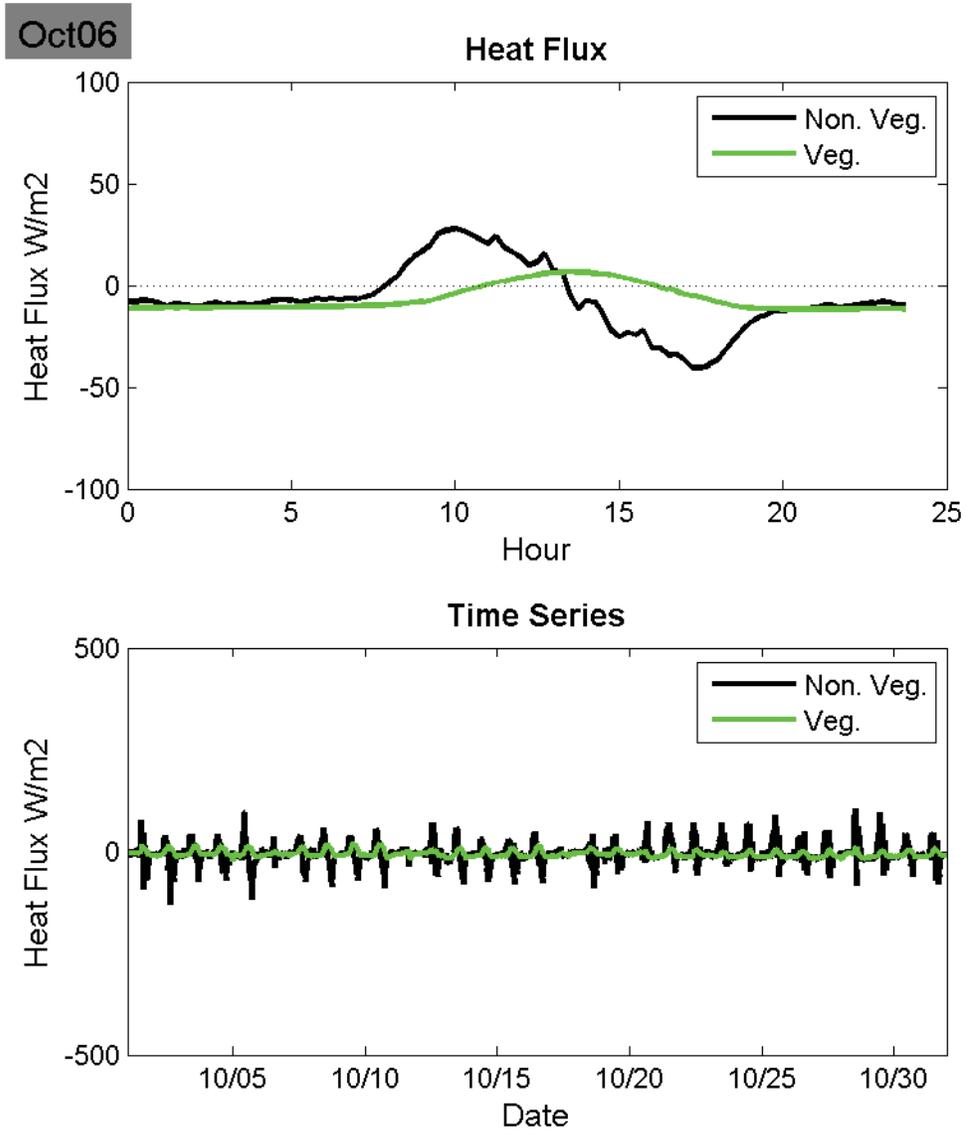
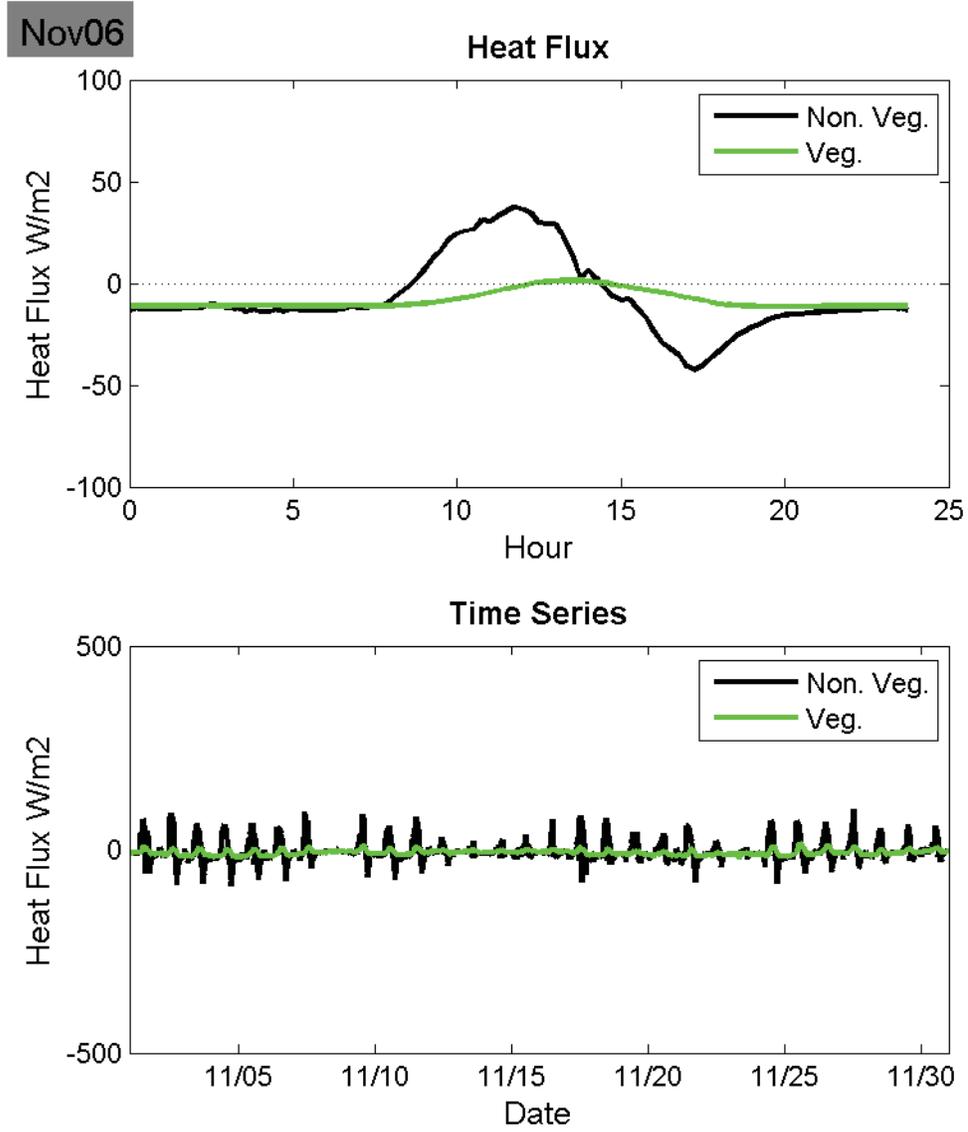
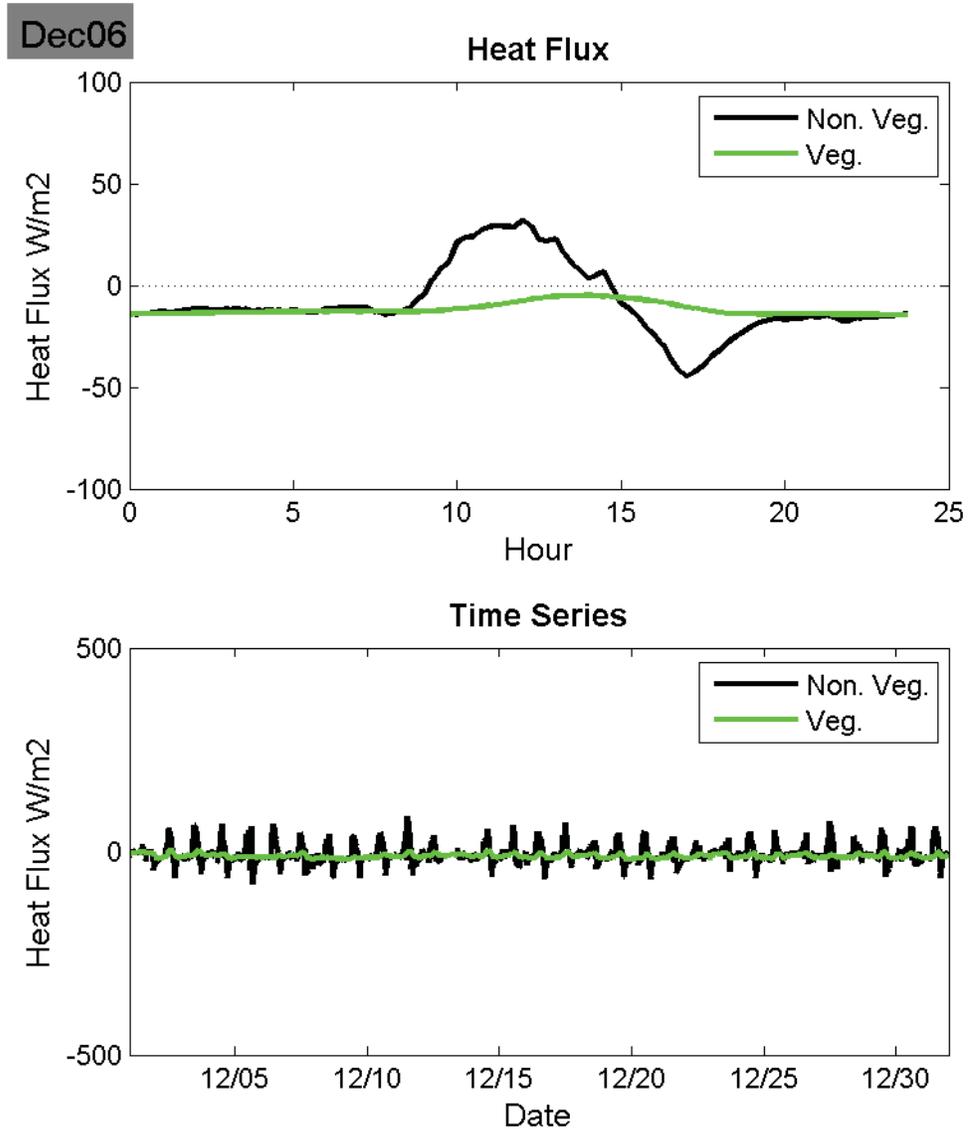
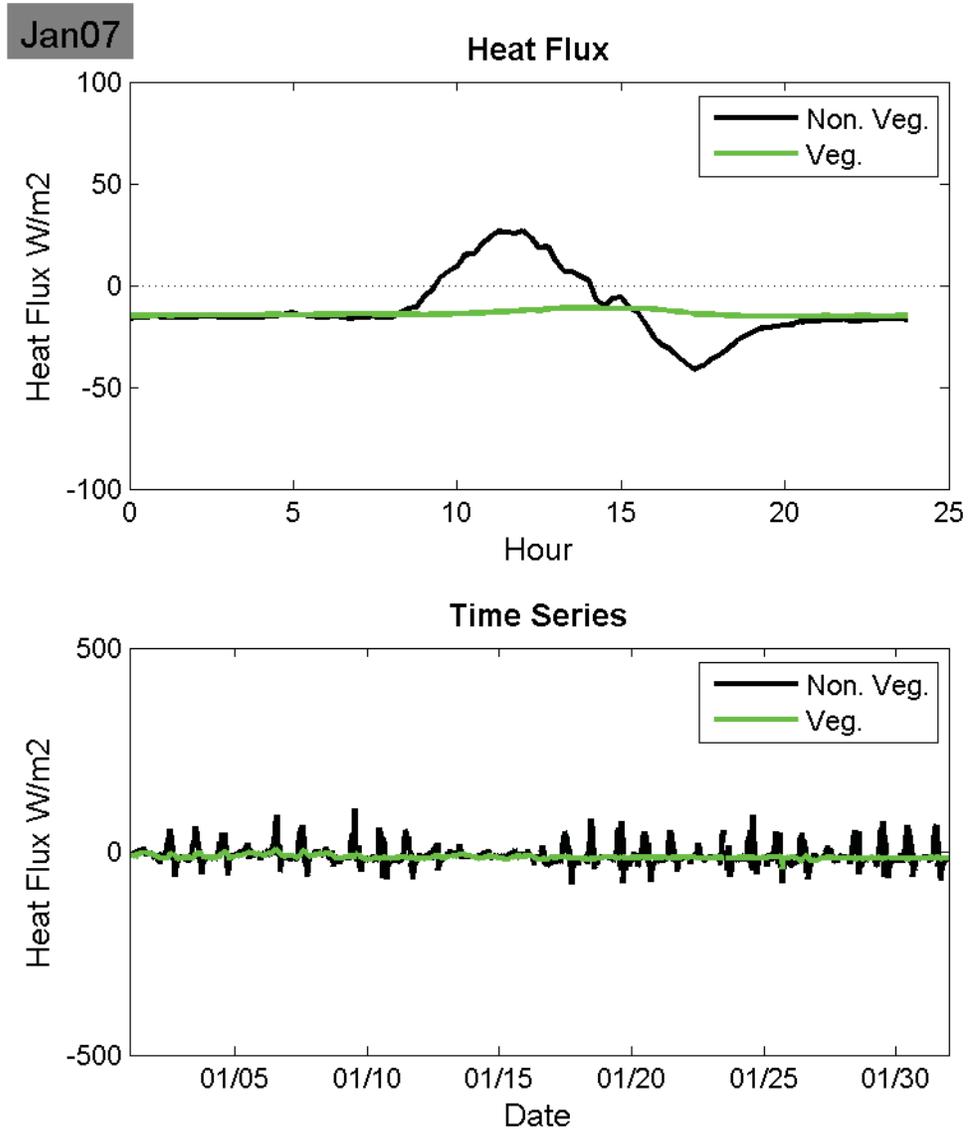
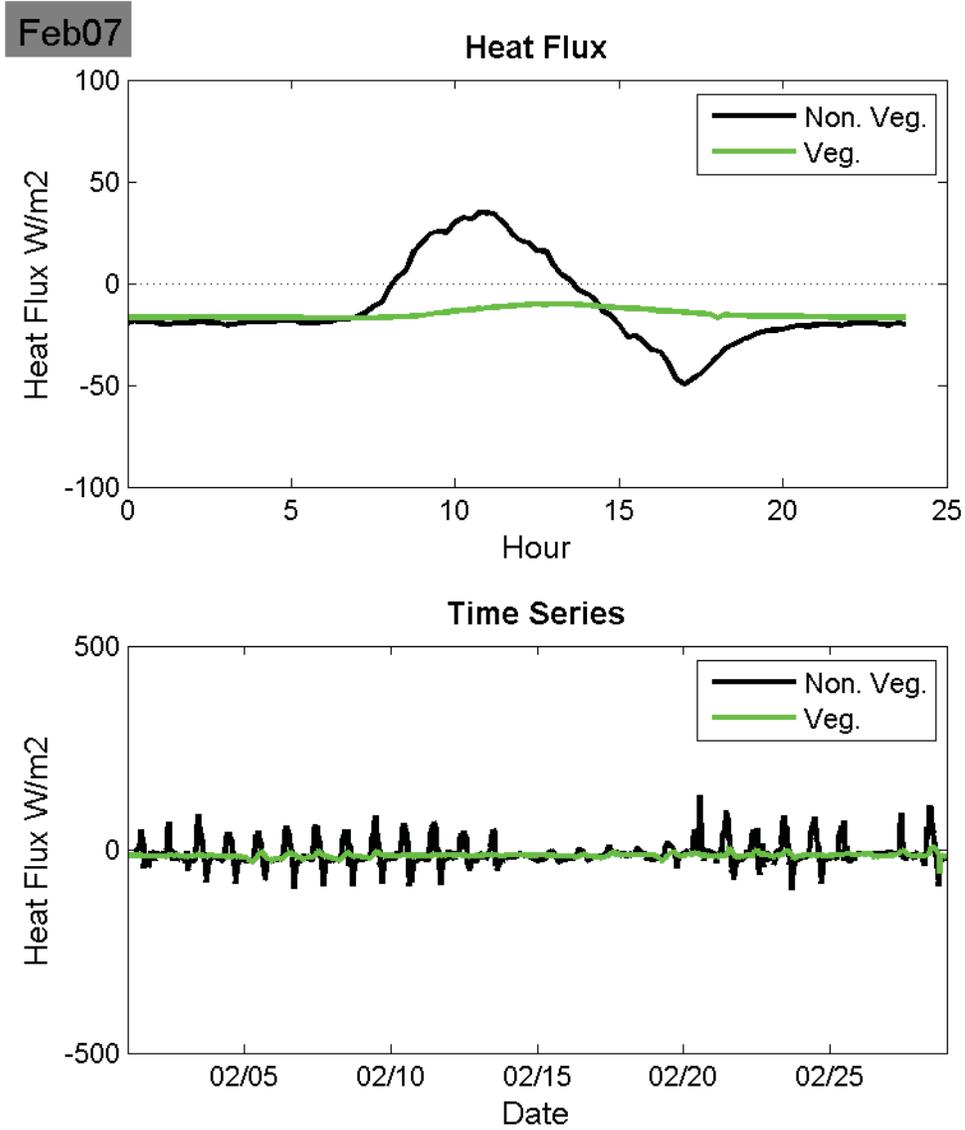
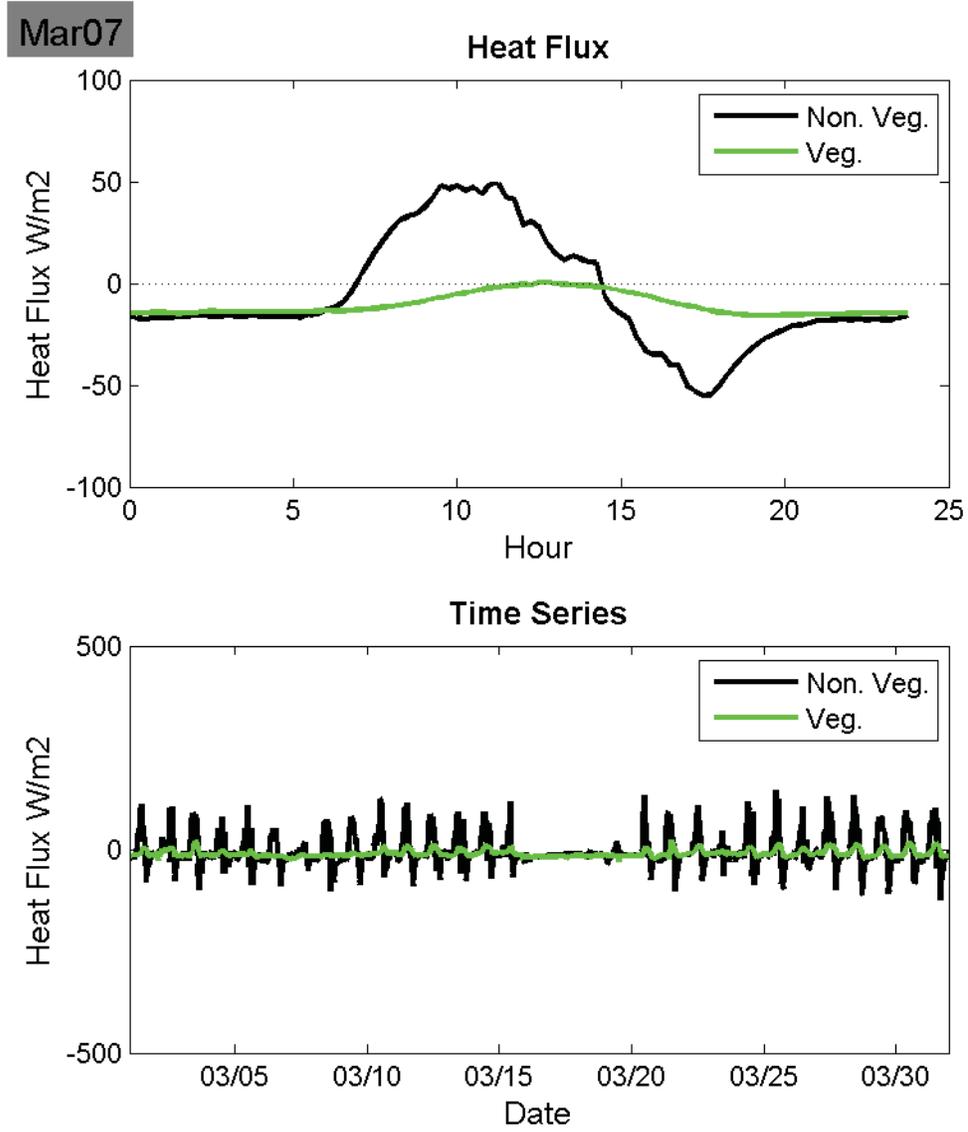
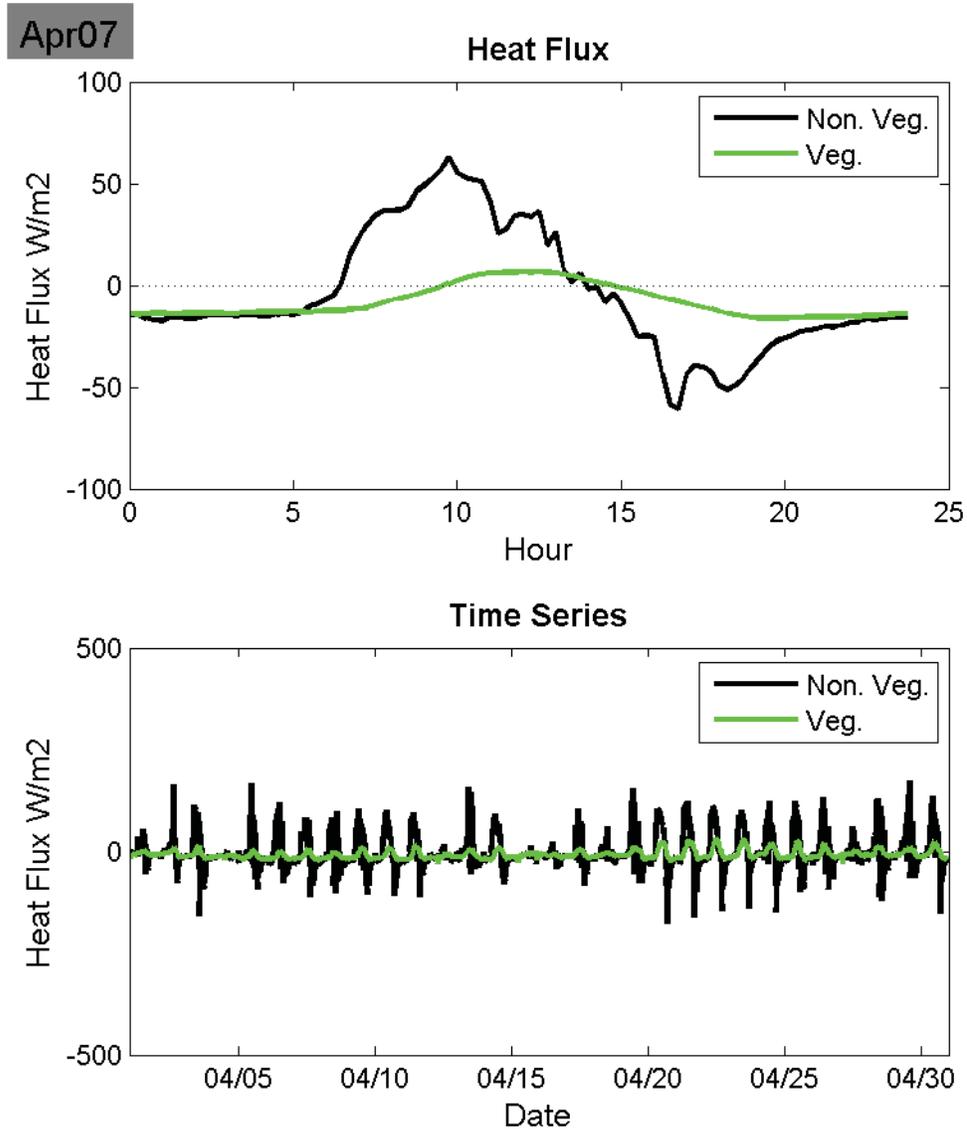
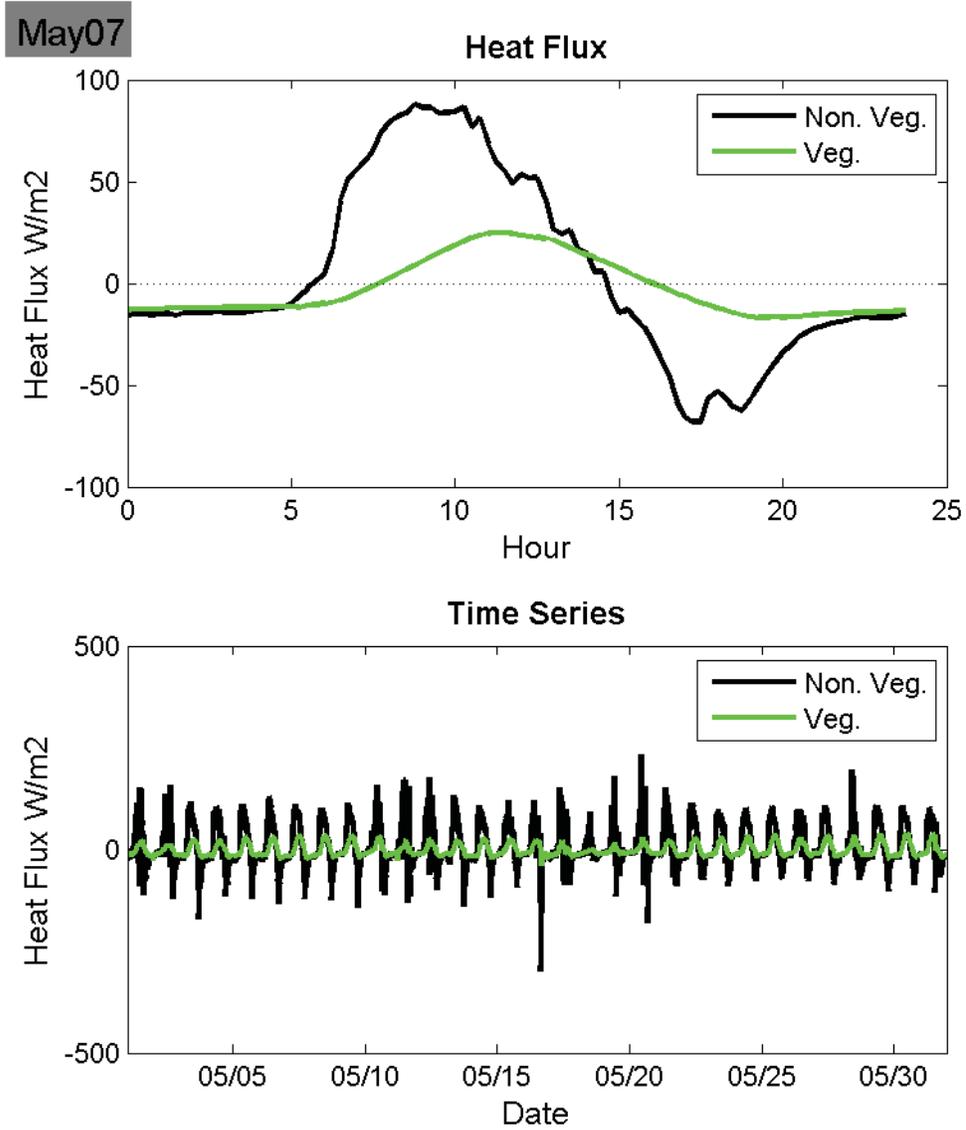
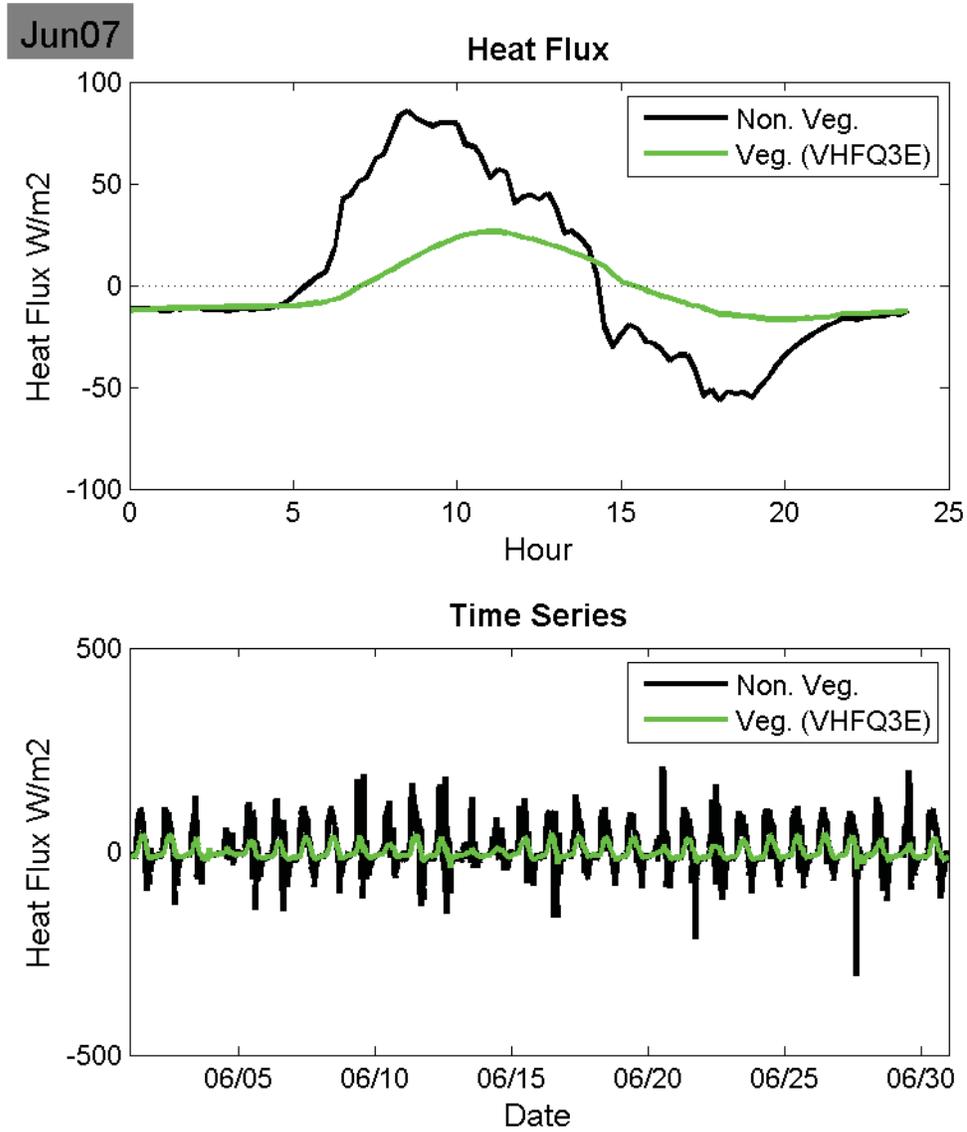
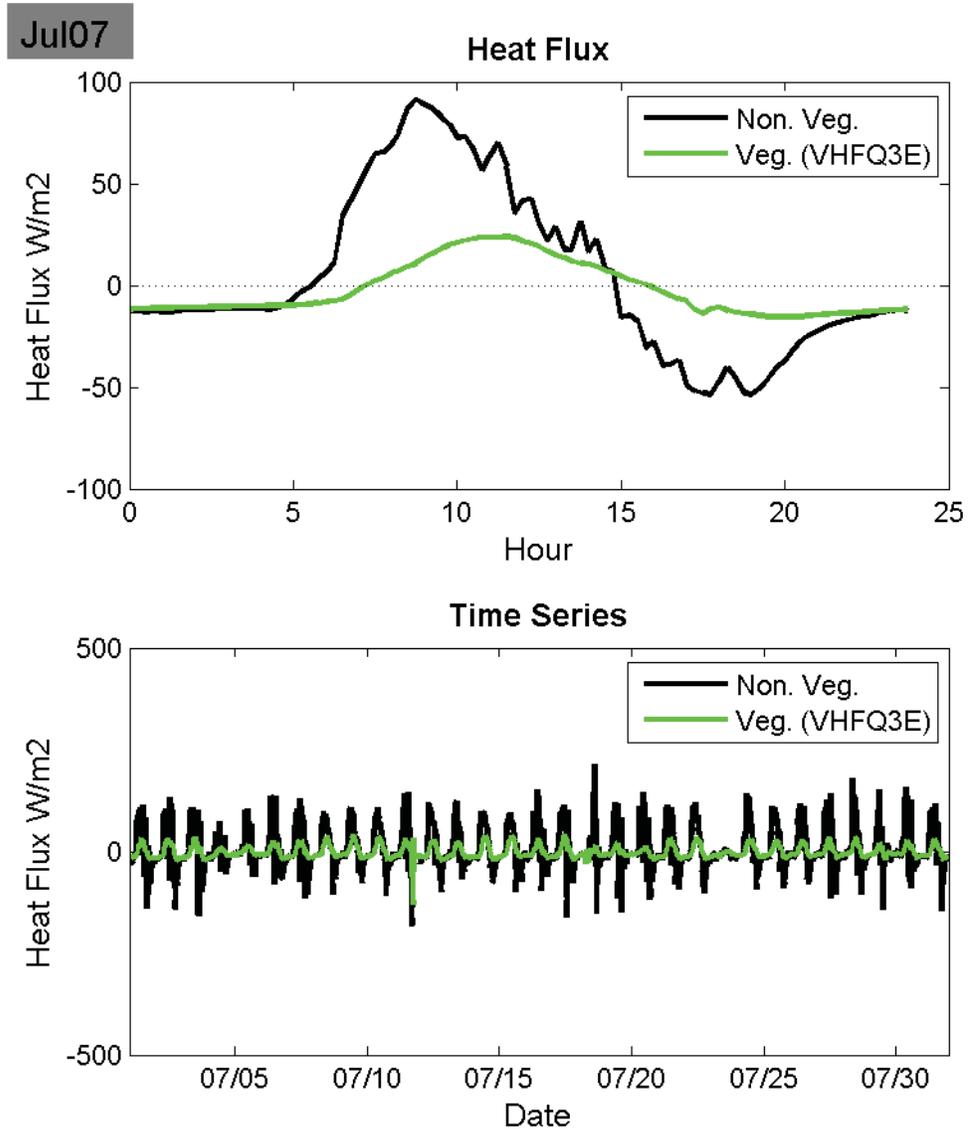
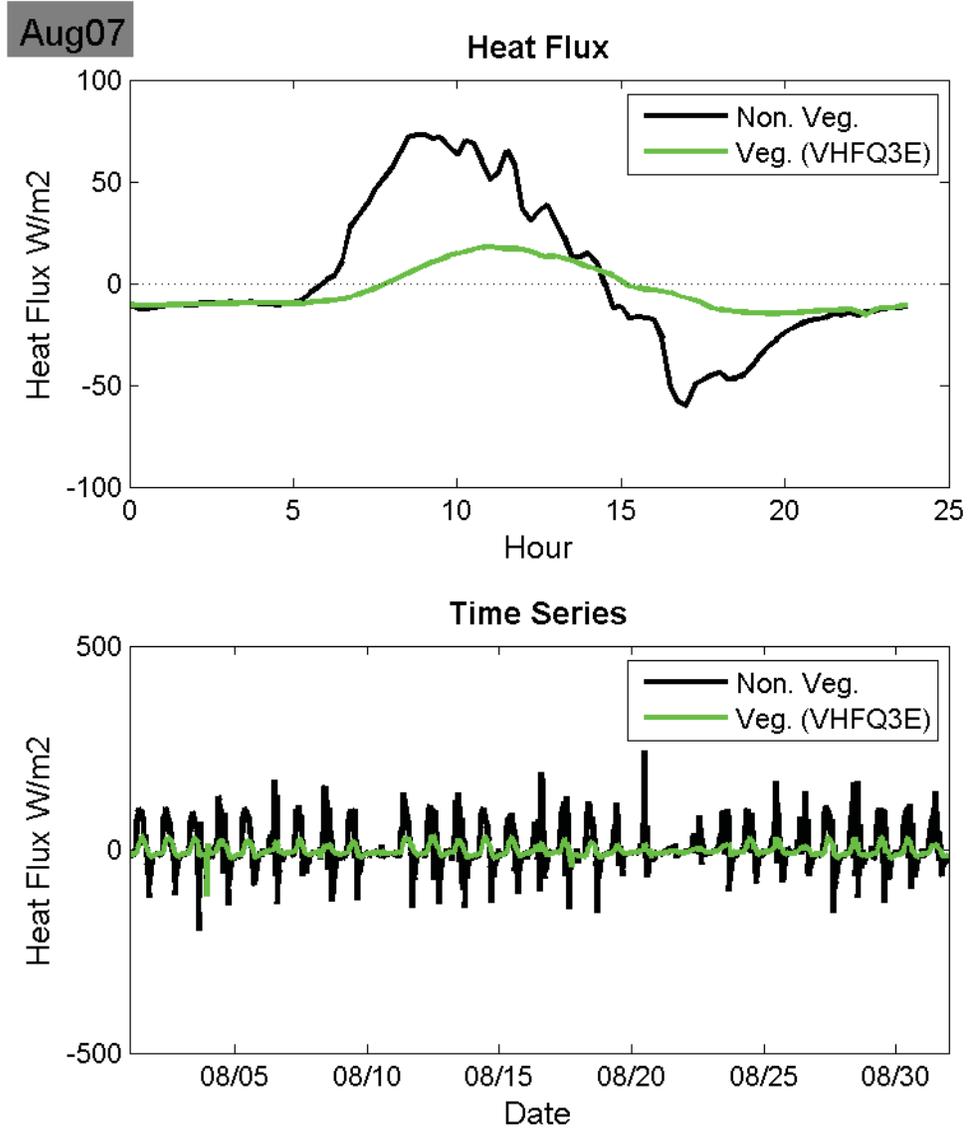
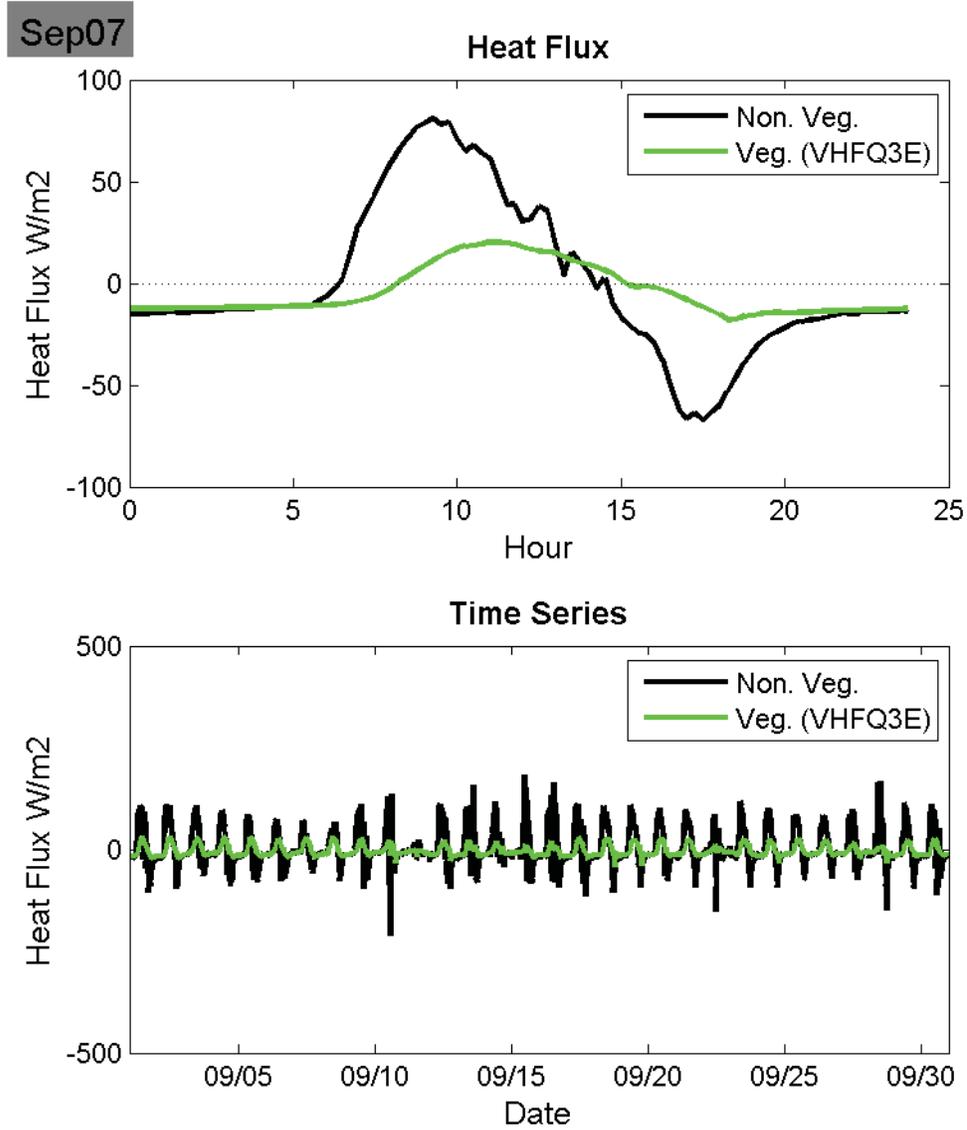
Figure 22: October 2006 Average diurnal heat flux through a green and non-green roof (top) and monthly daily heat flux.

Figure 24: November 2006 Average diurnal heat flux through a green and non-green roof (top) and monthly daily heat flux.

Figure 26: December 2006 Average diurnal heat flux through a green and non-green roof (top) and monthly daily heat flux.

Figure 28: January 2007 Average diurnal heat flux through a green and non-green roof (top) and monthly daily heat flux.

Figure 30: February 2007 Average diurnal heat flux through a green and non-green roof (top) and monthly daily heat flux.

Figure 32: March 2007 Average diurnal heat flux through a green and non-green roof (top) and monthly daily heat flux.

Figure 34: April 2007 Average diurnal heat flux through a green and non-green roof (top) and monthly daily heat flux.

Figure 36: May 2007 Average diurnal heat flux through a green and non-green roof (top) and monthly daily heat flux.

Figure 38: June 2007 Average diurnal heat flux through a green and non-green roof (top) and monthly daily heat flux.

Figure 40: July 2007 Average diurnal heat flux through a green and non-green roof (top) and monthly daily heat flux.

Figure 42: August 2007 Average diurnal heat flux through a green and non-green roof (top) and monthly daily heat flux.

Figure 44: September 2007 Average diurnal heat flux through a green and non-green roof (top) and monthly daily heat flux.

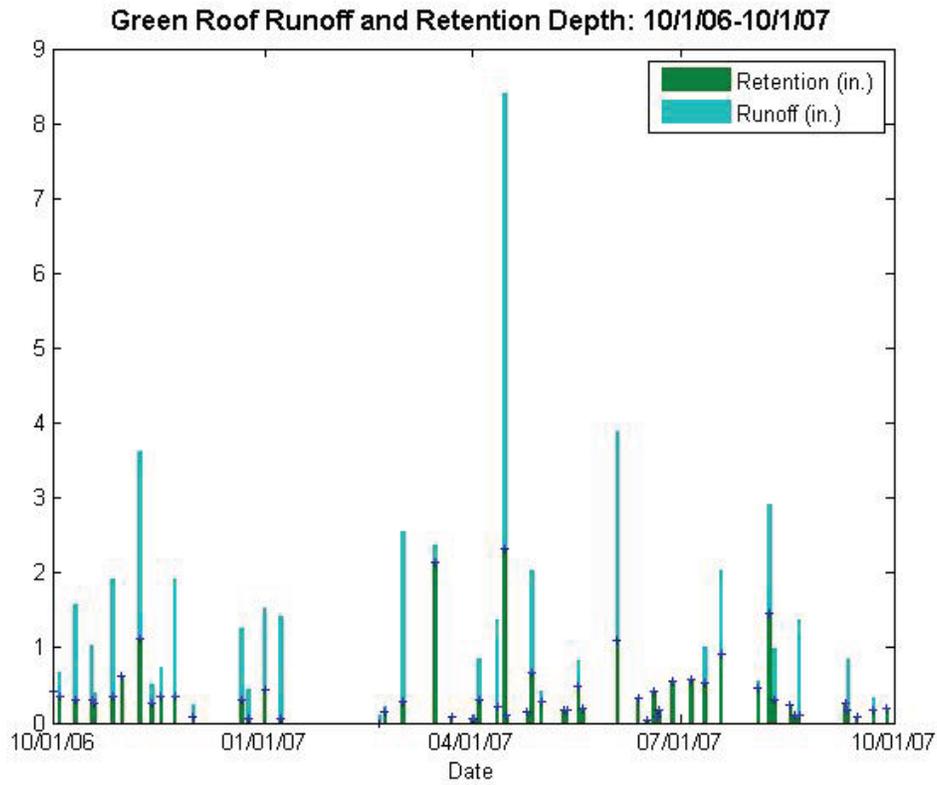
Figure 45: Runoff and retention of measured precipitation events by the Gratz green roof in New York City. The total bar height (Runoff + Retention) is equal to the measured precipitation.

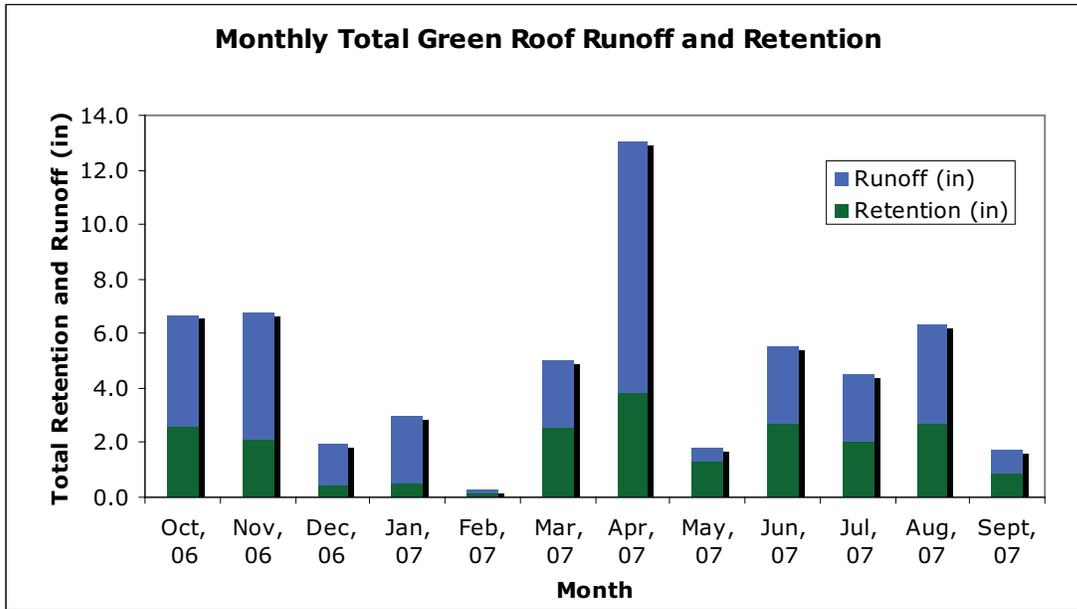
Figure 47: Monthly runoff and retention of stormwater by the Gratz green roof in New York City. Total bar (Runoff + Retention) height is equal to the total precipitation for events measured during each month.

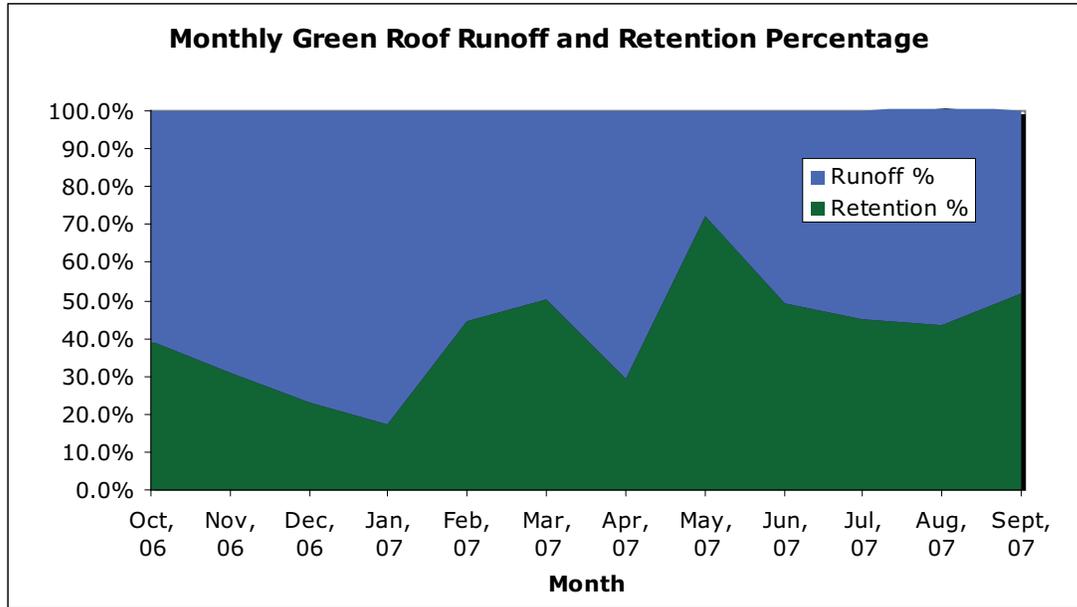
Figure 48: Stormwater runoff and retention as a percentage of the total precipitation of measured events for each month.

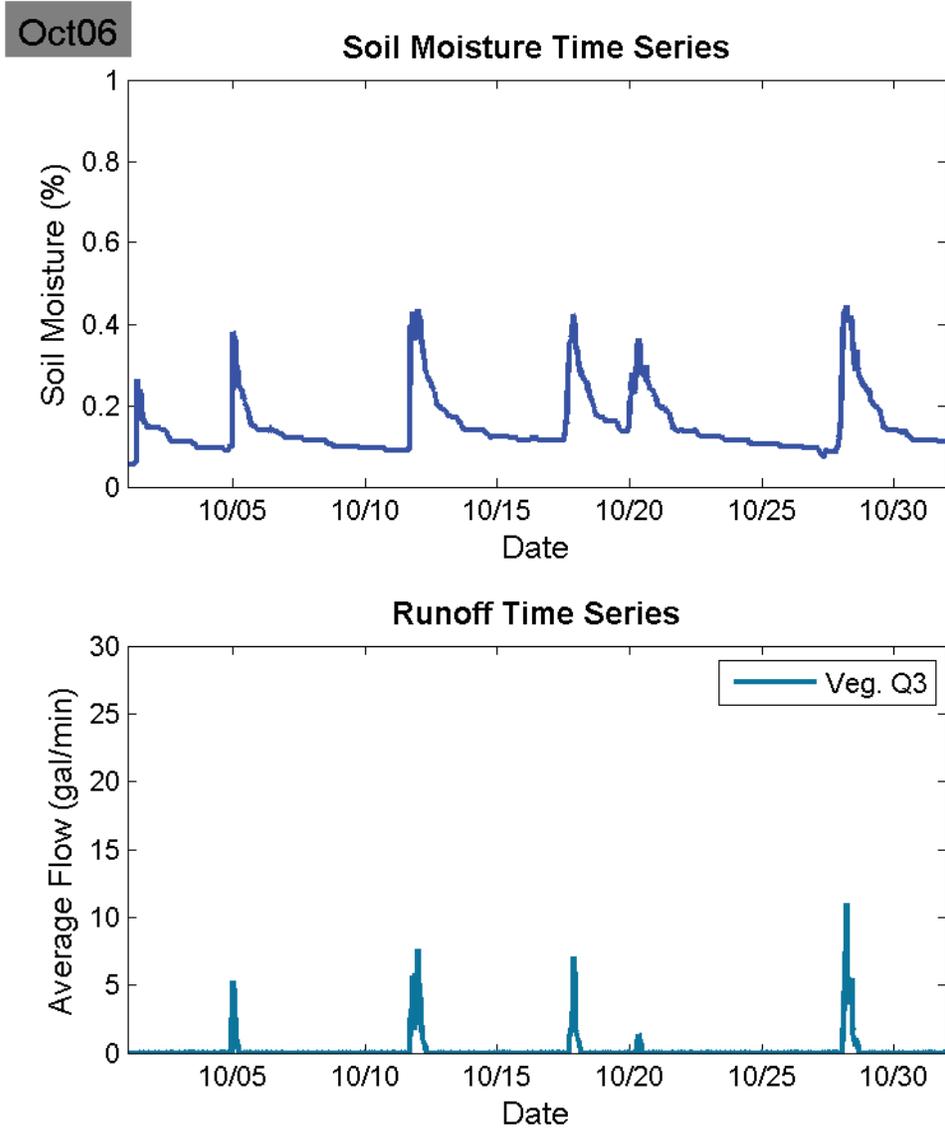
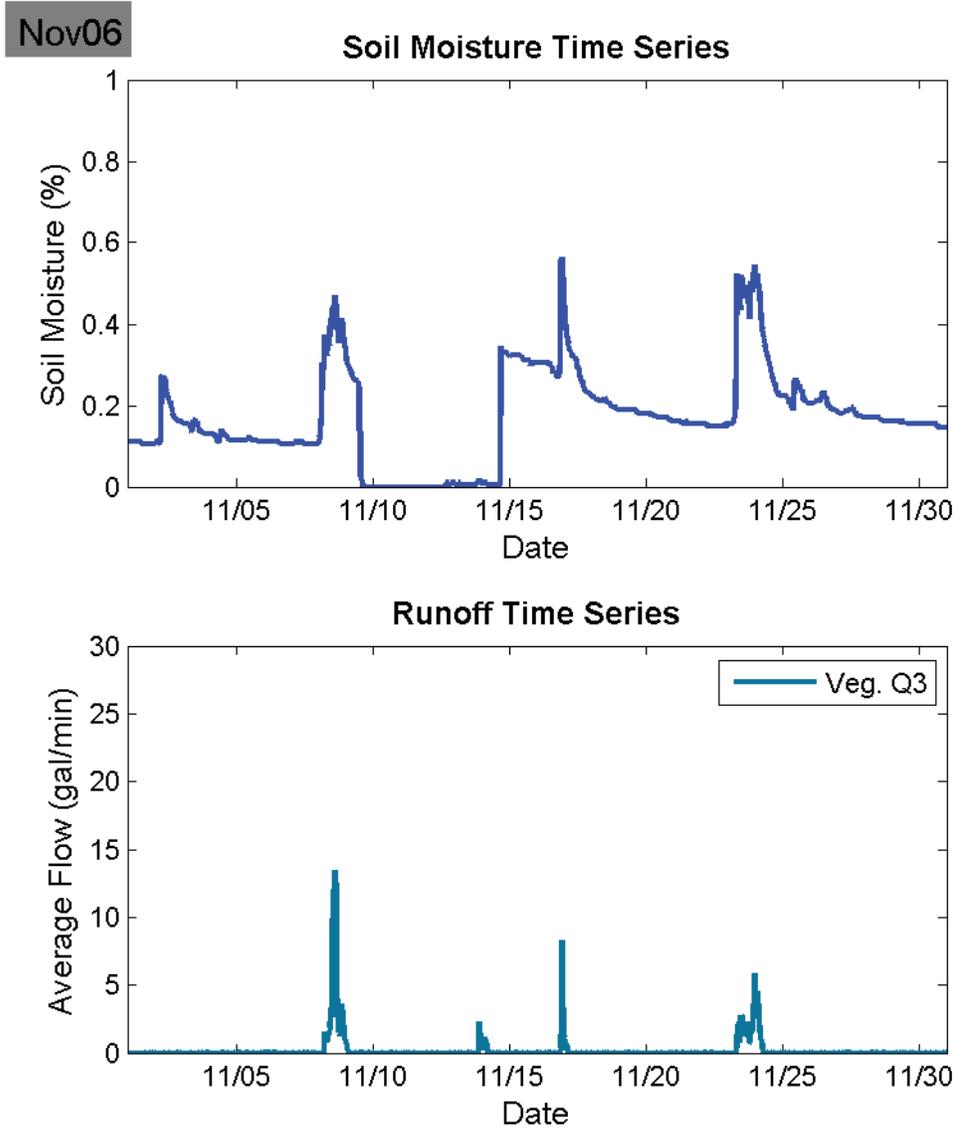
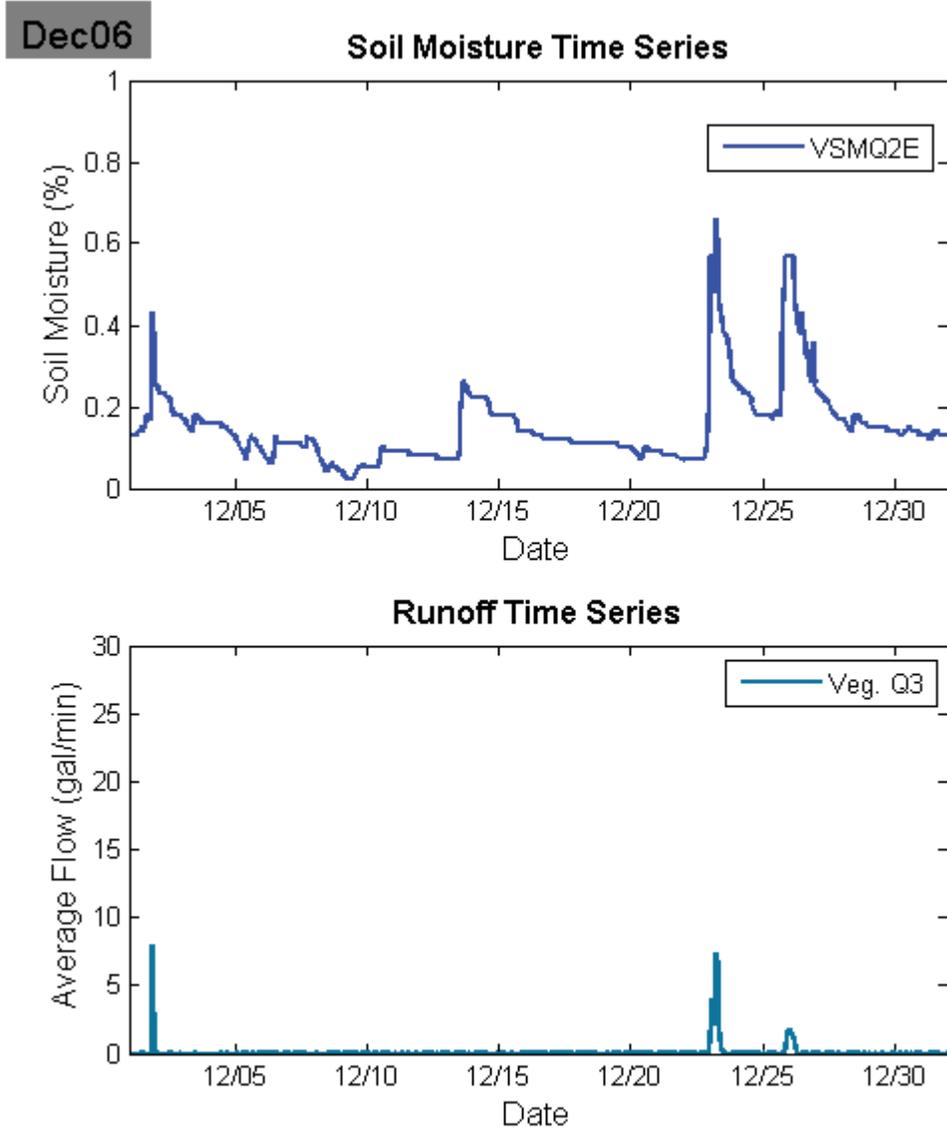
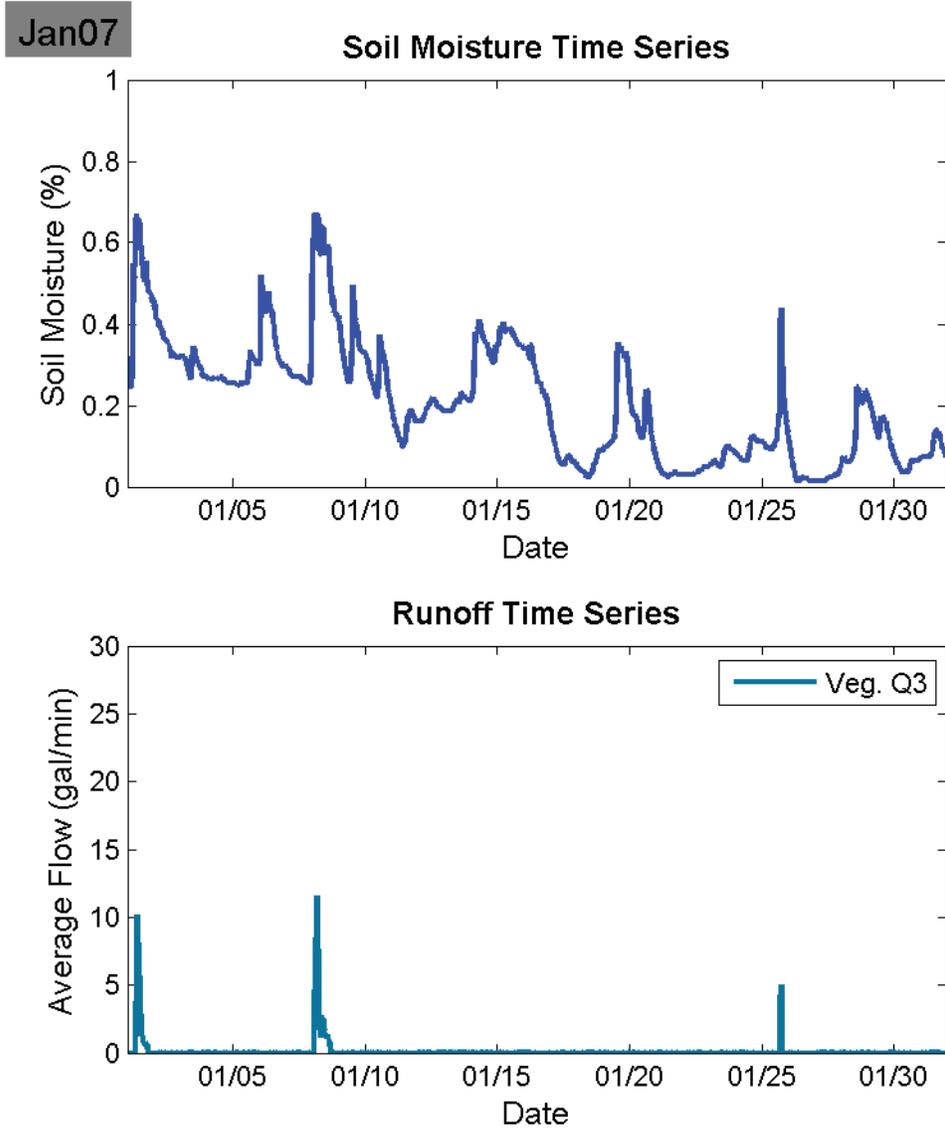
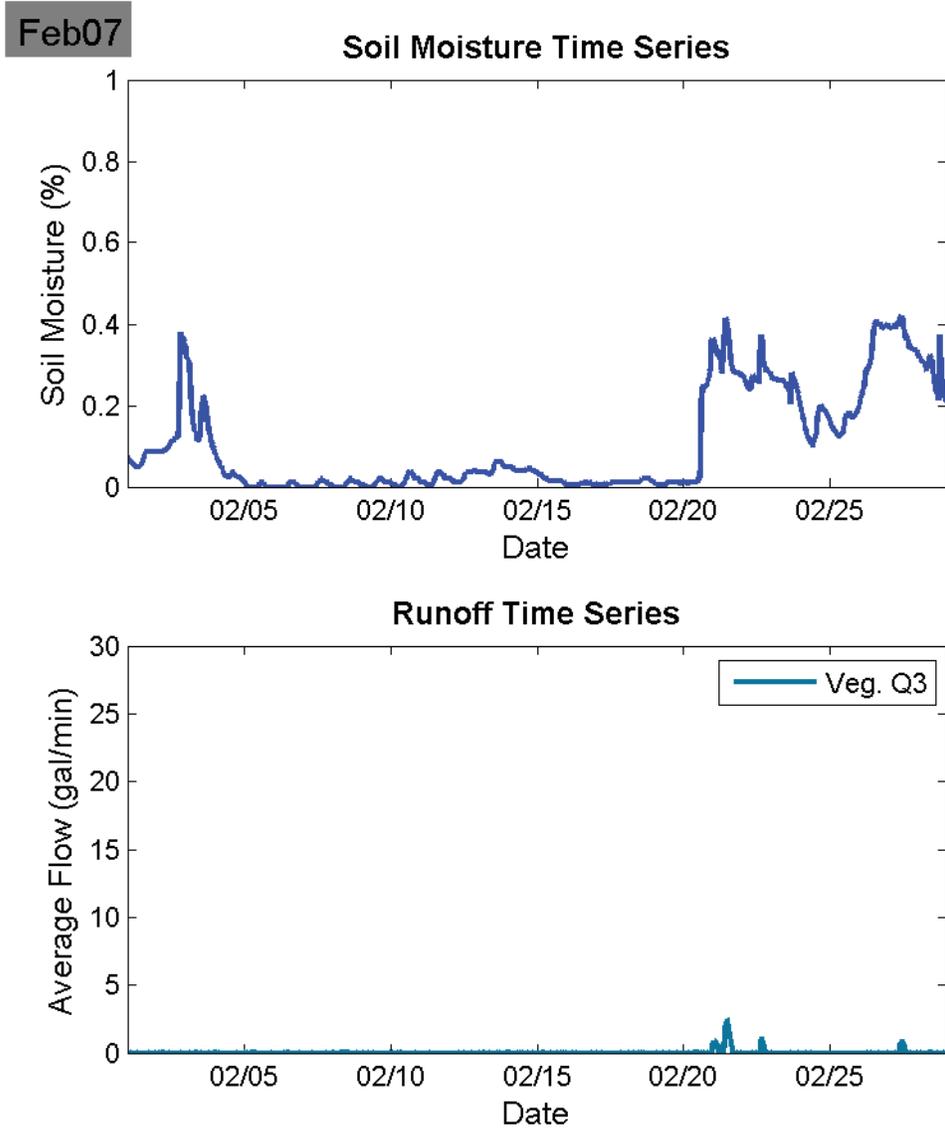
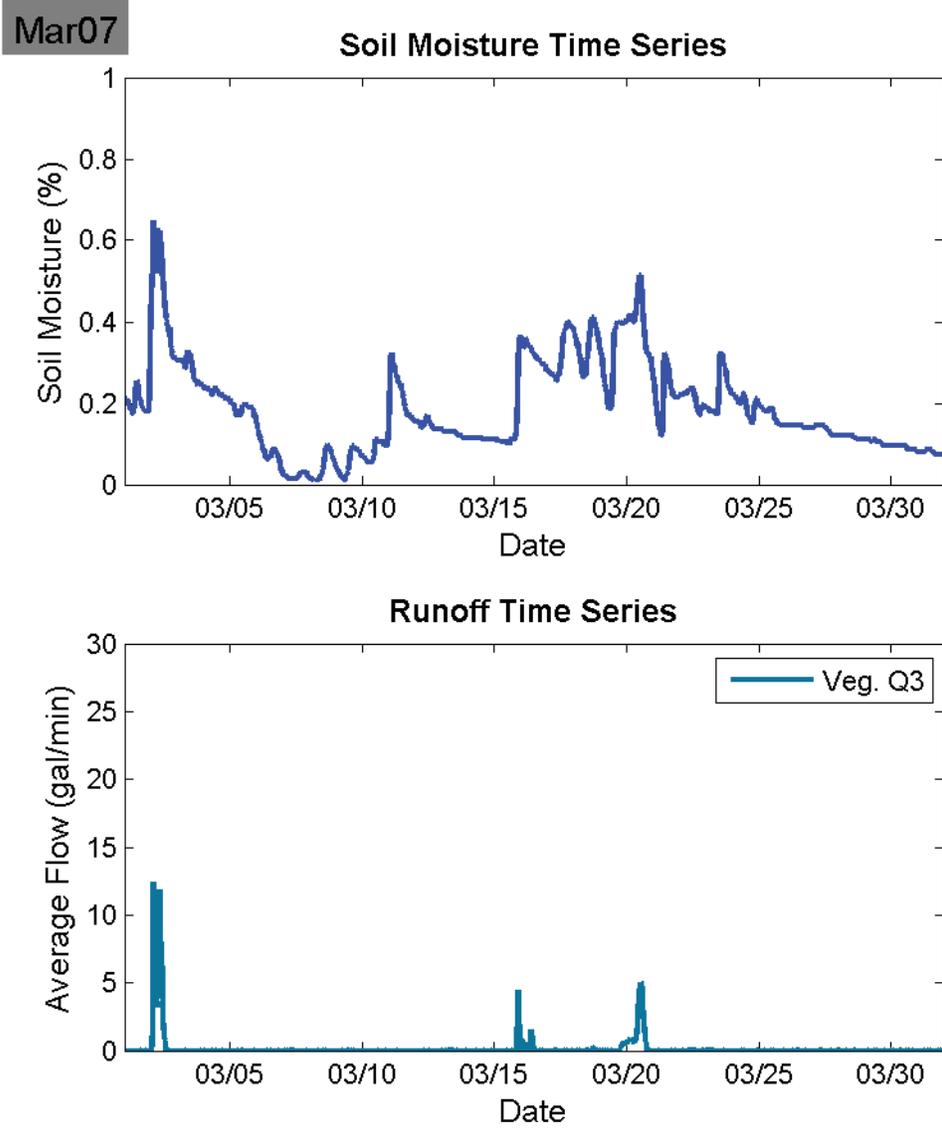
Figure 49: October 2006 Soil moisture (%) and Veg. Q3 runoff (gal/min).

Figure 50: November 2006 Soil moisture (%) and Veg. Q3 runoff (gal/min).

Figure 51: December 2006 Soil moisture (%) and Veg. Q3 runoff (gal/min). The quadrant III soil moisture (VSMQ3E) probe malfunctioned in this month, so in place of an average, only the quadrant II soil moisture (VSMQ2E) is shown.

Figure 52: January 2007 Soil moisture (%) and Veg. Q3 runoff (gal/min).

Figure 53: February 2007 Soil moisture (%) and Veg. Q3 runoff (gal/min).

Figure 54: March 2007 Soil moisture (%) and Veg. Q3 runoff (gal/min).
