**GREEN ROOF THERMAL AND STORMWATER
MANAGEMENT PERFORMANCE: THE GRATZ
BUILDING CASE STUDY, NEW YORK CITY**

**FINAL REPORT 09-05
DECEMBER 2010**

This report summarizes the findings for data collection from October 2006 to September 2007 on the Gratz Industries Green Roof Research Station. Notable for its large-scale innovative research design, this project addresses the deficiency in green roof thermal and stormwater data specific to the New York City region. In conjunction with the in-situ monitoring data and analysis, this report also includes thermal modeling of the Gratz building given conventional and green roof scenarios as well as runoff water quality results. The results of the monitoring during this period showed that green roofs are capable of lowering the maximum conventional roof membrane (surface) temperatures by as much as 35°C and reduces diurnal temperature fluctuations by as much as 30°C. While the conventional roof membrane temperatures frequently exceeded 70°C in the summer months, for the green roof the temperatures were consistently below 50°C. Reductions in temperature fluctuations decrease the stress on roof membranes thereby extending its useful duration. I

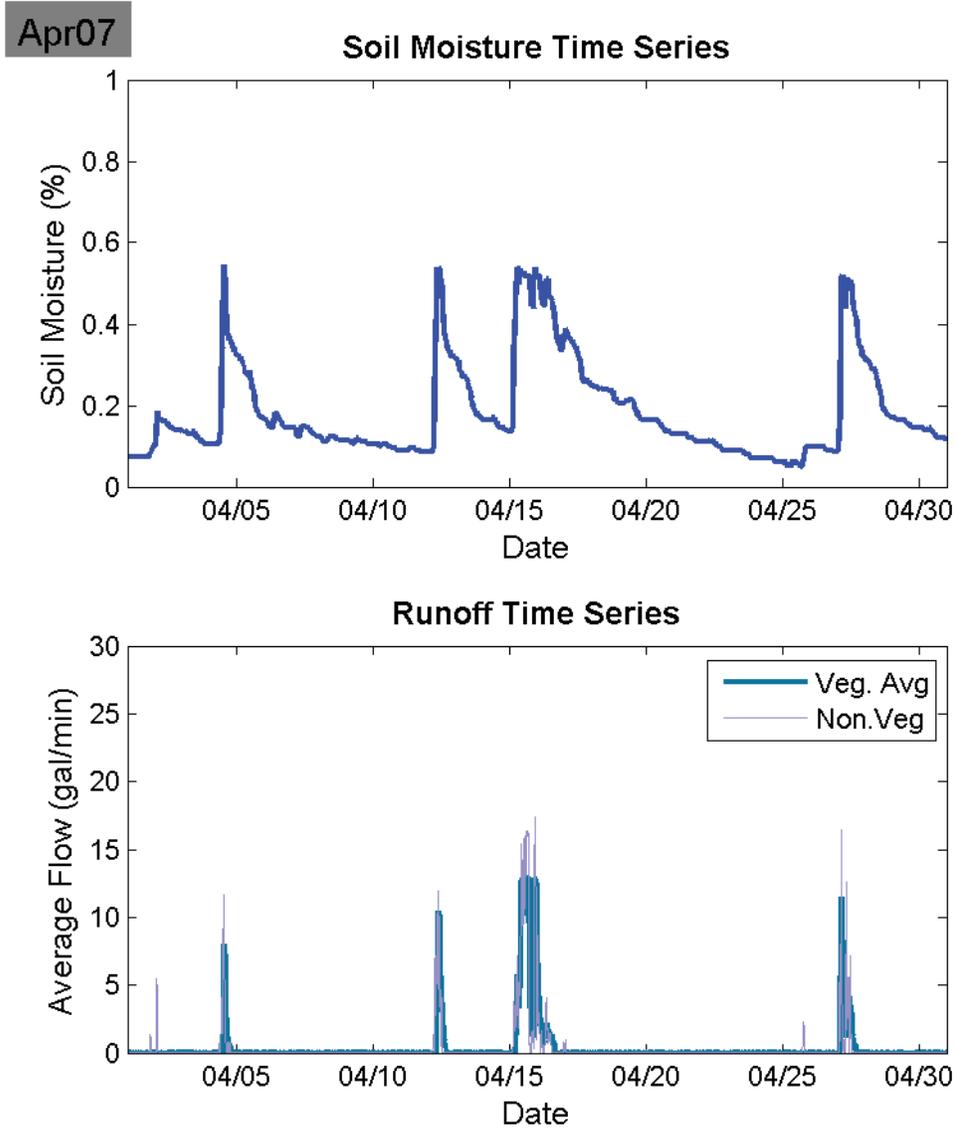
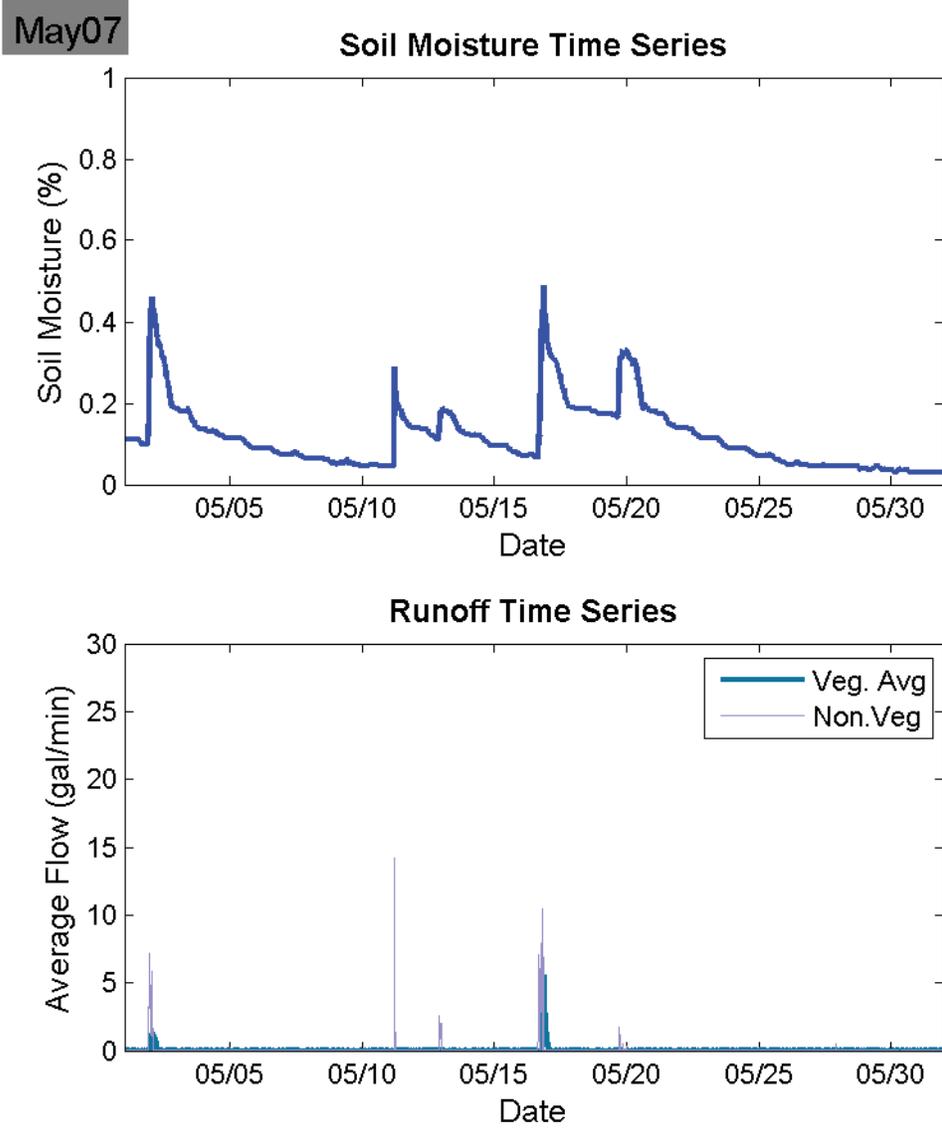
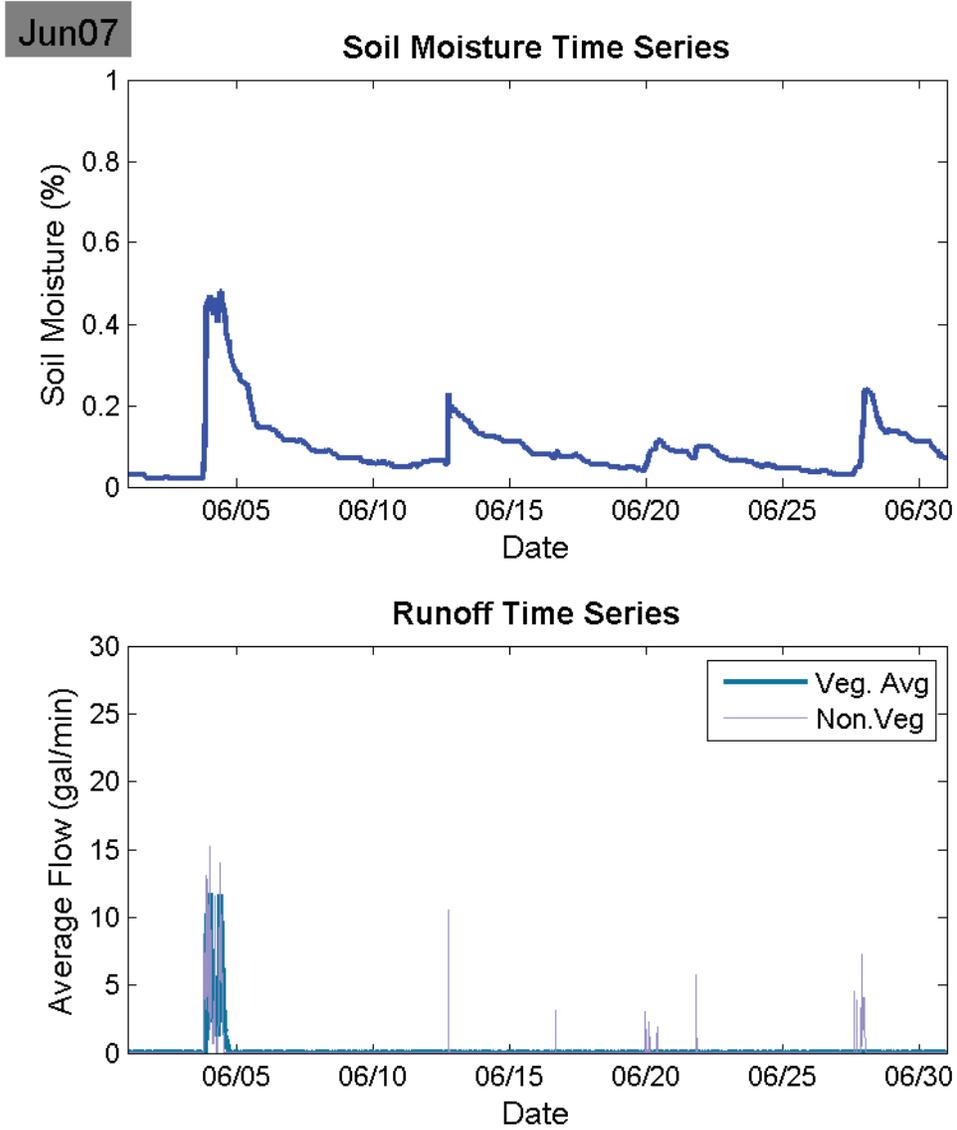
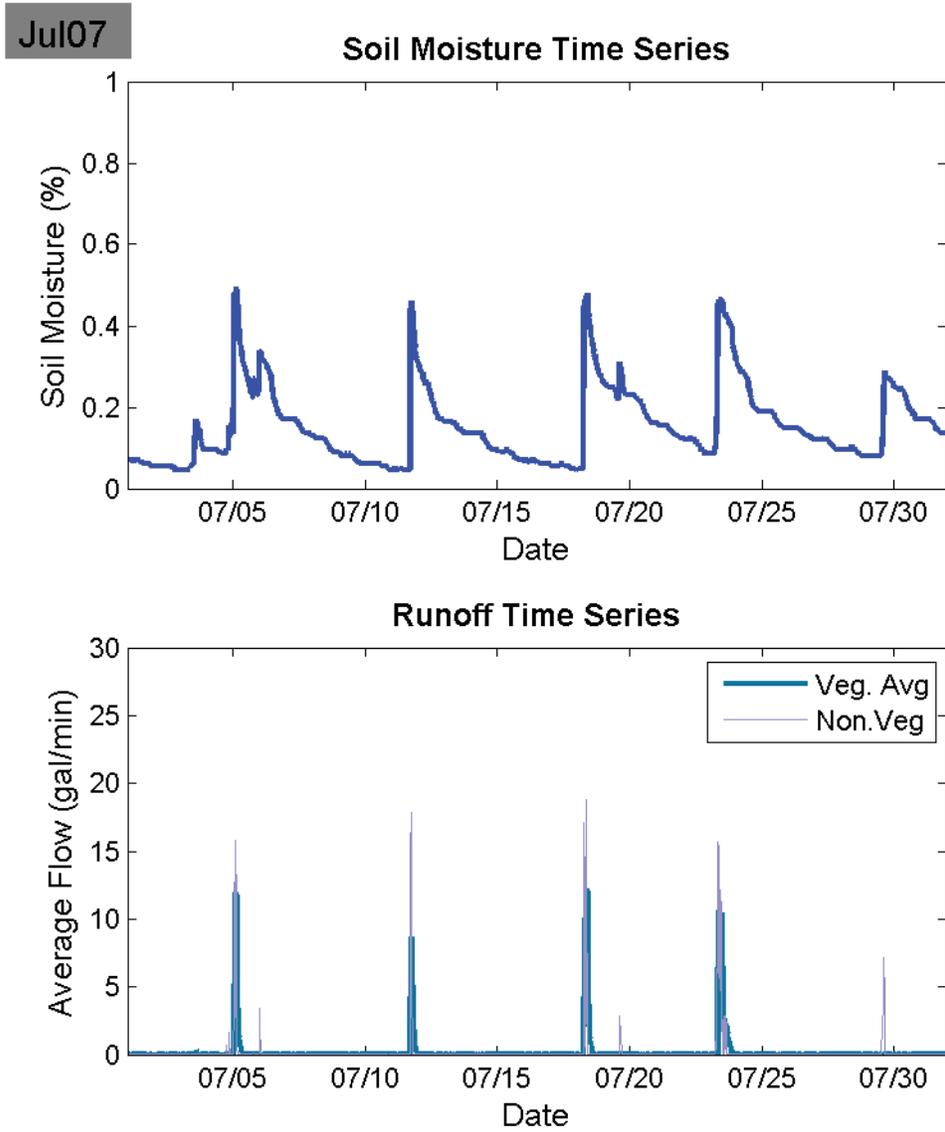
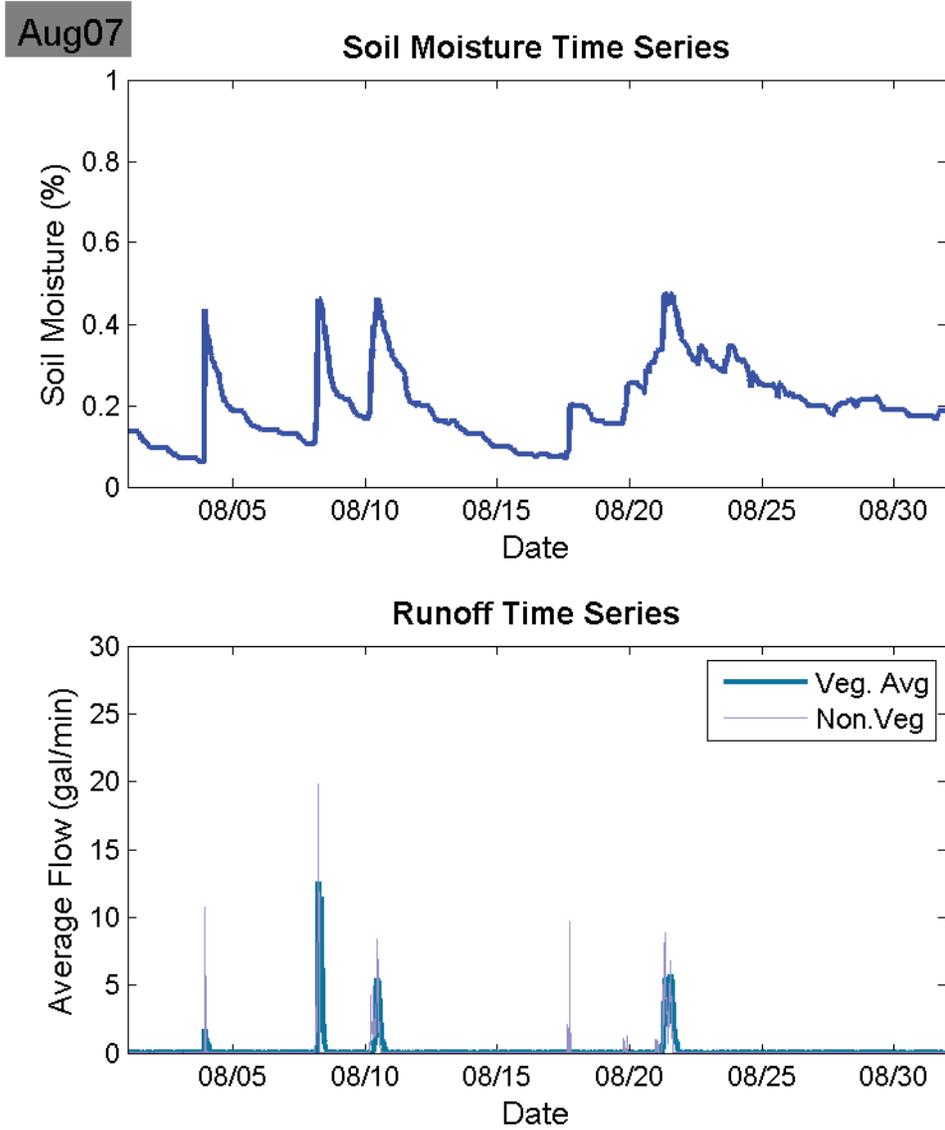
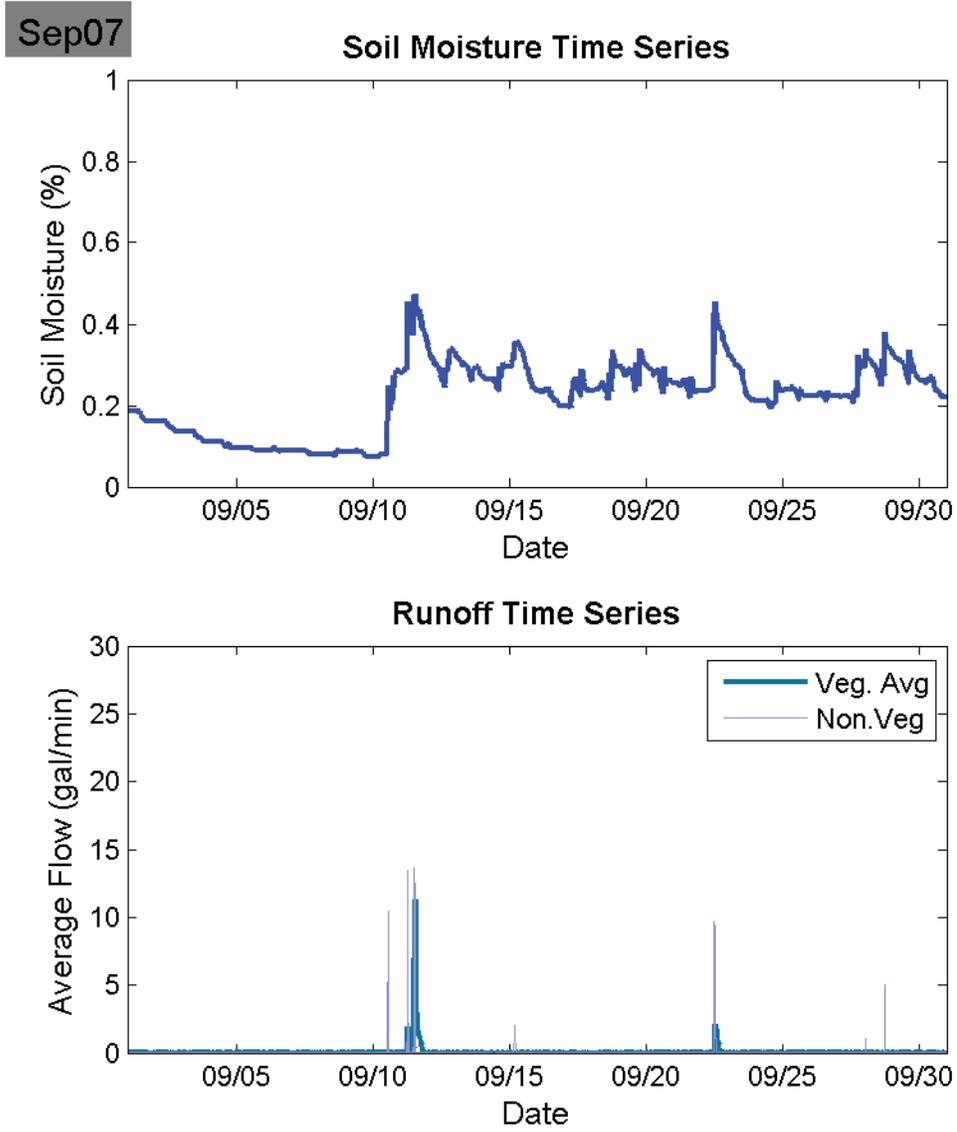
Figure 55: April 2007 Soil moisture (%) and Veg. Avg. runoff (gal/min).

Figure 56: May 2007 Soil moisture (%) and Veg. Avg. runoff (gal/min).

Figure 57: June 2007 Soil moisture (%) and Veg. Avg. runoff (gal/min).

Figure 58: July 2007 Soil moisture (%) and Veg. Avg. runoff (gal/min).

Figure 59: August 2007 Soil moisture (%) and Veg. Avg. runoff (gal/min).

Figure 60: September 2007 Soil moisture (%) and Veg. Avg. runoff (gal/min).

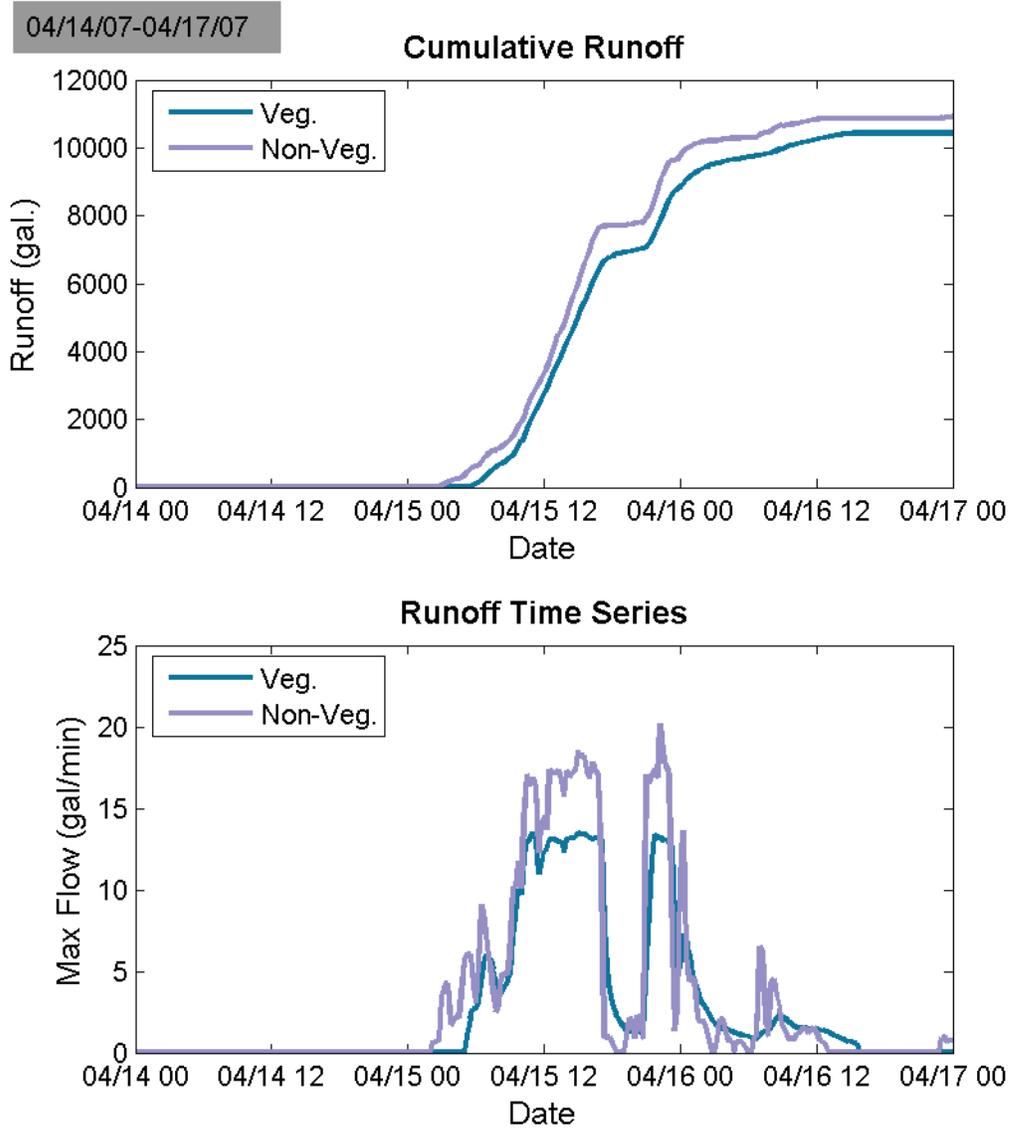
Figure 61: Runoff from Gratz vegetated and non-vegetated control roofs. Total precipitation in excess of 8".

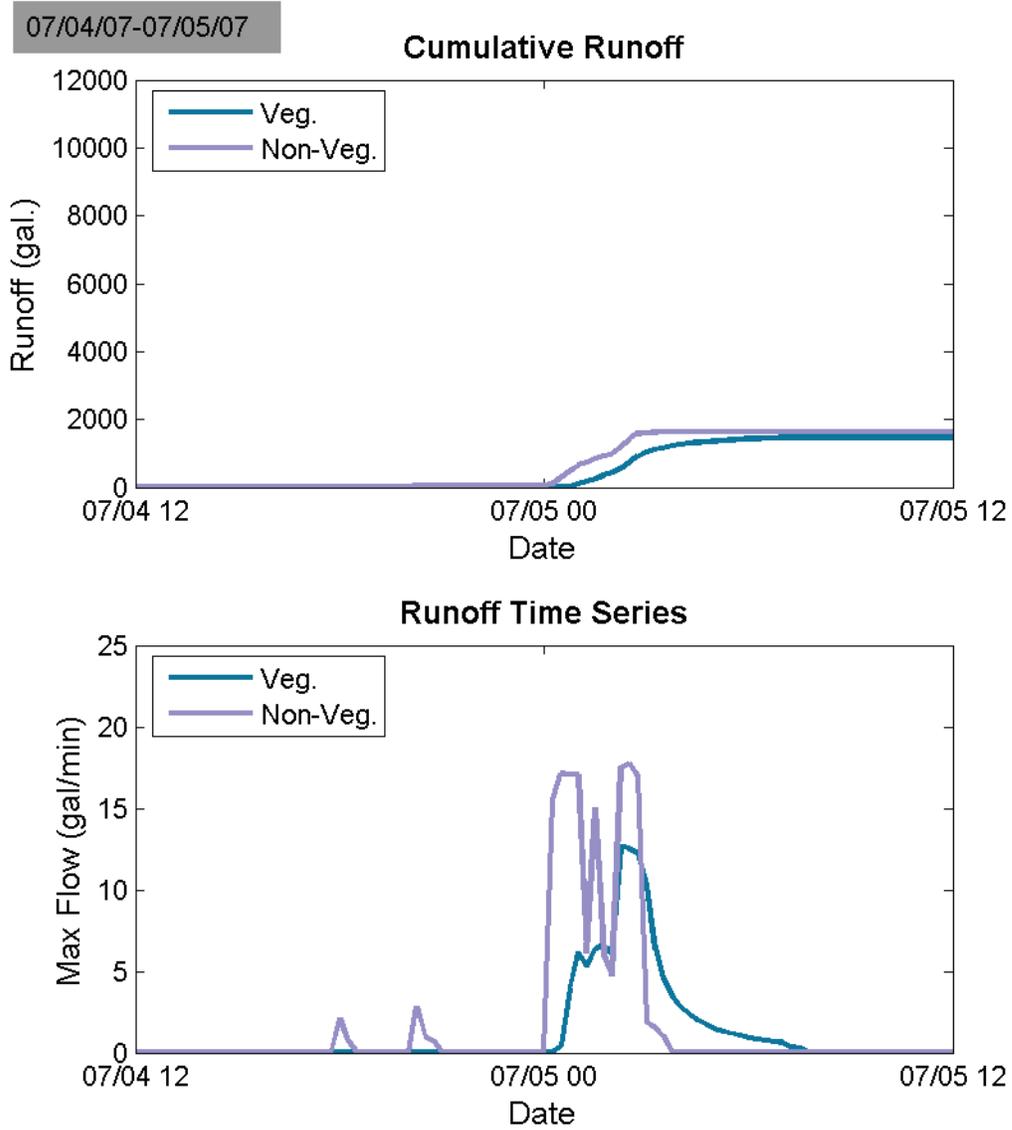
Figure 62: Runoff from vegetated and non-vegetated control roofs for a 1.4” summer rain.

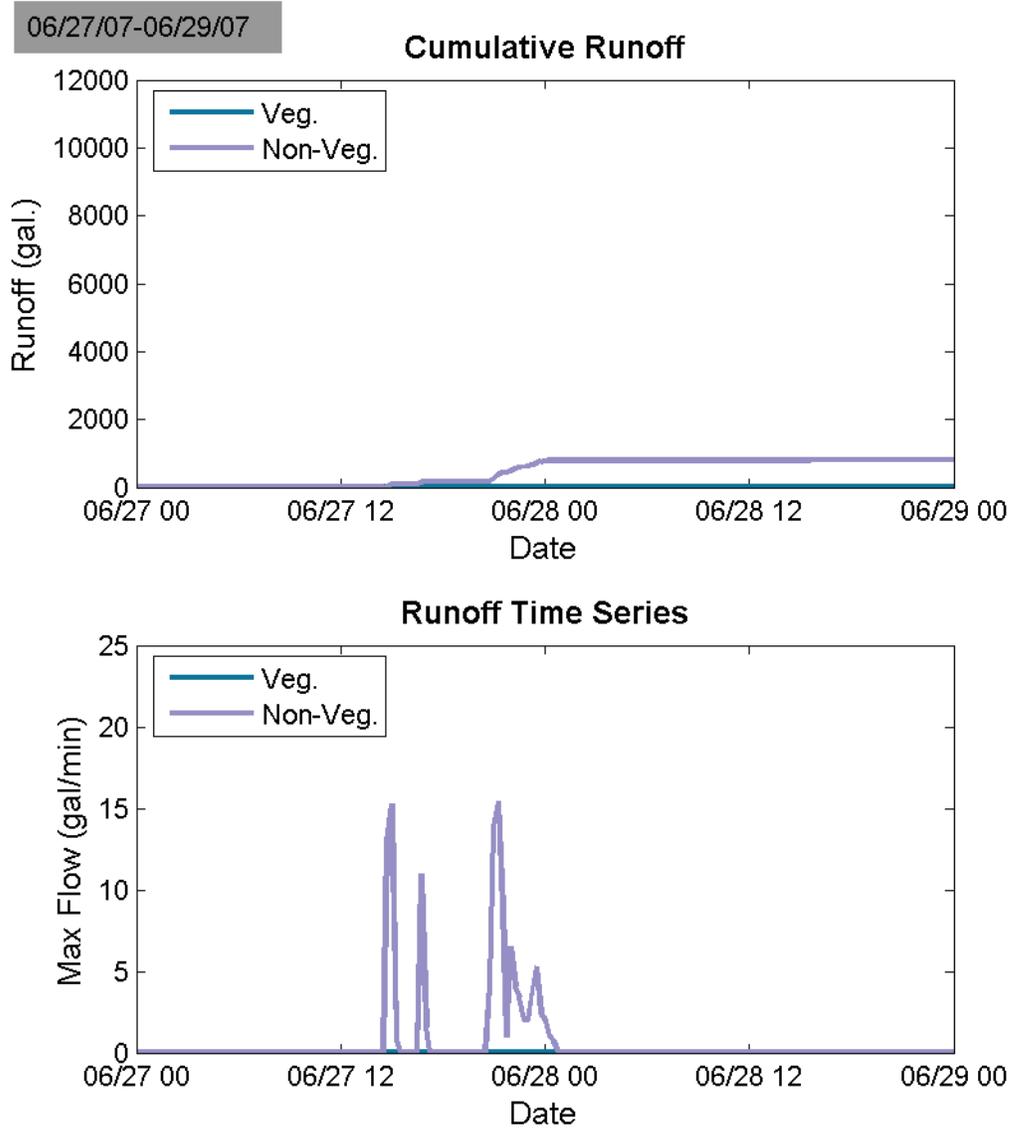
Figure 63: Runoff from control and vegetated roof sections for a typical summer rain of under ½ inch (~10 mm).

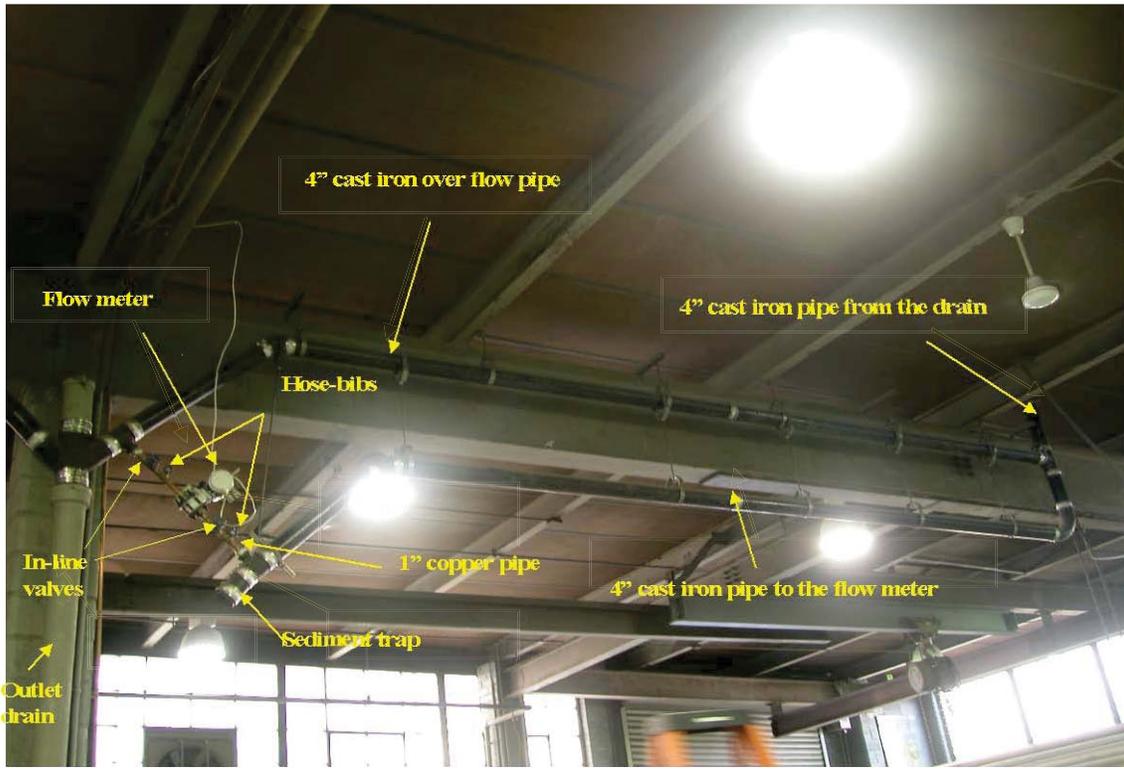
Flow meter installation at Gratz Industries

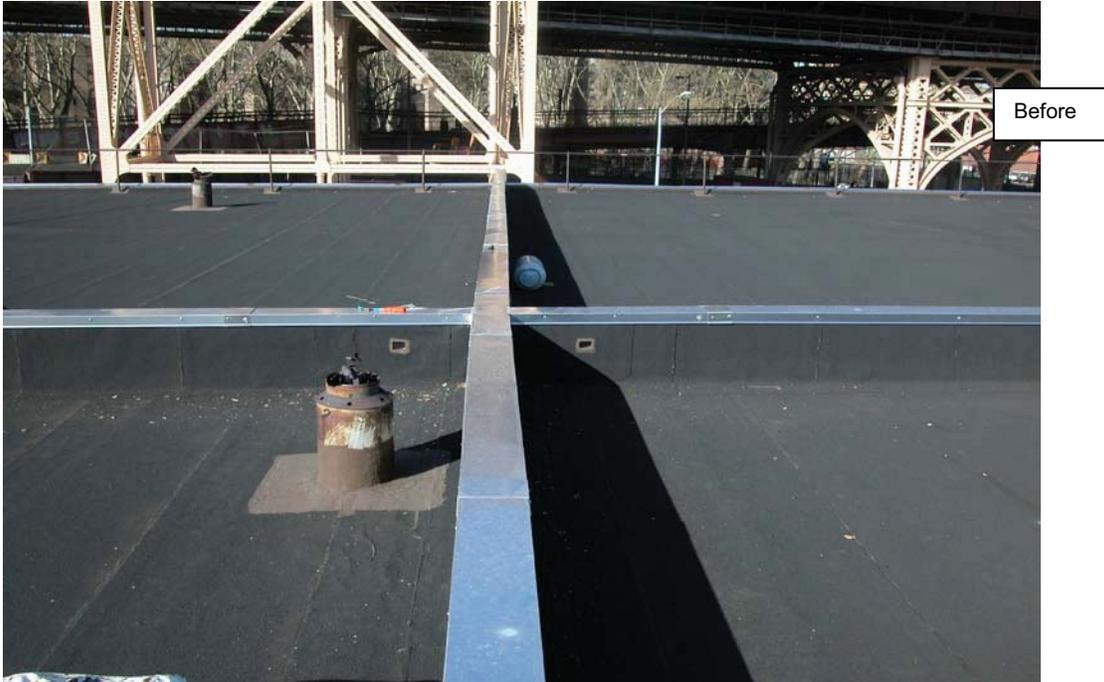
Four experimental quadrants at Gratz Industries before and after green roof installation

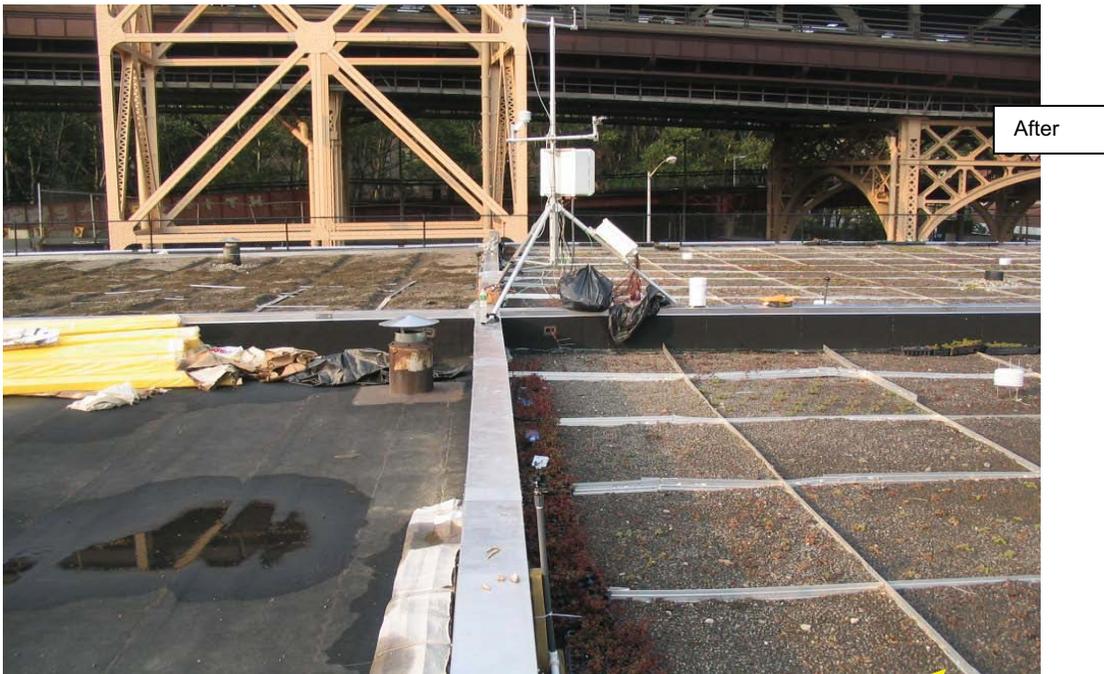
Thermocouple wires, flow meter wires, power cable and telephone cables run out of the gooseneck from the building at Quad I

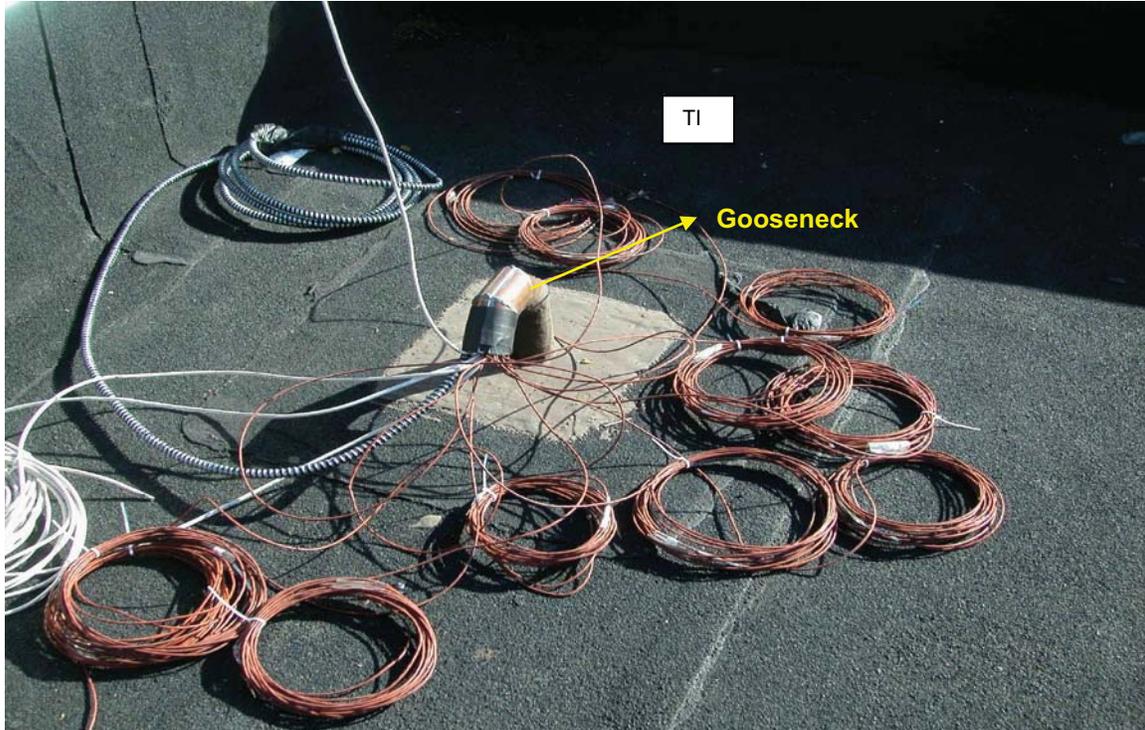
Installation of sensors at the rooftop of Gratz Industries building

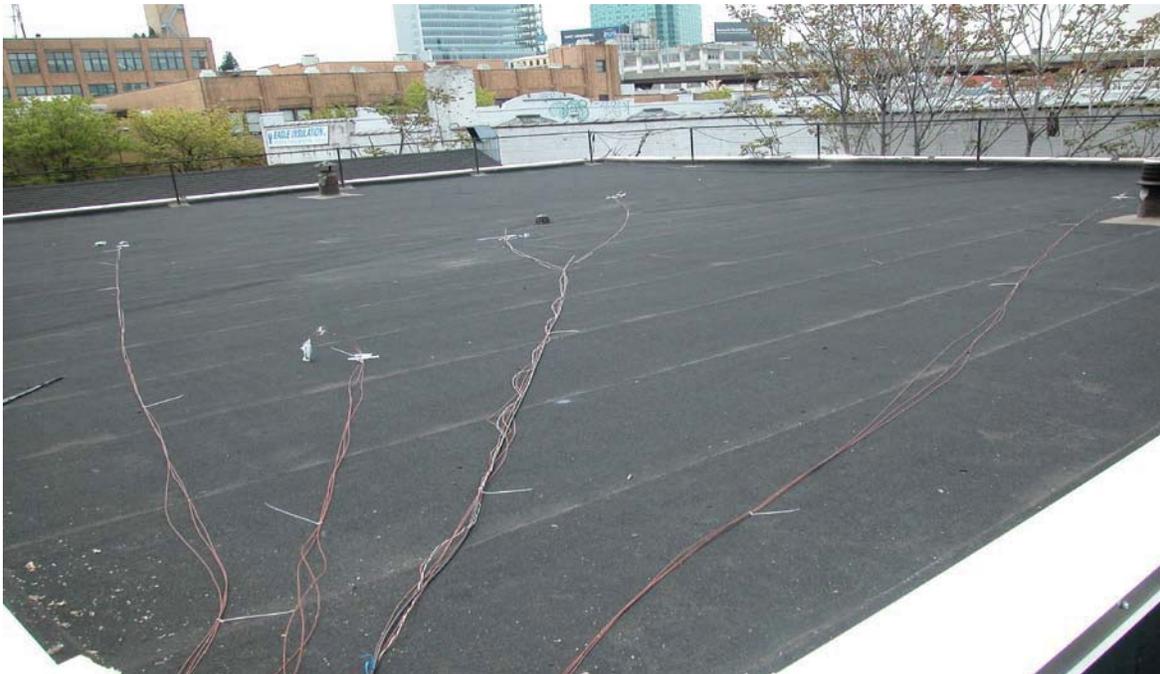
Installation of TI, TM, TT and TA Thermocouples. TI is at the ceiling inside the building. TA is covered by radiation shield.
