State-Licensed Disposal Area at West Valley: 2022 Annual Report

Final Report | March 2023 | Reissue June 2023

State-Licensed Disposal Area at West Valley

2022 Final Report

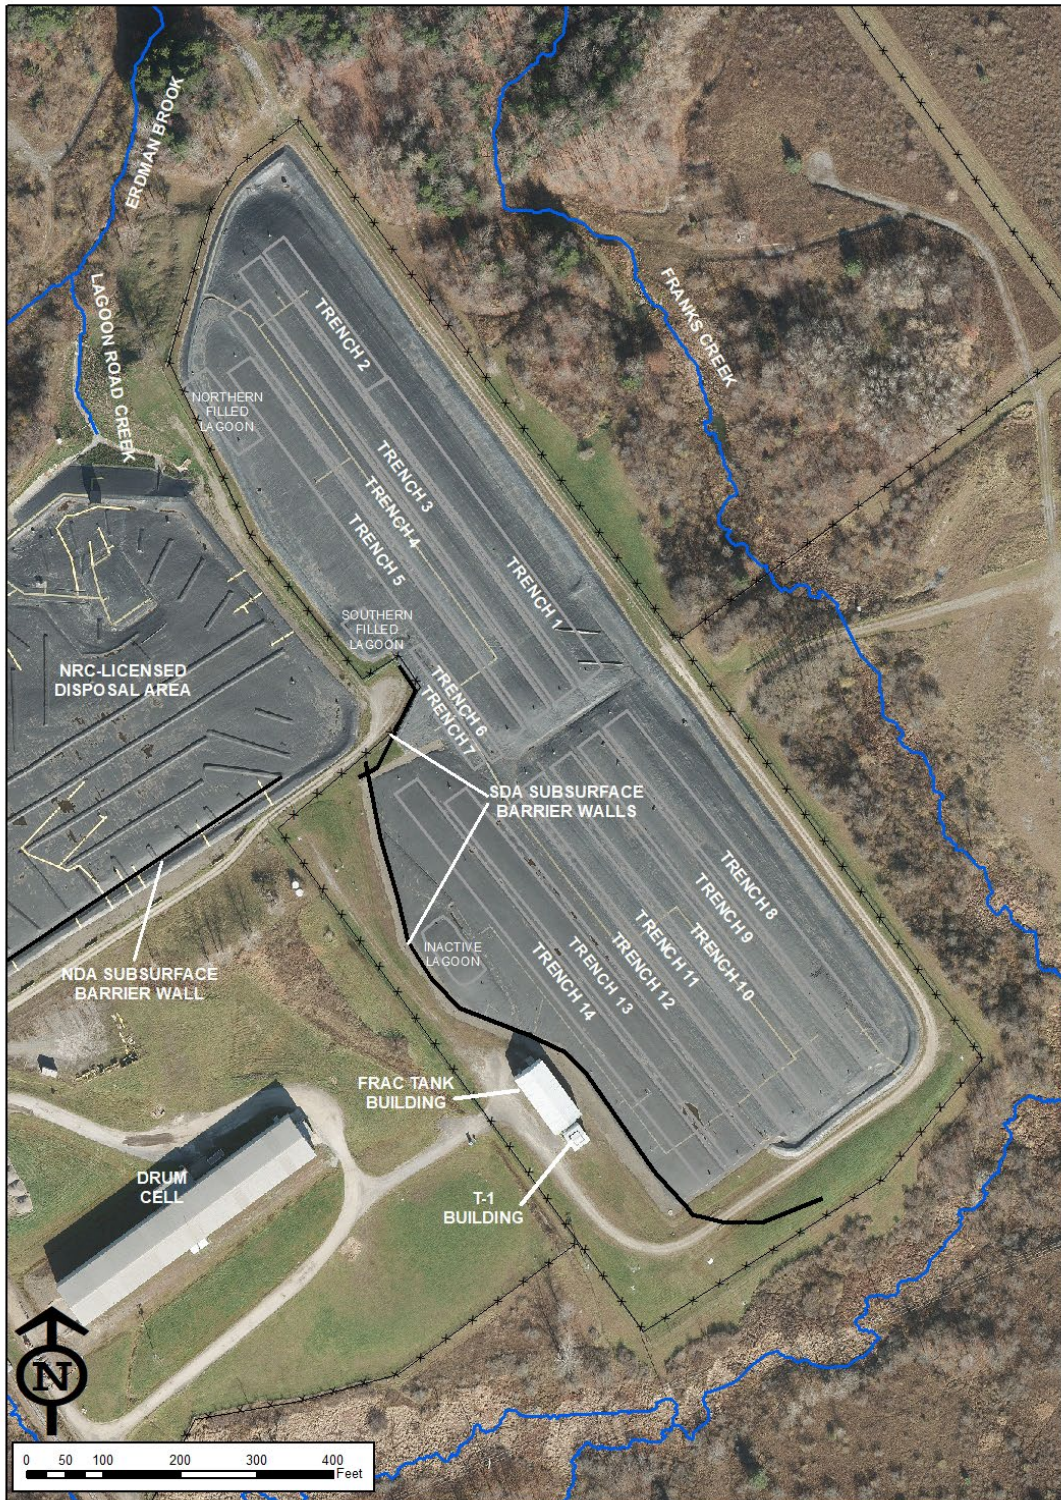
Figure 1-2. Aerial Photograph of the SDA

The SDA occupies approximately 15 acres of the WNYNSC (Figure 1-1) immediately adjacent to the West Valley Demonstration Project (WVDP). The SDA consists of three filled lagoons and two sets of parallel trenches that contain radioactive waste: 1 through 7 in the northern area and 8 through 14 in the southern area (see Figure 1-2). The SDA is surrounded by an eight-foot-high, chain-link fence, which includes a one-foot barbed-wire outrigger. NYSERDA controls access to the SDA by limiting the issuance of keys to the six, locked SDA gates. In addition, a contracted security service conducts routine patrols of the SDA's perimeter.

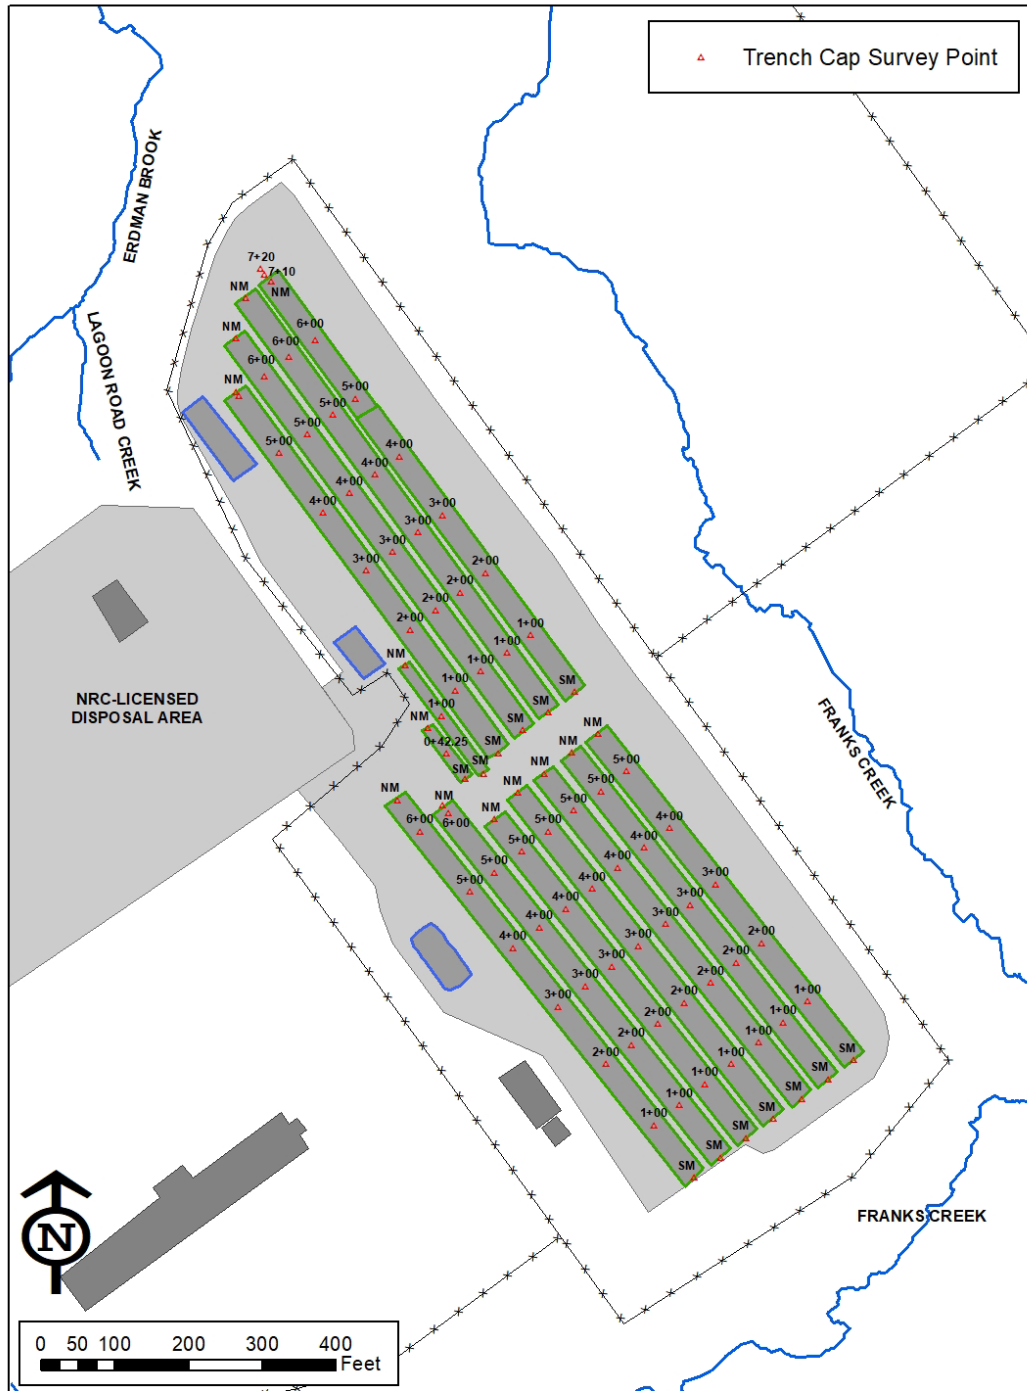
Figure 4-1. Trench Cap Ground Surface Elevations Survey Points

Areas of settlement were observed in 2013 on the southernmost 100-foot sections of Trench 13 as well as the northern area of Trench 14. Since 2014, NYSERDA has conducted quarterly focused topographic surveys in each of the areas identified above using a 10-foot grid pattern to monitor the rate of subsidence. A very slight decreasing trend of downward movement since 2013 has been identified. The current data collected indicates that this downward movement has stabilized and the changes in elevation are within the measurement error uncertainty. NYSERDA will continue to monitor these areas annually.

capabilities of the settled trench cap surface after the installation of the geofoam panels. The settlement gauge elevation measurements have remained very stable and within the measurement error uncertainty.

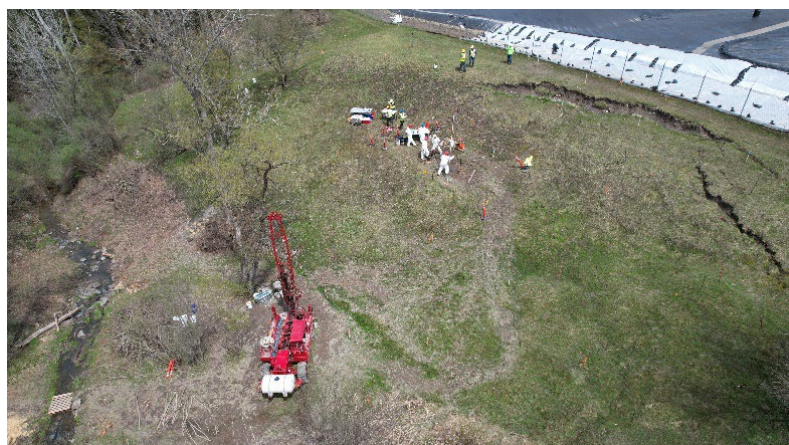
Figure 4-2. Aerial view of Geotechnical Investigation

In the spring of 2022, NYSERDA’s contractors installed 22 soil borings to determine the source of the soil slumping along the North Slope (see Figure 4-2). The borings were monitored for movement and based on the data collected, the investigation concluded that the soil slumping was in the soil that had been placed on the North Slope during the mid-1960s construction of the SDA trenches, and the soil slumping was not occurring in the deeper soils on the slope.

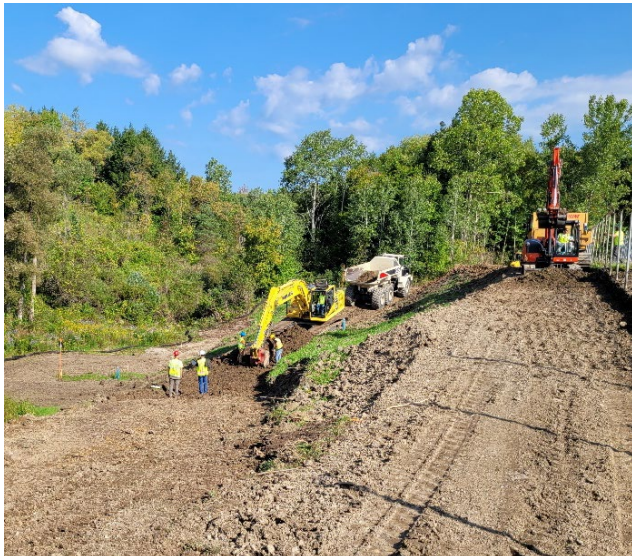
Figure 4-3. Loose soil removal from the North Slope

The design focused on the removal of the approximately 4,000 cubic yards of loose soils from the North Slope down to the deeper more structurally competent soil (see Figure 4-3). The loose soils were placed in one of two soil staging areas for final characterization in 2023.

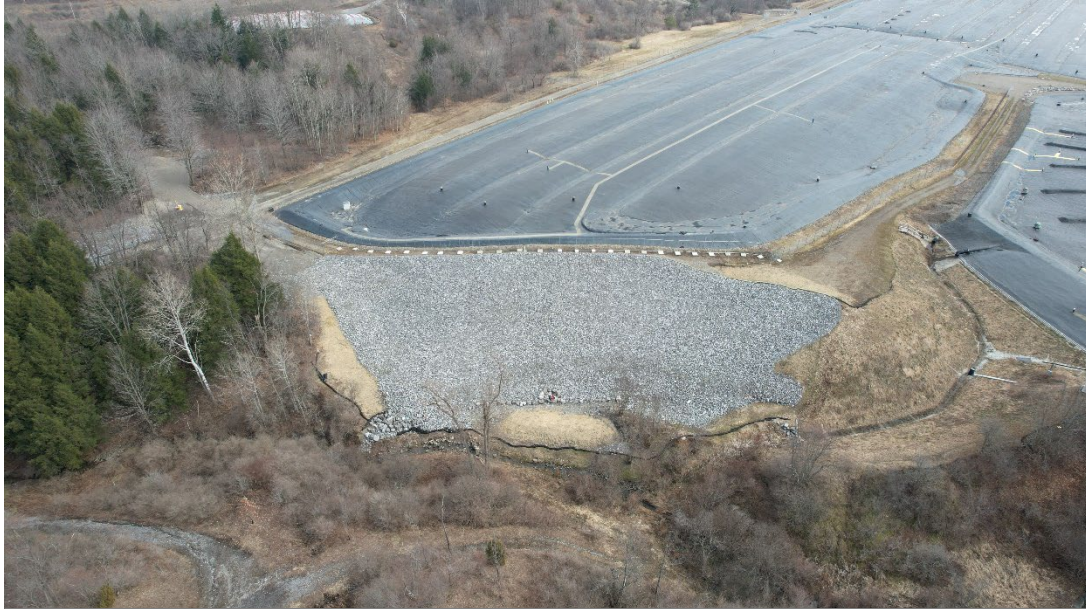
Figure 4-5. Aerial view of the completed North Slope Stabilization Project

Finally, the steepness of the slope was reduced to a more stable geometry through the replacement of these soils with sand and bedding stone followed by layers of larger limestone. The total quantity of stone and sand placed on the slope was approximately 3,145 cubic yards.

Site restoration to fully complete this project is scheduled for the spring of 2023 (see Figure 4-5).
