netZero Village:

A Commissioning and Third-Party Measurement and Verification Report

Final Report | Report Number 19-10 | February 2019

Taitem Engineering, PC

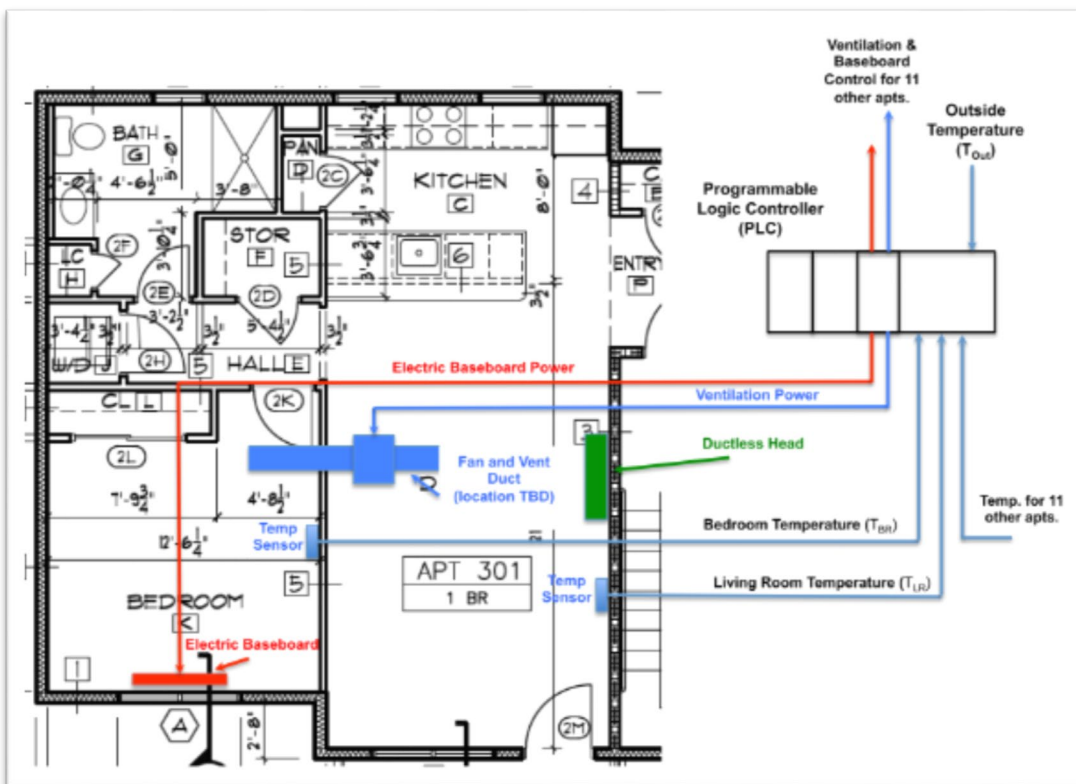
Figure 2: Apartment HVAC System Schematic

Mechanical heating and cooling of each apartment is supplied by a single-head ductless mini-split heat pump located in each apartment's living room. This single heat pump was sufficient to condition the entire, multiple bedroom apartment in most cases.

A transfer fan between the living room and bedrooms and a single section of electric baseboard were installed in each primary bedroom to supplement the heat pump if needed. These systems are controlled with a program created and implemented by the developer and only operate when certain outdoor and space temperature conditions are met.

Schematic drawing of a typical apartment with key HVAC systems and their connection to the developer provided supplemental heat control system.

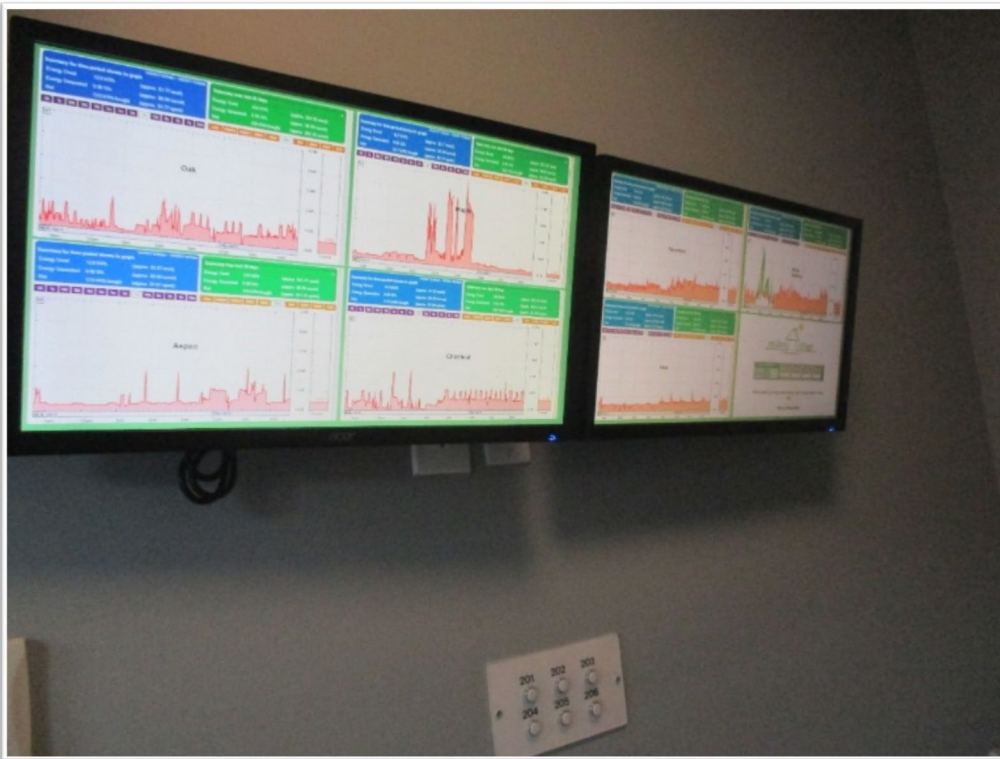
Figure 3: Behavior Modification System

eGauge brand smart meters were installed on each apartment electric meter to track and influence occupant behavior by providing real-time feedback on their usage. Usage data from each apartment is tagged with a unique, randomly assigned identifier and displayed on a screen located in the building entrance.

Photo of usage display screens in apartment vestibules.

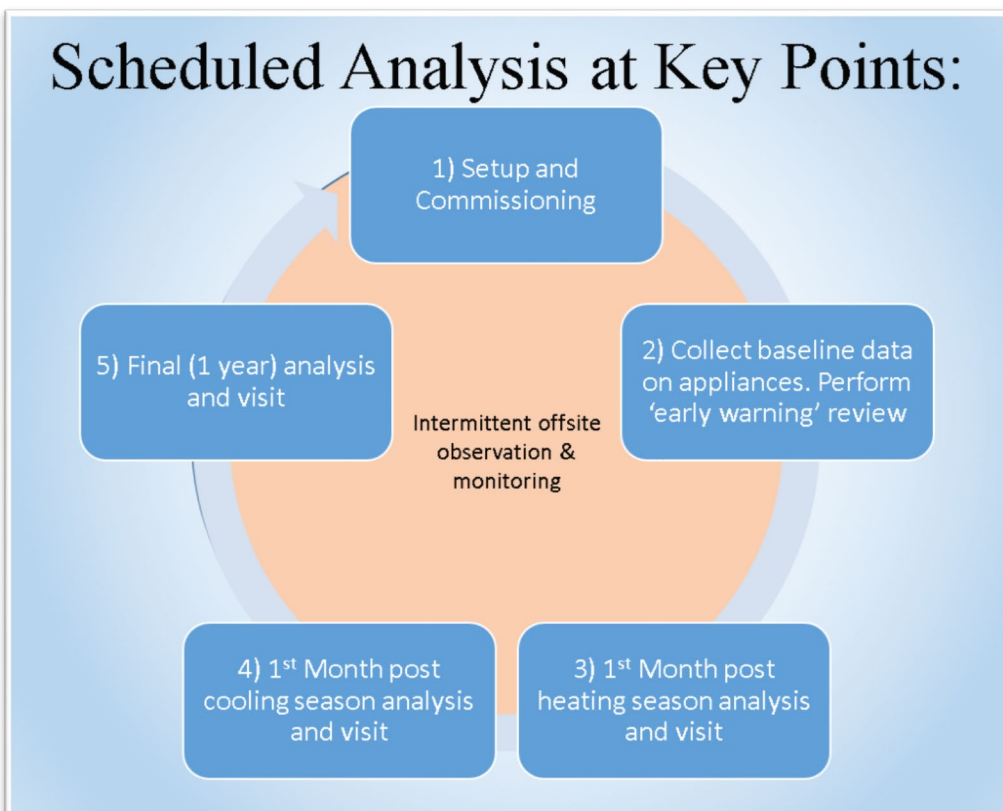
Figure 4. Cyclic Analysis Diagram

Three key points were targeted for the preliminary, early-warning rounds of analysis. The first round was planned to occur after the first month of occupancy, catching any significant issues, but not necessarily tied to any specific weather conditions. The next round of analysis was planned to occur after the first month of heating use (identifying issues with heating systems), followed by another analysis after the first month of cooling use.

Graphic of task flow and scheduled analysis targets for commissioning and measurement and verification processes. Circular diagram intended to show continuing pattern and ongoing intermittent involvement as well as key interaction points.

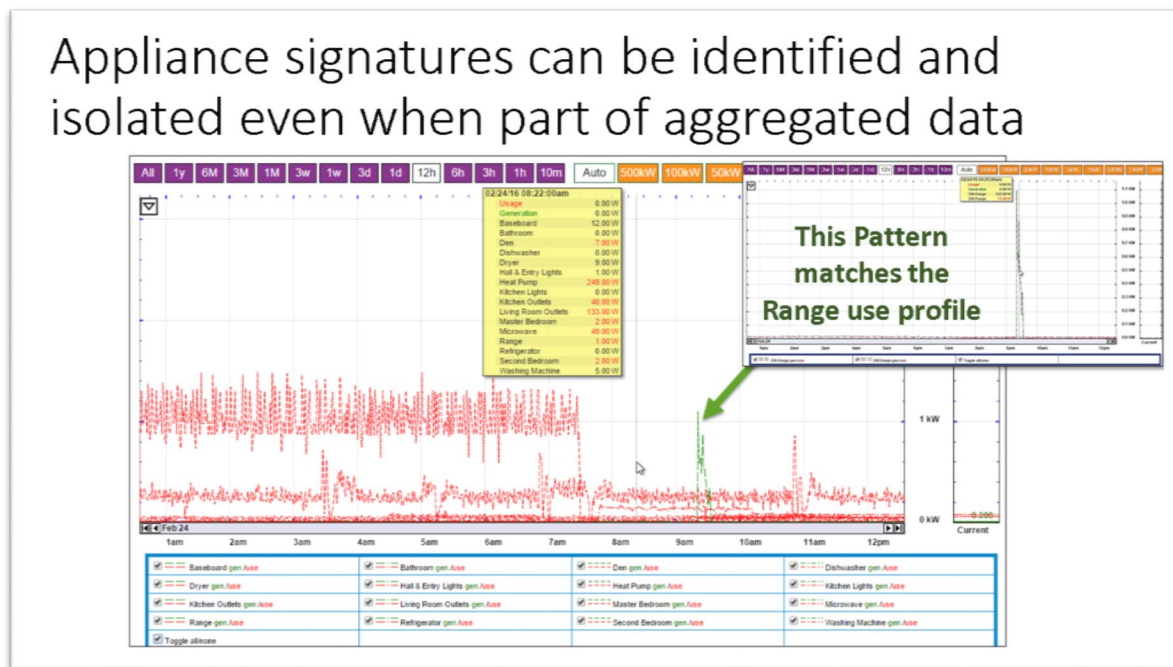
Figure 5. Identifying Appliance Use Signatures

Adopting sampling strategies to cost effectively monitor specific end loads in a subset of the apartments is one way to begin to gather data on how the different appliances and systems contribute to the apartment usage. Typically, a small sample of devices would be monitored, and assuming similar use was observed, their average usage levels attributed to the rest of the units.

Display of multiple end uses from an apartment with a single use pattern isolated and highlighted in green.

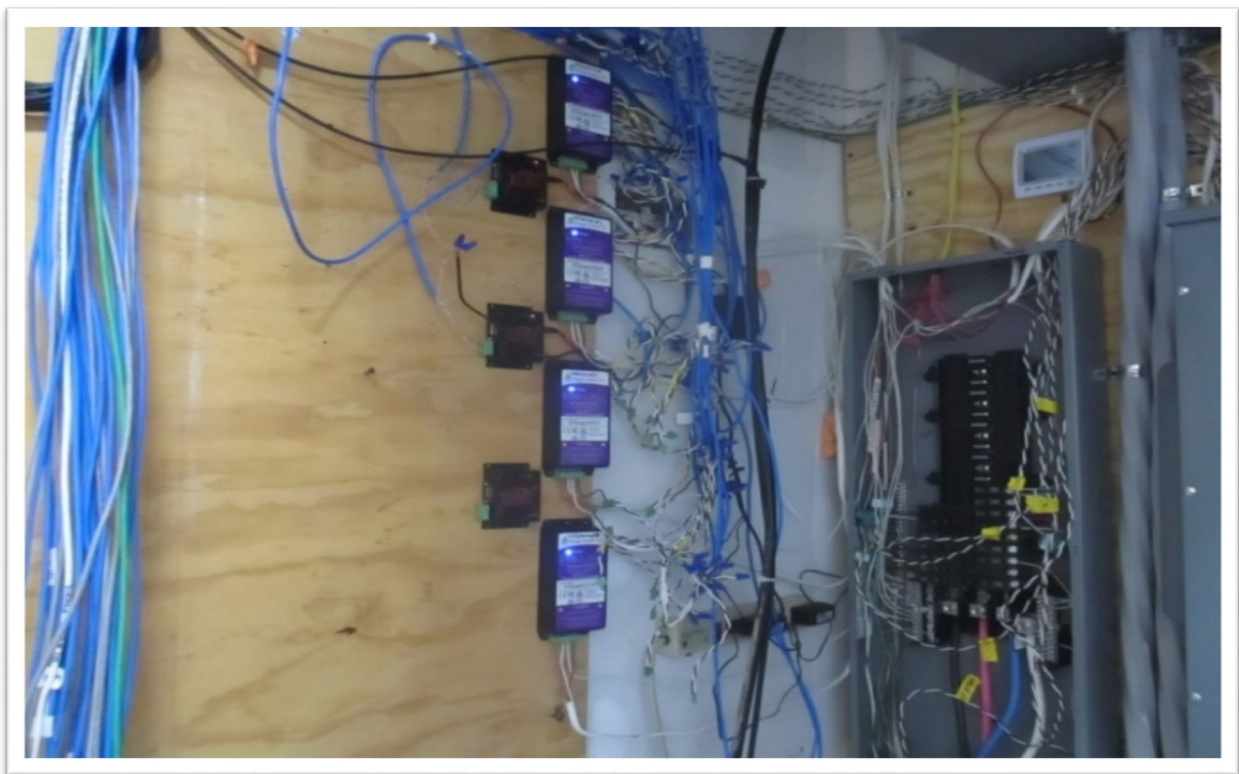
Figure 6. eGauge Monitoring System Setup—Central eGauge Systems

By running CAT5 cable from a central utility room to each apartment electrical panel while the building was in construction, capability was built in to move sensors from one apartment to another, and between different end loads, as needed. This allowed us to use a single set of equipment⁹ to collect more specific information on any units with higher than anticipated use, and to shift the investigation focus to specific sets of appliances.

Photo of several eGauge units installed in the common utility room. CAT5 cable run from the apartments is connected to each monitoring unit as required.

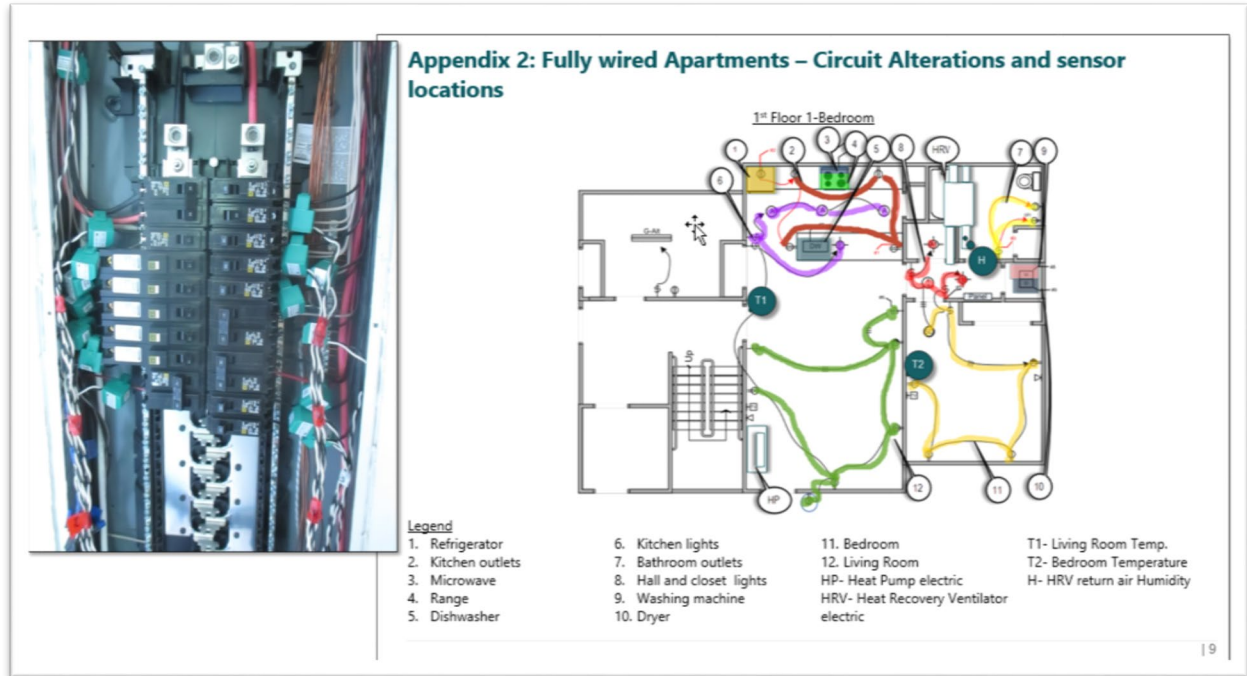
Figure 7. eGauge Monitoring System Setup—Apartment Electrical Panels

Photo of the interior of a fully monitored apartment. CT sensors are located on all end loads in the apartment. Circuit layout is displayed in the diagram to the right.

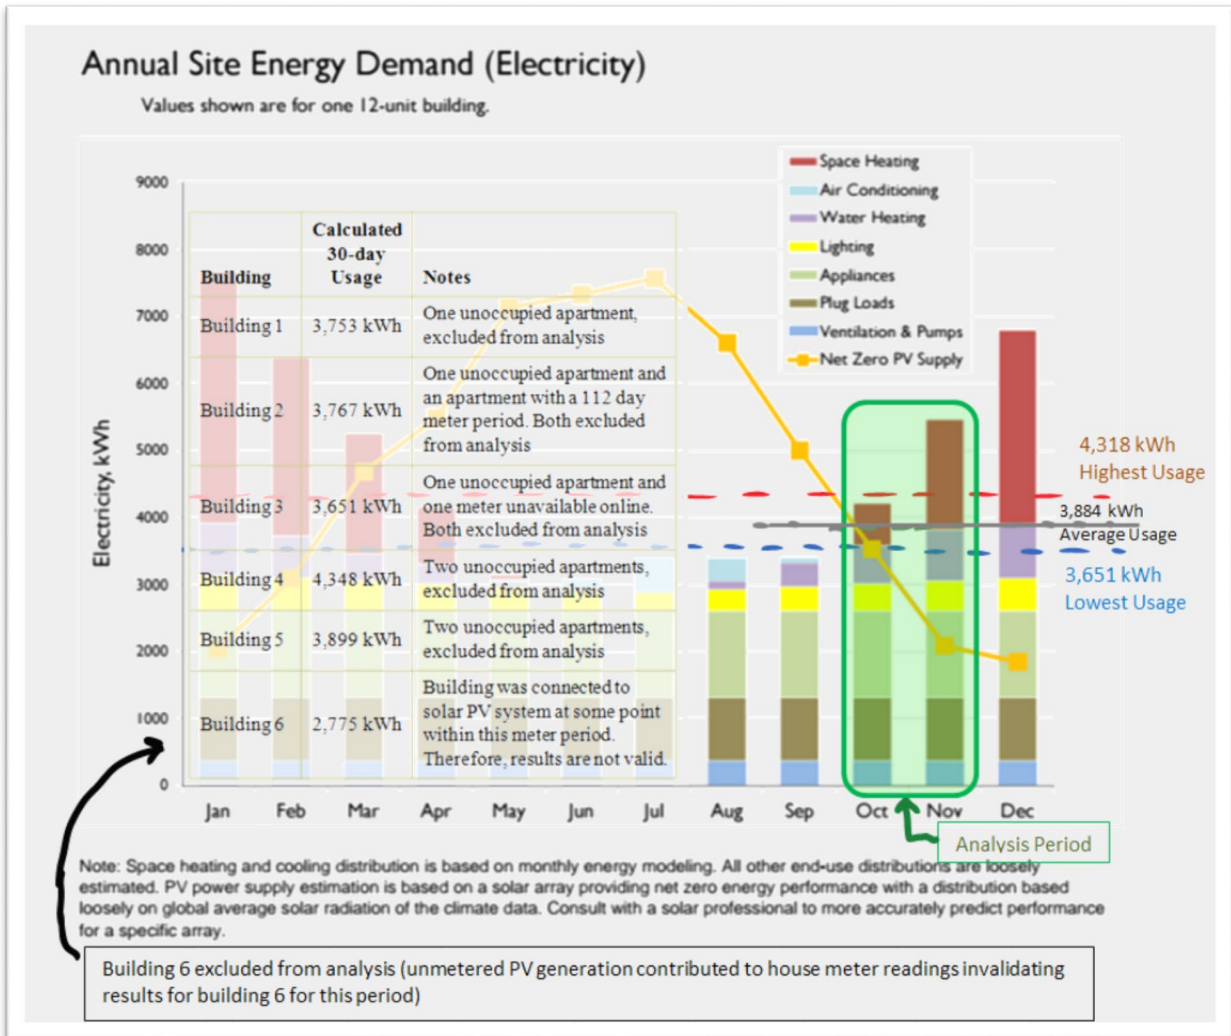
Figure 8. Early Warning Energy Use Summary—Target versus Actual

Graphic displaying GreenHammer energy use and generation model results, annotated with table of 1st month usage data from each building and overlay of actual usage (min, max, mean) versus predicted during the applicable date range.

The first round of analysis was completed immediately after the buildings were occupied and before most of the solar PV systems were operational. PV generation was omitted from this round of analysis.

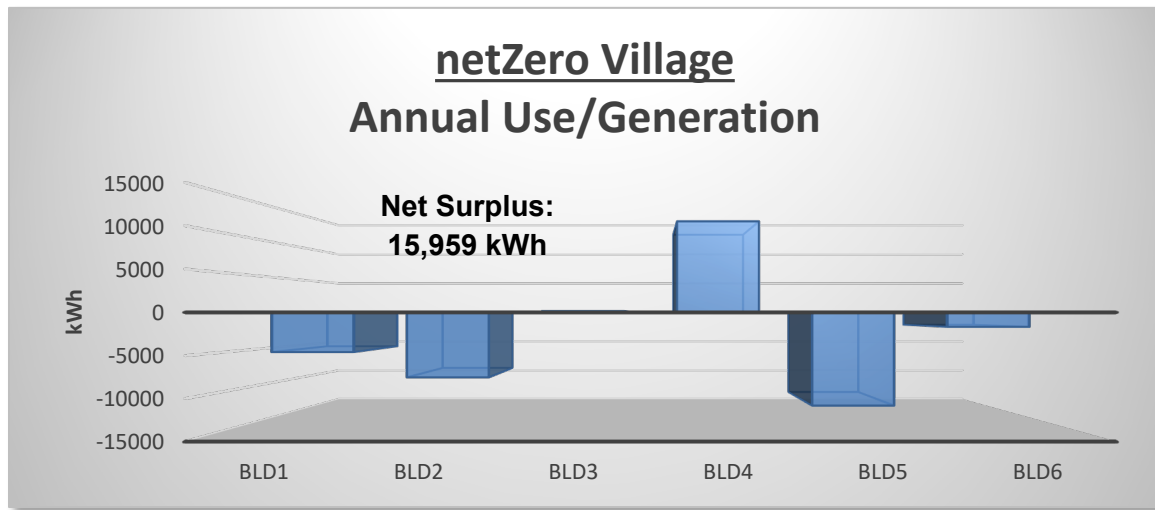
Figure 9. Annual Energy Use at netZero Village

As noted in the summaries and elsewhere in this report, the results from the utility data are promising. All but one of the buildings were at or below net zero use levels.²⁷ Building 4 is the only unit that failed to achieve net zero levels of use due to a malfunction in the solar PV system serving that building. It should be noted that even with this malfunction, the amount of overshoot is the same general order of magnitude as the excess energy generated by some of the other buildings.

Annual use per building bar chart showing all but one building at or below approximate usage targets.

In total, the six buildings performed better than expected, generating a net surplus of 15,959 kWh²⁸ as measured by the utility during the monitored period. This is encouraging and shows potential for future years of net zero use, even after the solar generation starts to diminish and equipment efficiencies drop slightly.

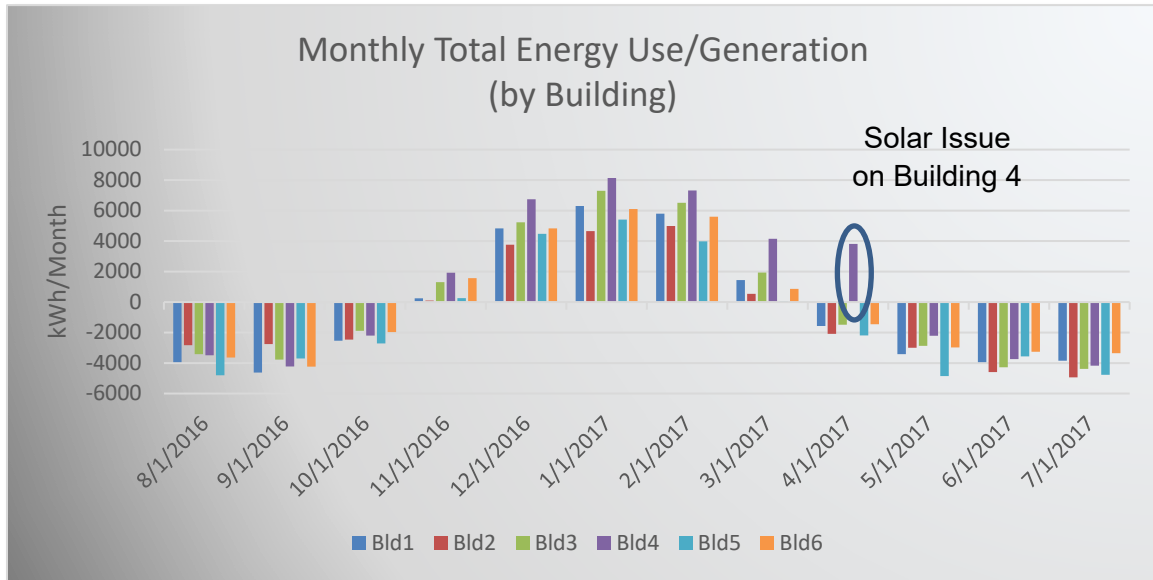
Figure 10. Monthly Building Energy Use at netZero Village

Looking at the buildings' monthly use, it is clear that although there is some variation in use, in general the buildings are regular in their usage patterns and magnitude. Again, this is a promising sign as regular, repeatable usage patterns indicate a properly operating building and will help isolate abnormal usage patterns.

Monthly use per building bar chart showing one year of data. Outlier usage for Building 4 from solar issues highlighted in April portion of chart.

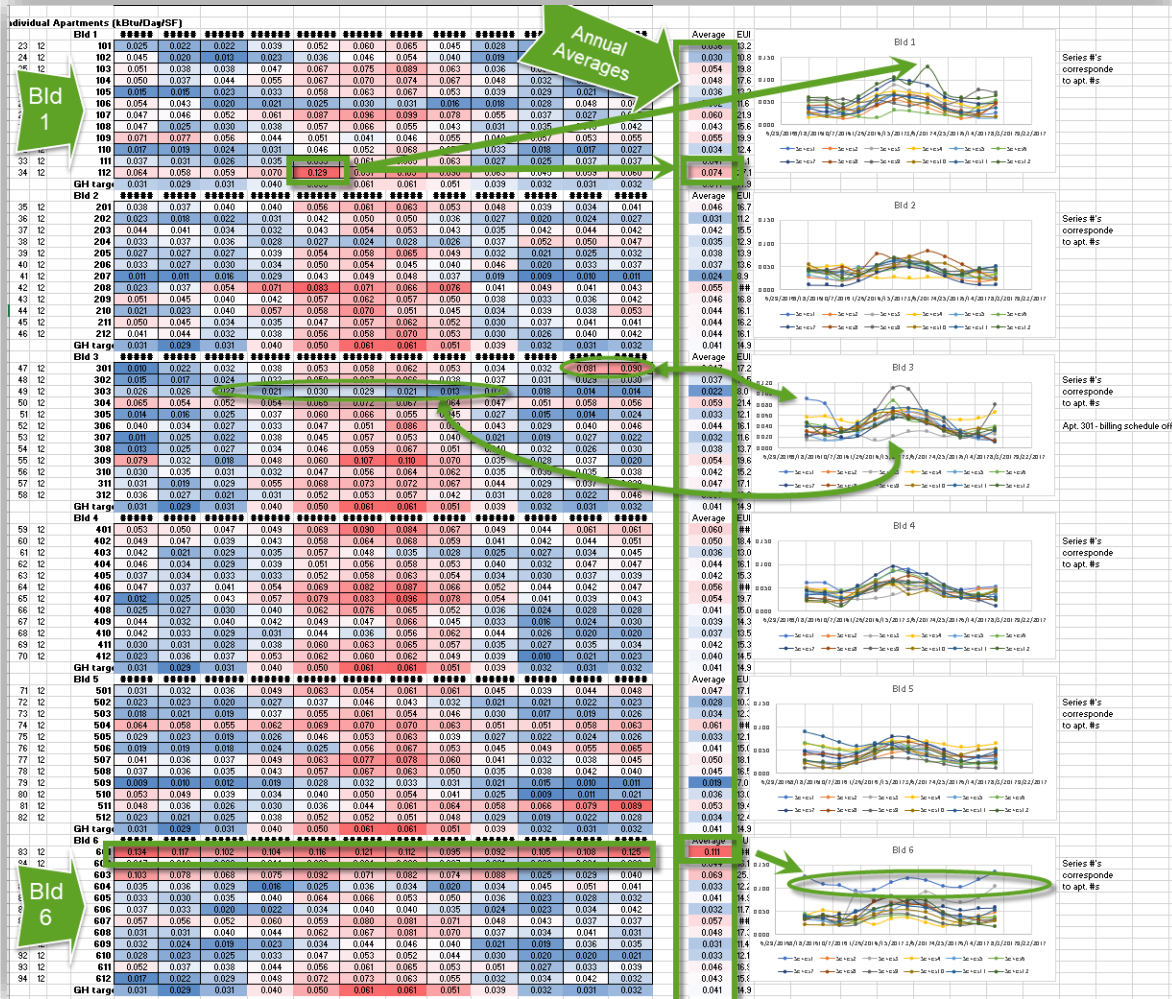
Figure 11: Screenshot of netZero Village Utility Analysis Tool Provided to Owner

Because this data is readily available and can be a useful tool to the owner for diagnostics, forecasting, and early response, several of the tools used in this analysis were provided to the owner. One of the primary tools is a spreadsheet analysis that allows the owner to import data provided by the utility (in its raw, unformatted version) and will then automatically parse the data into the appropriate billing periods, compare it with the predicted energy use, and creates a color coded set of tables and charts that can be used to identify outliers.

Screenshot of spreadsheet tool provided to owner with specific features and methods of use highlighted in green text and markup icons.
