High Performance Insulation in Existing Multifamily Buildings: A Demonstration Project Using Aerogel Materials

Final Report

November 2013

Report Number 14-02

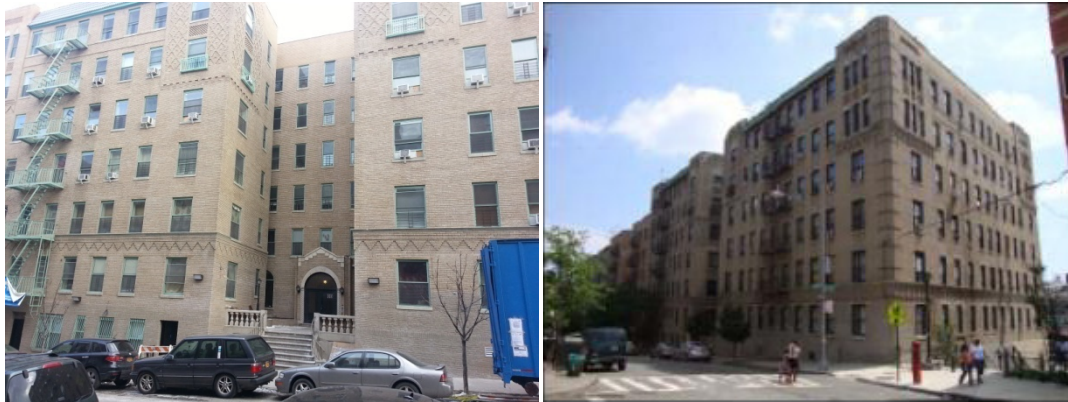
Figure 1. 1770 (left) and 1780 (right) Davidson Avenue

In 2012, Davidson Avenue Cluster in the Bronx shown in Figure 1 was selected. The rehab of these buildings, owned by TPT Davidson Avenue LLC, and operated by Bronx Pro, ultimately became the confirmed site for the aerogel installation project. Design and construction costs totaled \$19.8 million. Construction began in July 2012. Estimated completion was July 2014, and actual completion is projected for December 2014.

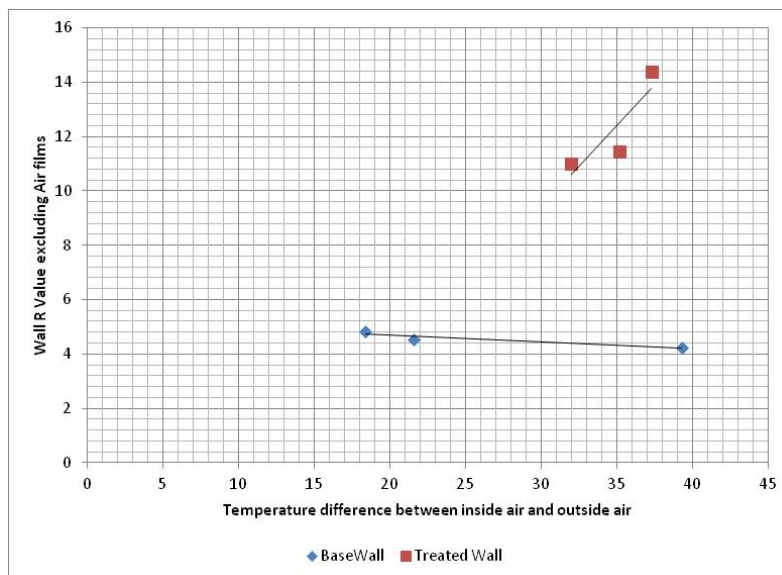
Figure 1 –Wall R values and Delta T across walls

Trial	Base Wall	Average dT	Treated	Average dT	Aerogel
1	4.84	18.4	11.01	32	6.17
2	4.53	21.6	14.4	37.3	9.87
3	4.25	39.3	11.46 ¹	35.2	7.21
Average	4.5	26.4	12.3	34.8	7.75

Table 1 - Measured R values of wall assemblies excluding air films

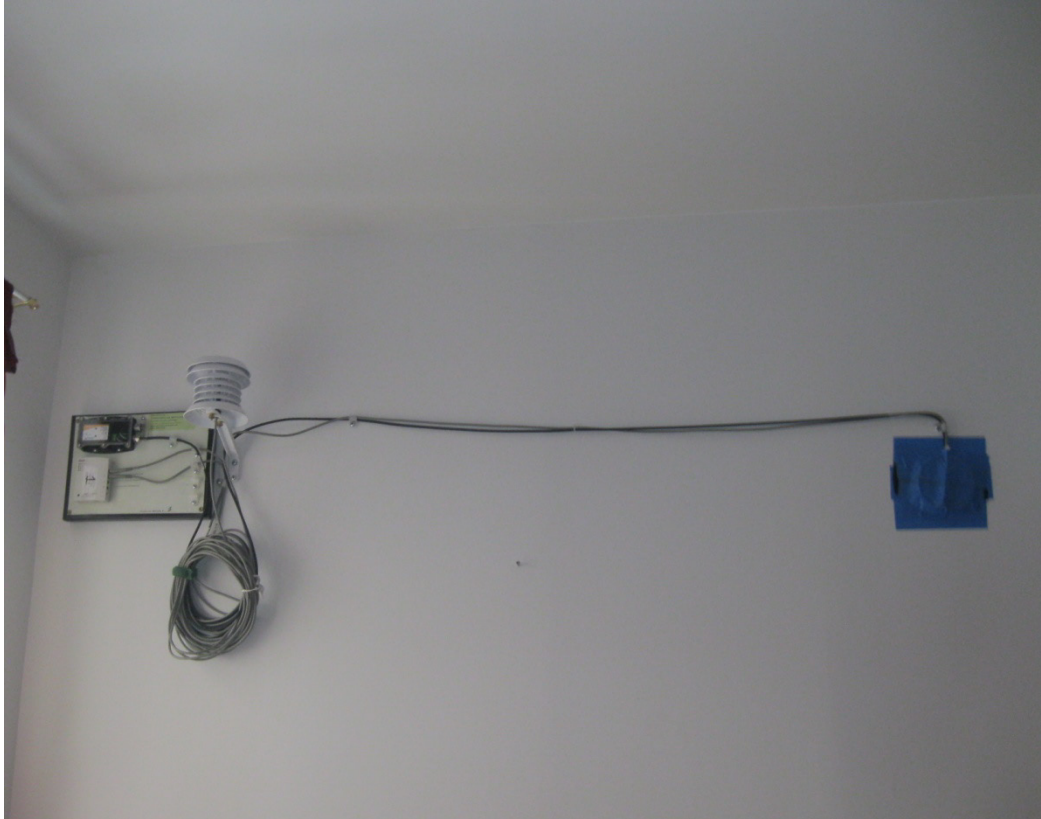
Figure 3 – Interior Equipment Setup Photo

A 5 inch square of painters tape was applied to the inside surface of the test wall as shown in the photograph above. The heat flux sensor was adhered to the painters tape using double-sided tape.

The Inside surface temperature sensor was an Onset TMC20-HD Water/Soil Temperature sensor adhered to the face of the heat flux meter using tape.

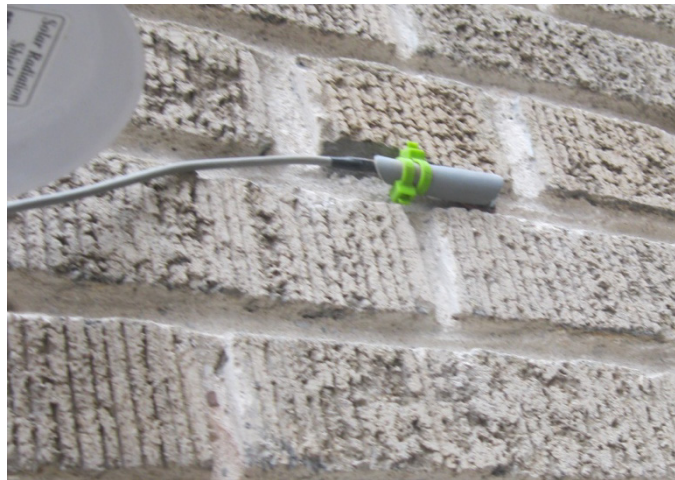
Figure 6 – Exterior Surface Temperature Sensor Photo

Outside air temperature sensors (shown with green bracket in above photograph) were Onset TMC20-HD Water/Soil Temperature sensors mounted on brackets that were attached to the building cladding and shielded from solar radiation using an Onset RS3 radiation shield. Wiring for exterior sensors was routed through the nearest window opening to the datalogger inside the unit.

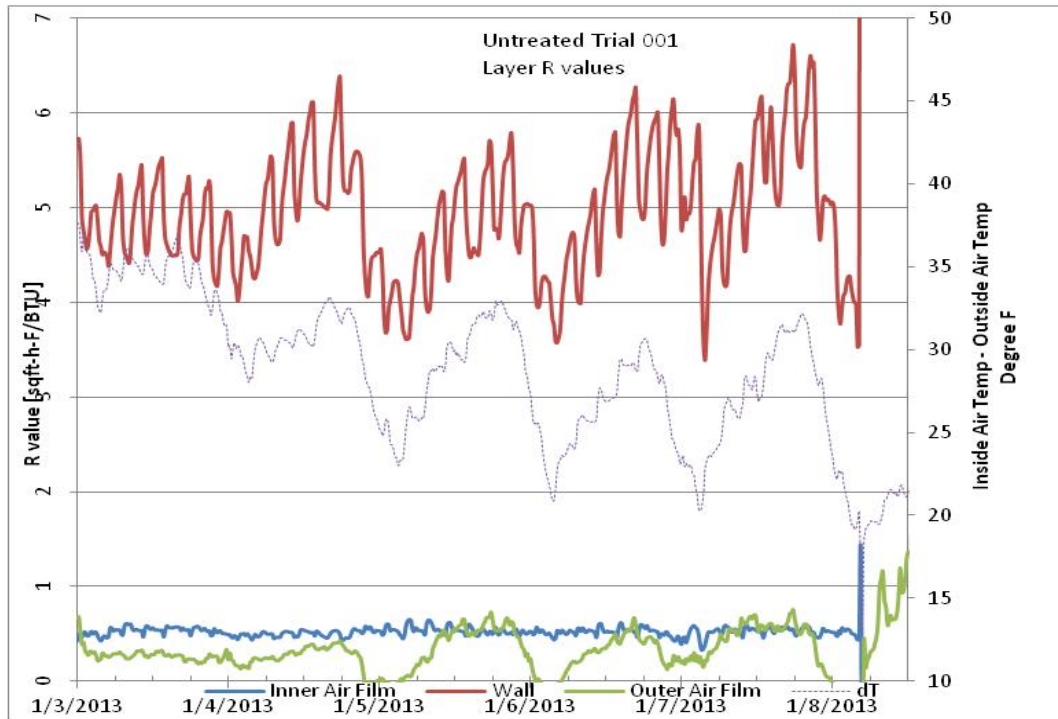
Figure 8 – Trial 1: Untreated wall layer R values over trial time

For the data in the above graph (Untreated Trial 001), the interior sensor was dislodged by work crew on 1/8/13. Remaining trial data was meaningless. From this graph, R value averaged 4.84 with a corresponding average dT of 18.4 °F ($T_{is} - T_{es}$).

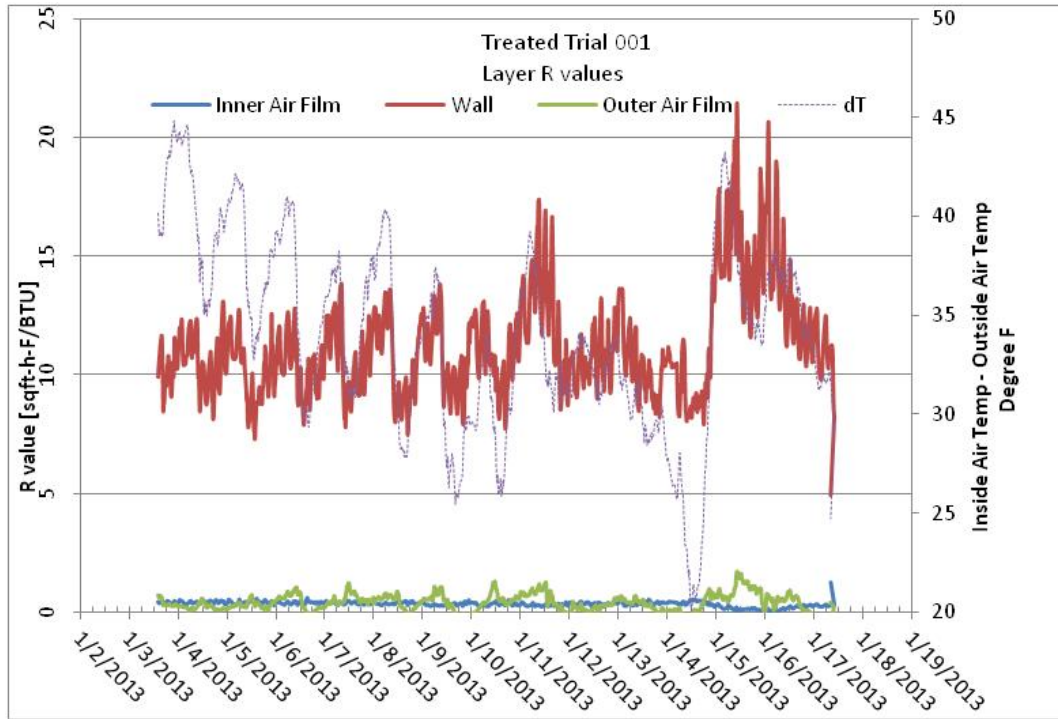
Figure 9 – Trial 1: Treated wall layer R values over trial time

For the Treated Trial 001 (graph above), R value averaged 11.01 with a corresponding average dT of 32.0 °F.

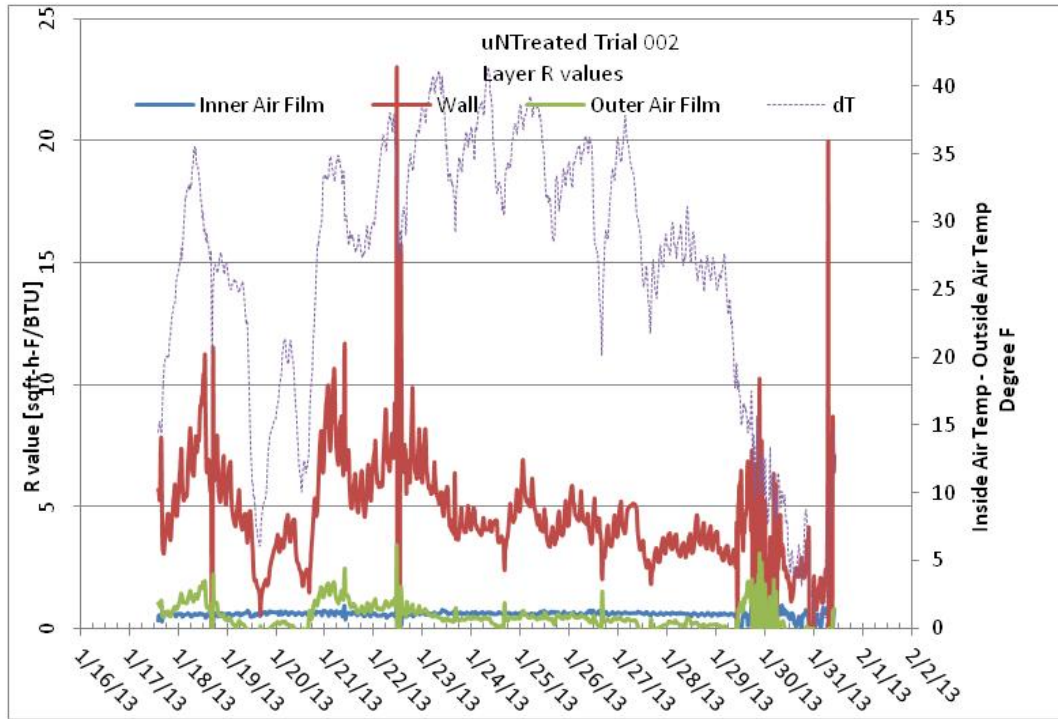
Figure 10 – Trial 2: Untreated wall layer R values over trial time

For the Untreated Trial 002 (graph above), R value averaged 4.53 with a corresponding average dT of 21.6 °F.

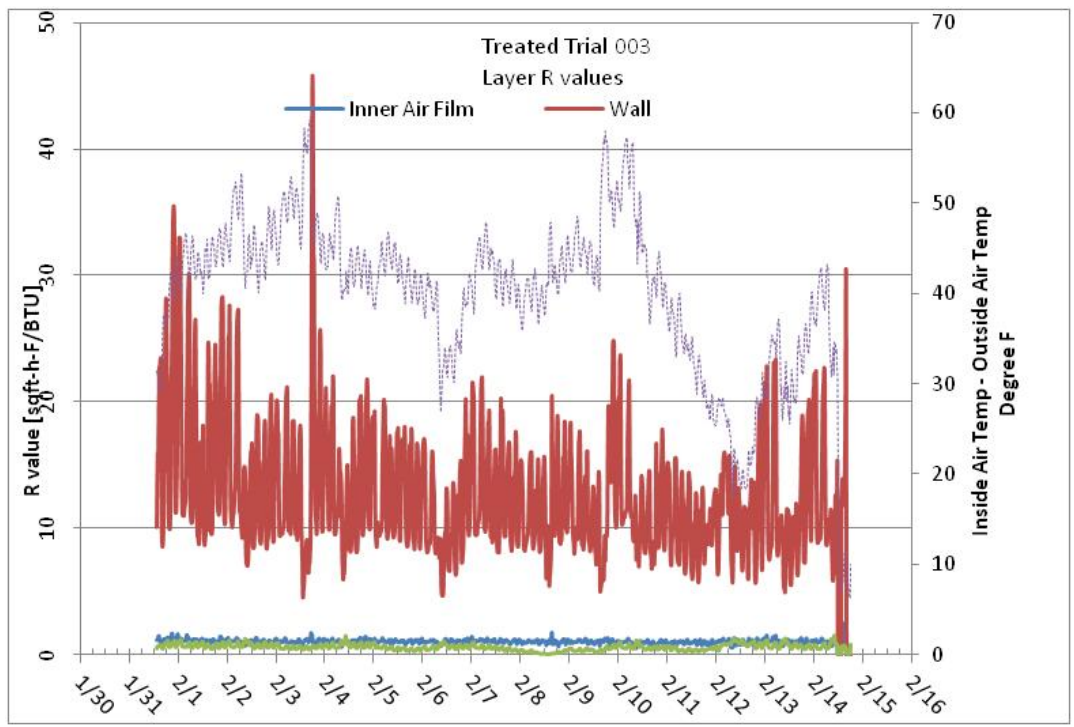
Figure 13 – Trial 3: Treated wall layer R values over trial time

For the Treated Trial 003 (graph above), R value averaged 11.46 with a corresponding average dT of 35.2°F.

The exterior temperature data (exterior surface temperature and exterior air temperature) for the Treated 003 trial was corrupted. These values are needed to determine the R value of the exterior air film. Cross plots from the previous trial show that while the R value of the exterior air film varies widely with changing weather conditions, the value from one sensor location to another is somewhat constant (see plots below). Although the correlation is not perfect (all the data would fall on an $x=y$ line), it does allow an estimation of the R value of the Treated wall.

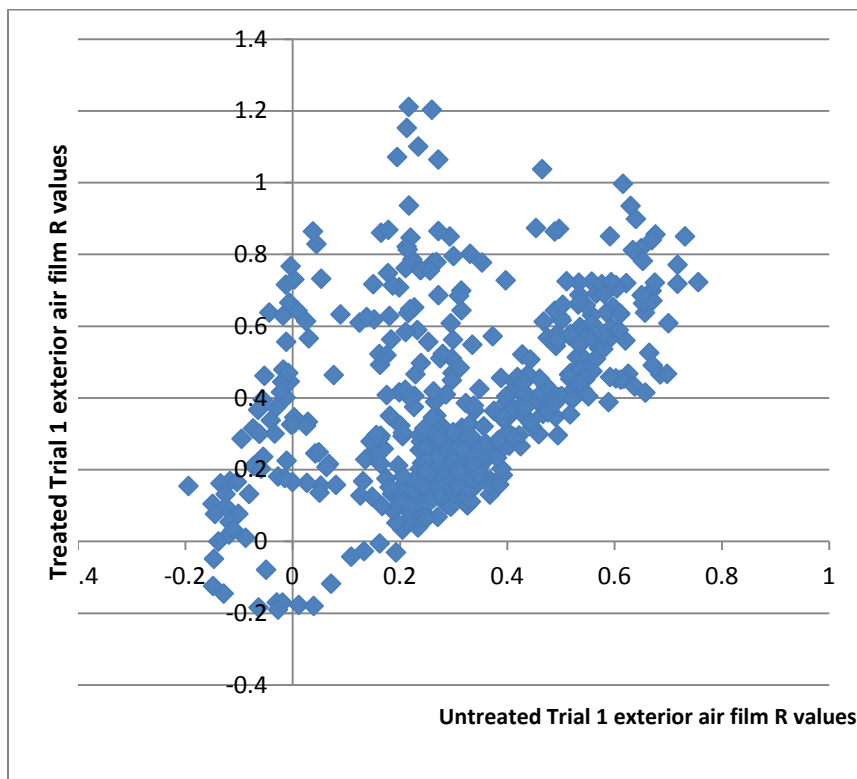
Figure 14 – Cross Plot of Exterior Air Film R-values for Treated and Untreated Trial 1 Walls

Cross plot of Exterior Air film R values for the Treated and untreated Trial 1 wall.

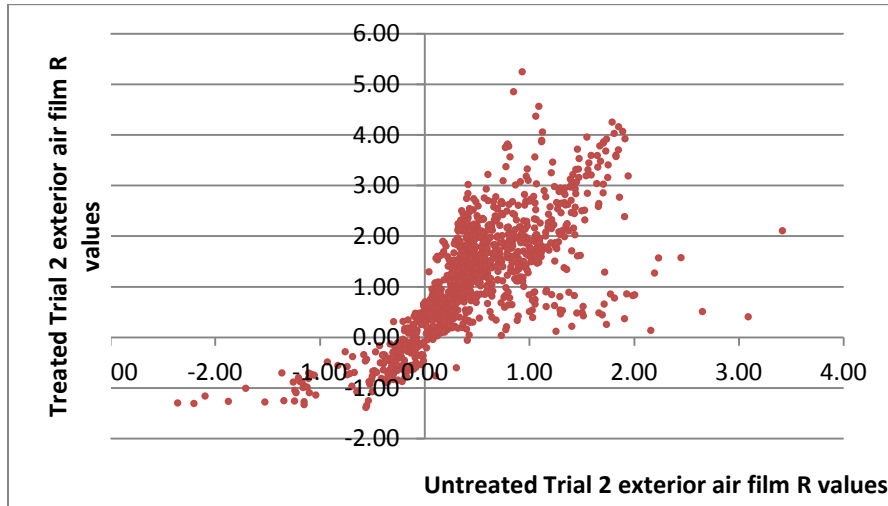
Figure 15 – Cross Plot of Exterior Air Film R-values for Treated and Untreated Trial 2 Walls
 Cross plot of exterior air film R values for the Treated and untreated walls in Trial 2.

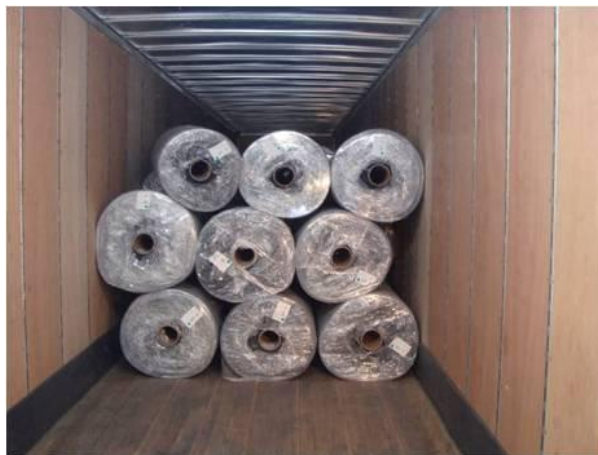
Aerogel insulations when shipped in full rolls are typically 57” wide weighing approximately 200 lbs per roll. Individual rolls are shrink-wrapped and stacked into delivery truck as shown in picture to right. Individual rolls can be moved manually with two people from the delivery truck to storage area but the use of a pallet jack or forklift will be helpful to speed the process and minimize individual handling and increase safety. If moving rolls manually, the rolls can be moved with the use of an aluminium tube placed through the center of the roll and picked up from either end. The following series of pictures shows the best practices sequencing for moving rolls with a forklift. The specific process will be customized to the location and requirements of the off-loading site.

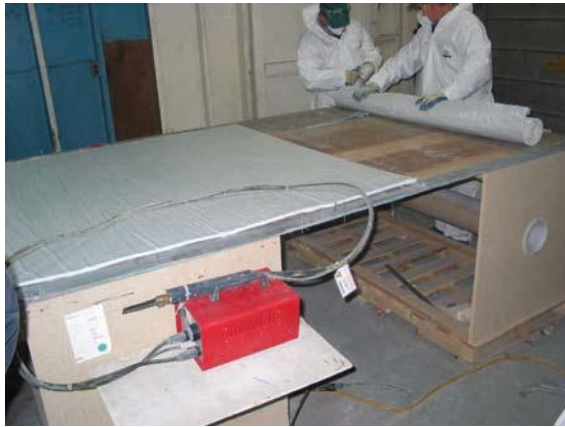
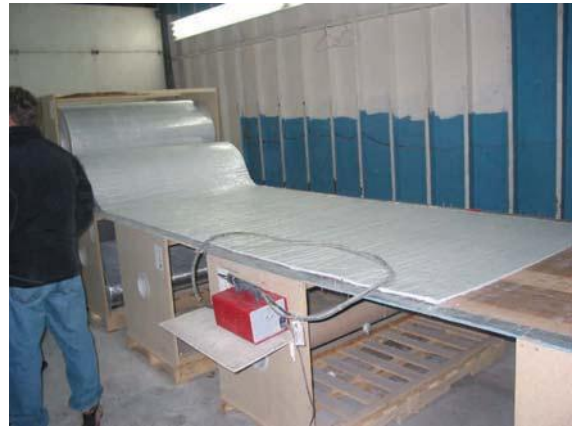
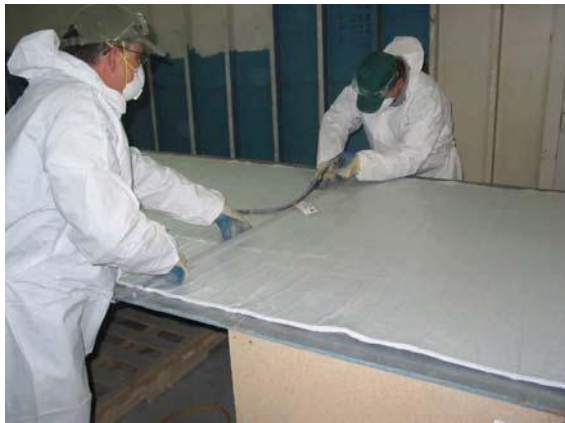
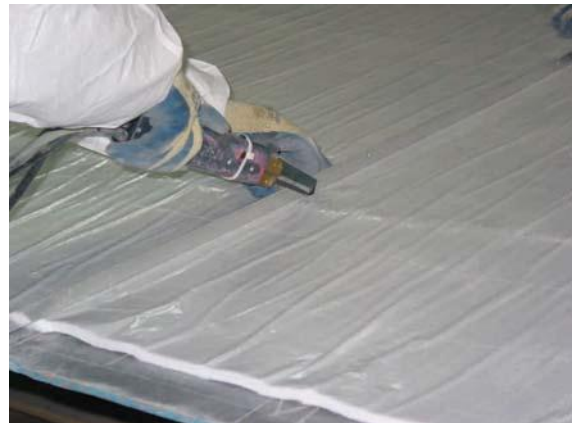
BULK CUTTING AREA

To achieve the most productive work environment for use with Aerogel insulations we suggest the following setup.

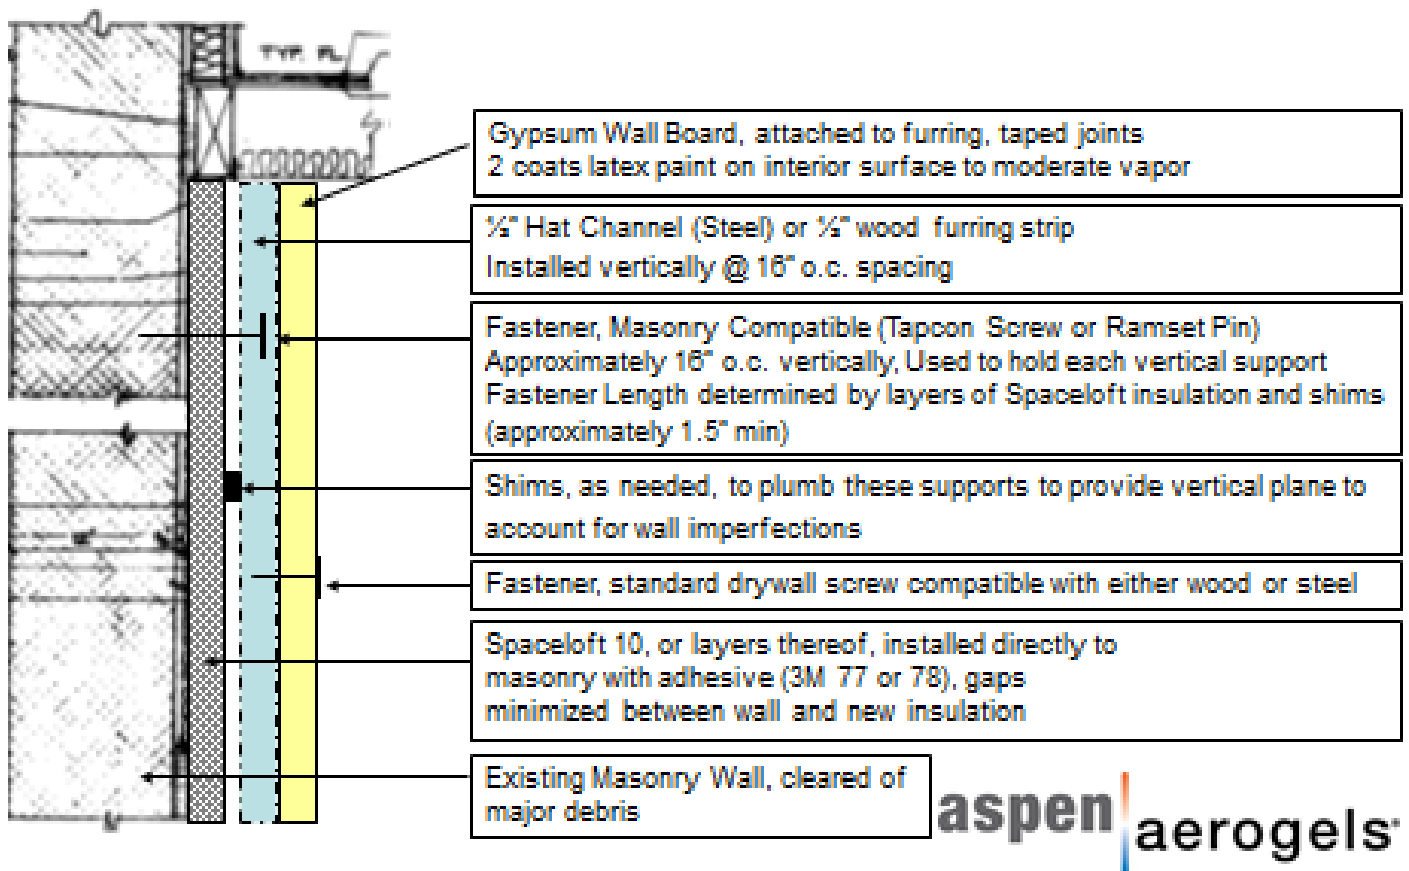
Proposed Wall Section Design For Spaceloft Aerogel Insulation Interior Installation with Channel for Conduit

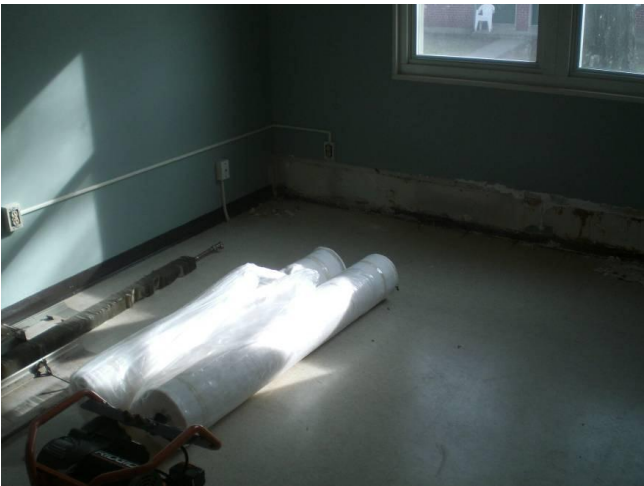
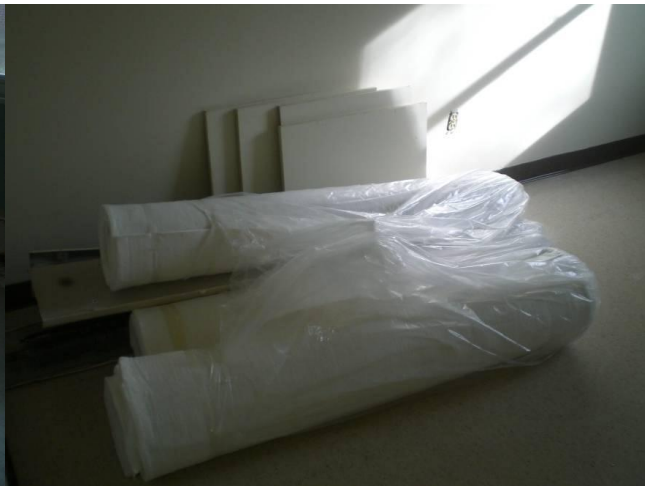
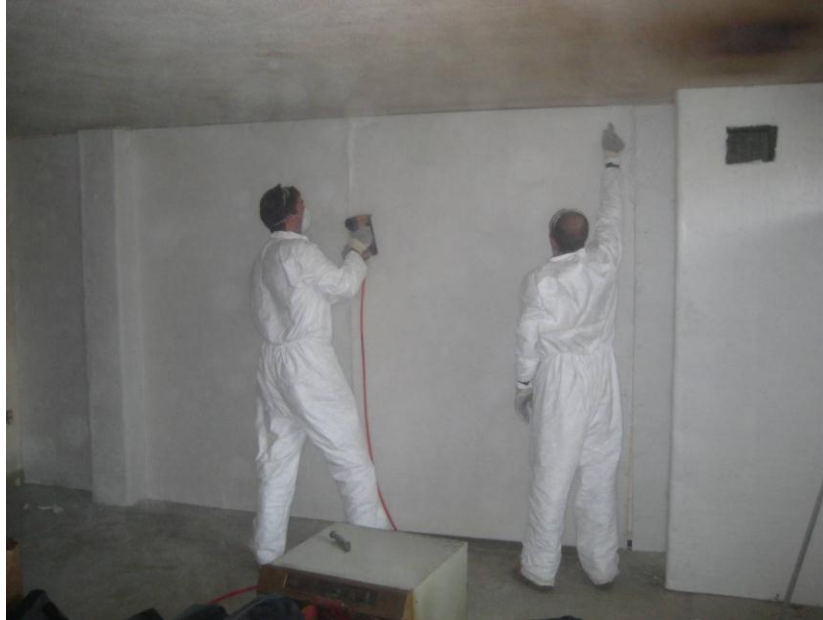
- Two layers of Spaceloft aerogel blanket will be applied to the wall area
- Spaceloft blanket roll material will be pre-cut to the ceiling to floor height outside the unit
- Roll and place cut material into plastic bags and staged within established access path
- Insulation will be installed vertically from ceiling and draping down to floor or finish height

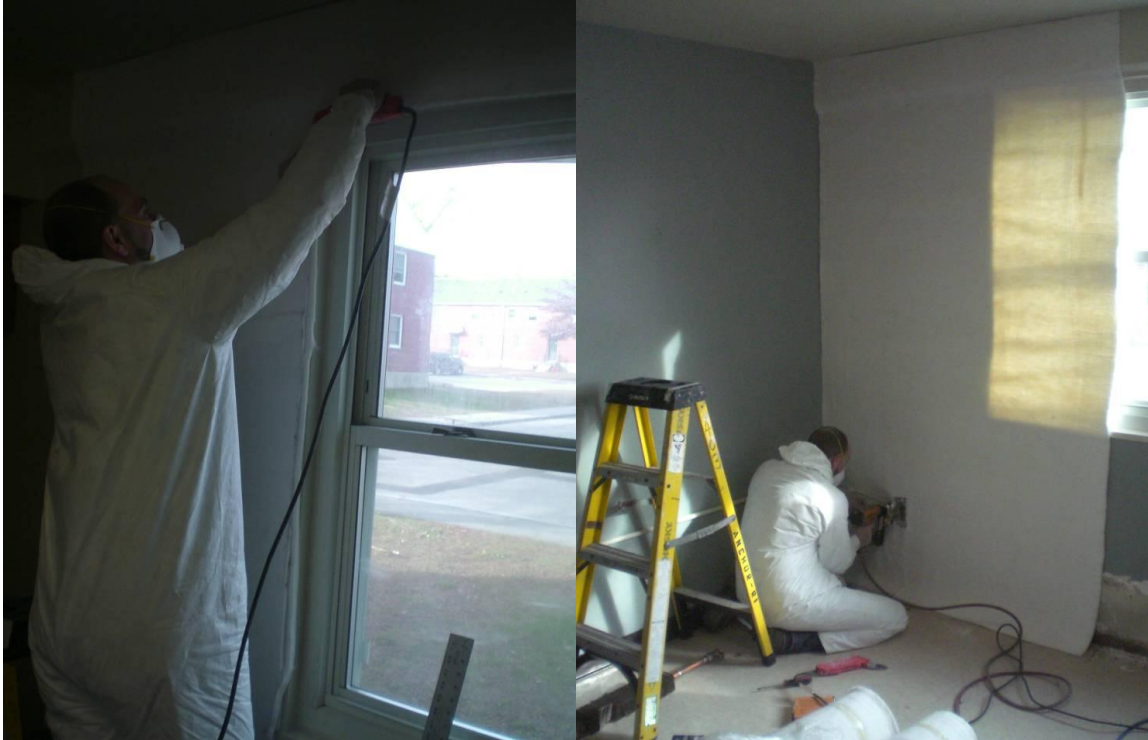
3. Aerogel Fastening Technique

- Pneumatic staple over existing plaster
- Aerogel Fastening pattern
 - Field: Minimum 1 staple every 16" o.c. horizontally along the top and vertically at the edges to hold Spaceloft/Aerogel in place
 - Openings: Min 1 staple every 6" o.c. along border of opening, or cont. spray adhesive

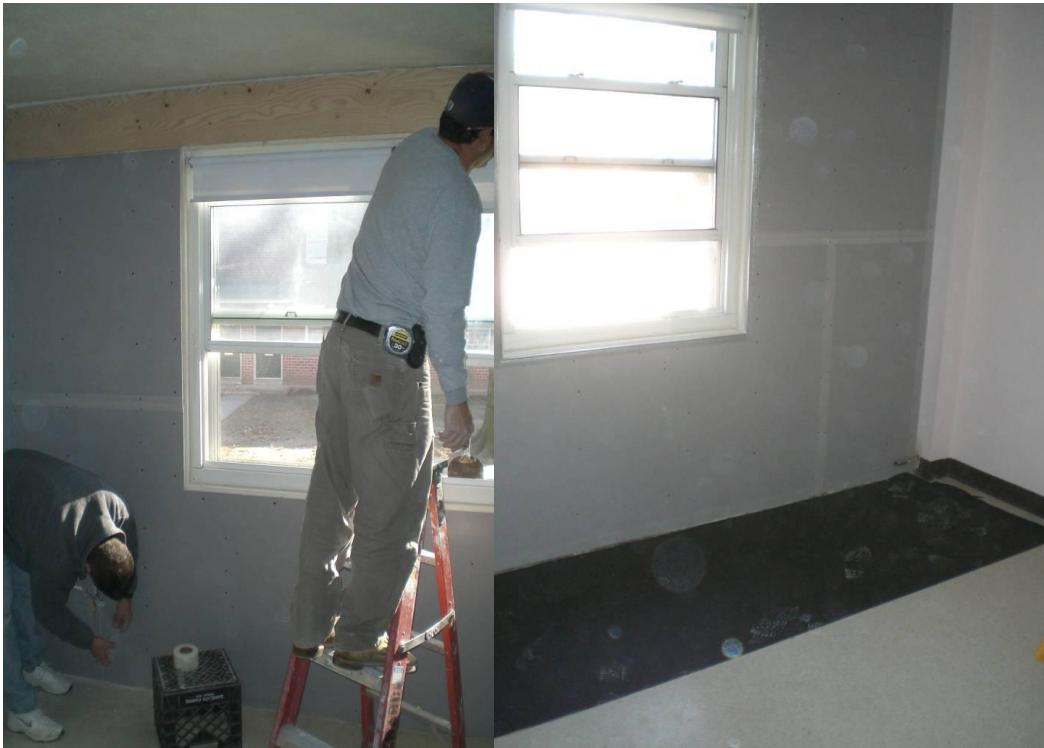
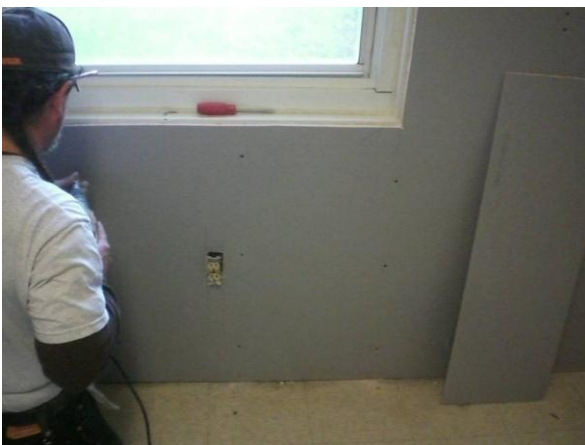
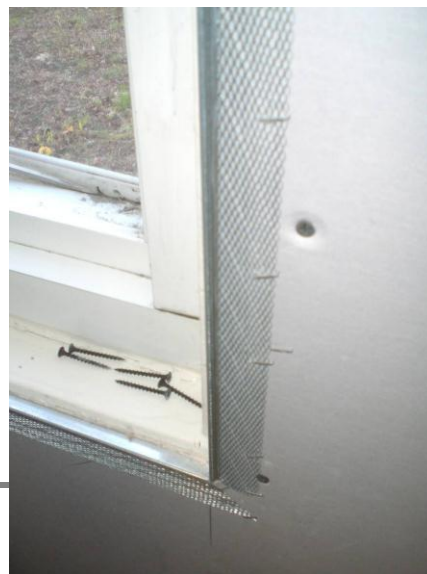
- Identify wood strapping locations (16" o.c.) with pencil marks at ceiling and floor
- Ensure that drywall screws are of sufficient length to reach wood strapping
- (minimum 2" to accommodate existing wall and aerogel insulation)
- Install by standard wall board technique, over all aerogel on exterior walls

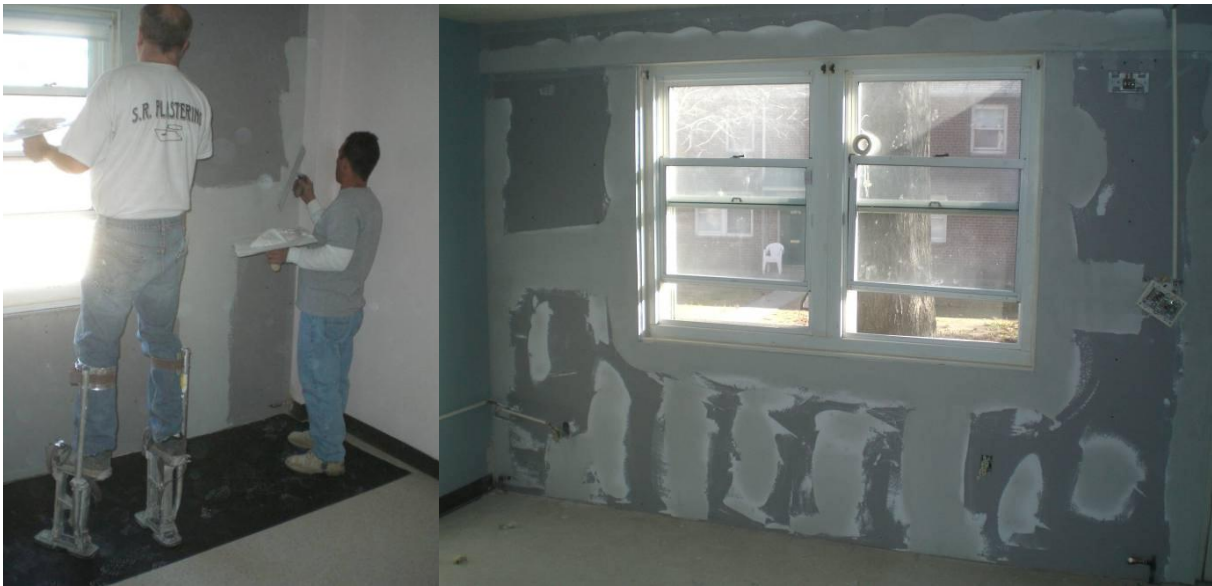
- L-trim and caulk installation at all window and door openings
- Apply dry wall tape and joint compound at gypsum board joints and along L-trim
- Sanding of joint compound to provide a quality interior finish
- Install extension boxes for flush mounted wall sockets
