Blackout Provides Real-World Test for Resilient DERs

prepared for
NYSERDA

June 30, 2020

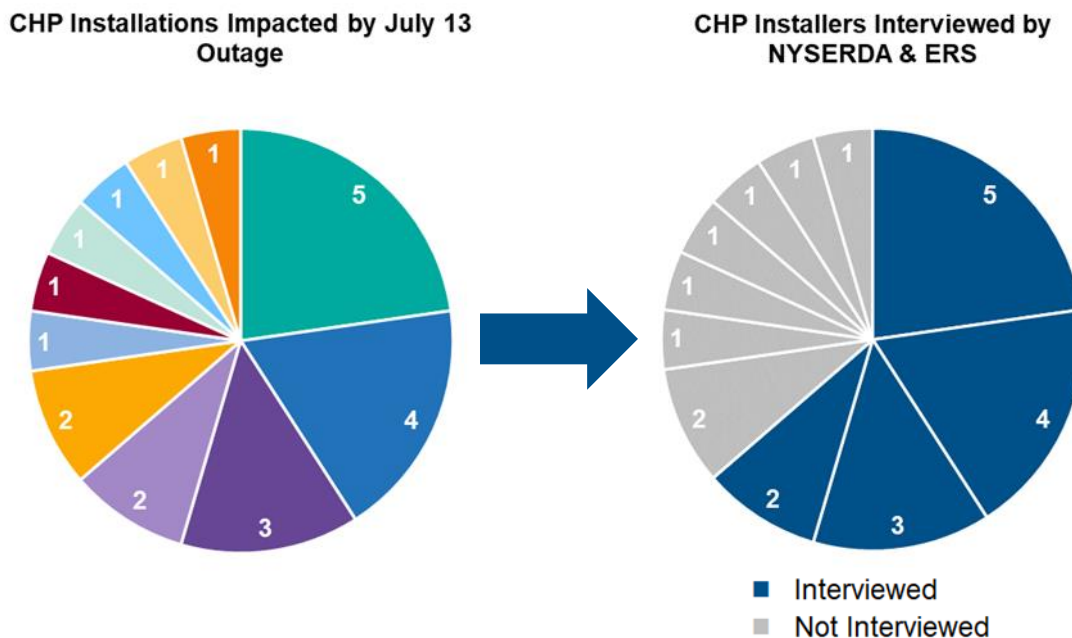
Figure 4. CHP Installations Impacted by Outage & Interviewed, Grouped by Installer

As previously discussed in NYSERDA DERs Affected by the Power Outage, we identified 22 CHP systems at facilities impacted by the July 13 power outage, spread across 15 installers and/or operators, although high quality data was only available for 13 systems. NYSERDA ultimately chose to interview only four CHP installer/operators. Although only 27% of the potential operator pool was interviewed, these four firms represented the majority of the systems impacted – they had acted either as the system installer or the system operator for 63% of the total sites, as documented in Figure 4.
