NYSDEC Truck Scrapage Guidance

This document describes vehicle scrapage requirements required to meet the VW Settlement funded vehicle scrapage eligibility.

Truck Destruction Requirements

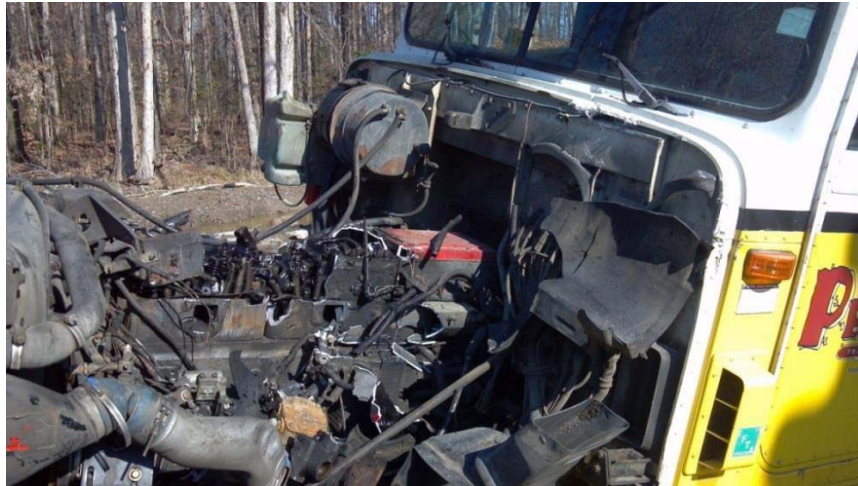
Example of visible destruction of the engine block

- Cut or drill a minimum 3-inch diameter hole through the engine block.

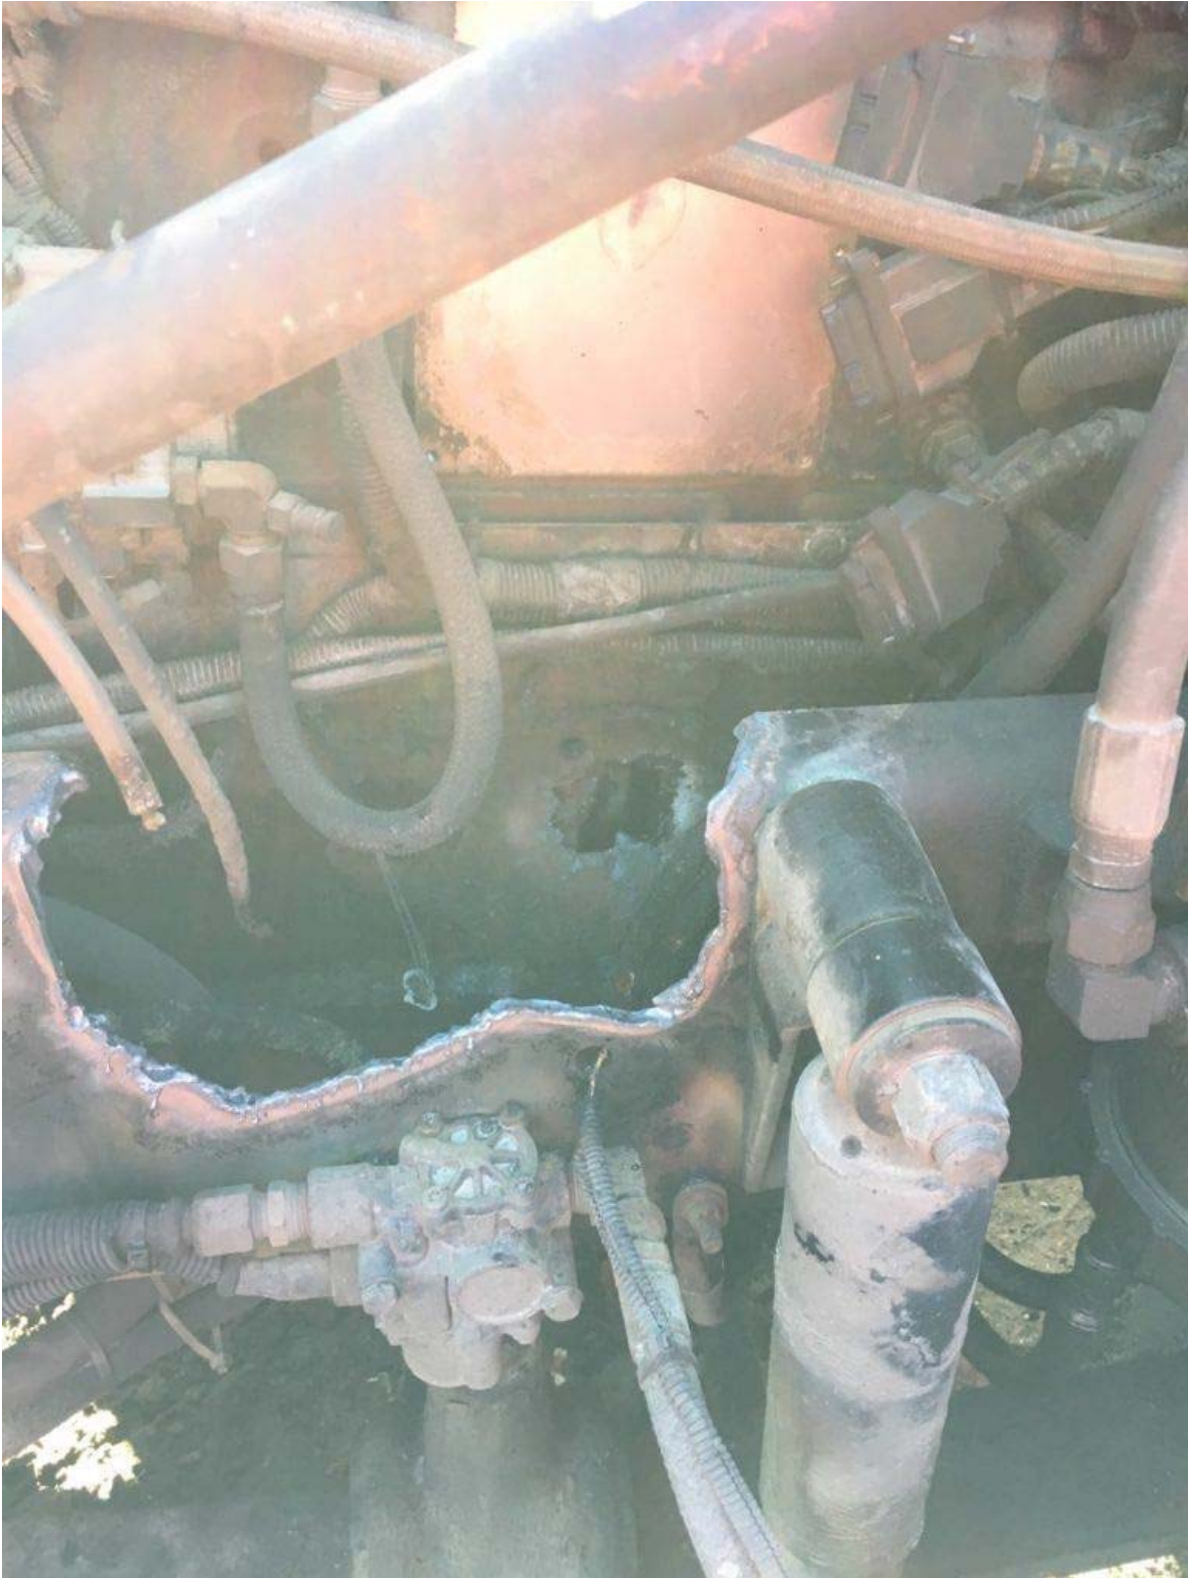
Example of complete engine hole

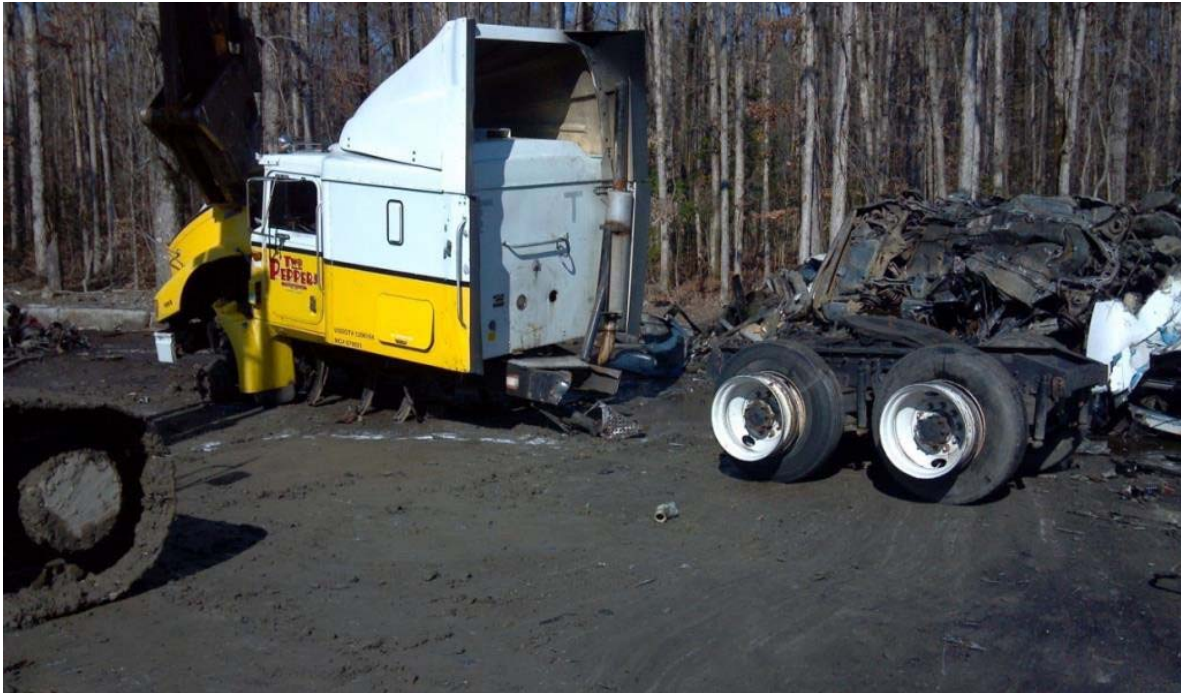
Example of chassis cut in half

- Cut or shear both the chassis rails between the two axles.

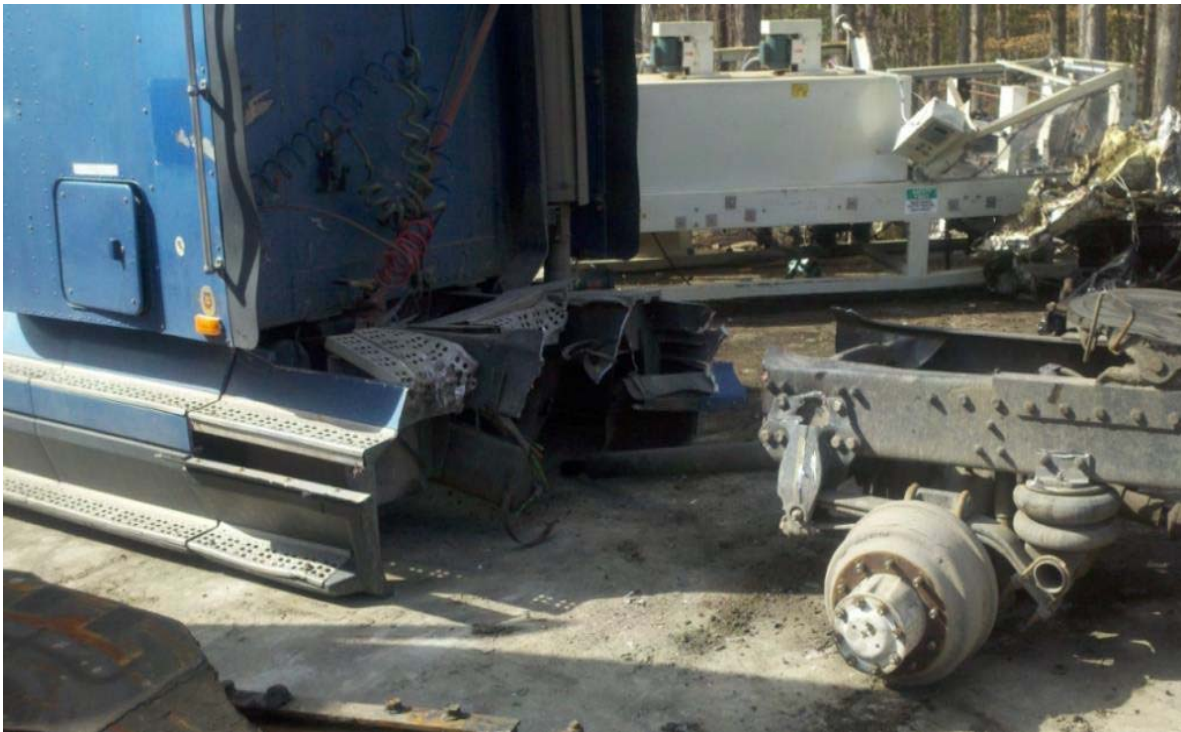
Example of chassis completely cut
